## 2003 Workhorse Step Van

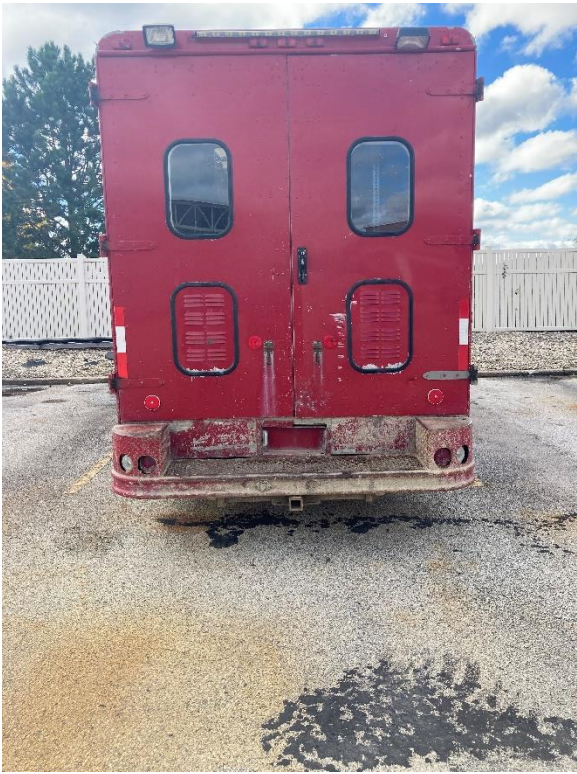
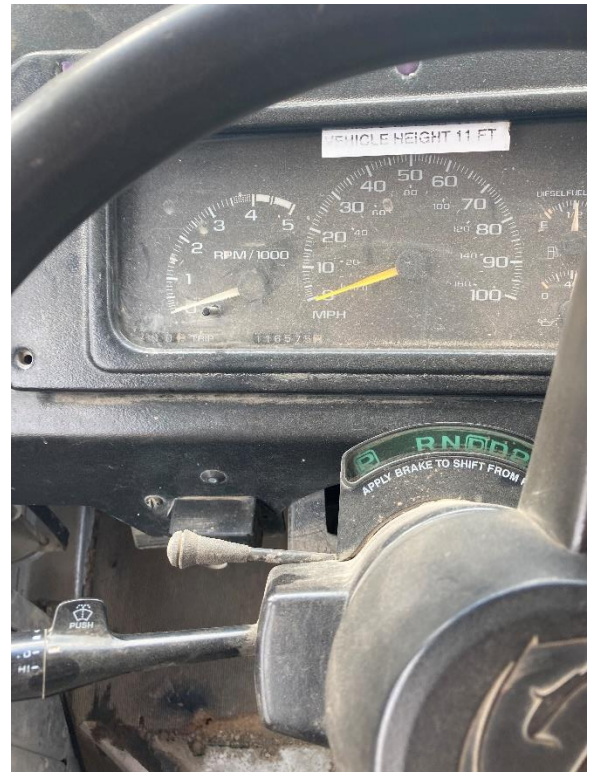
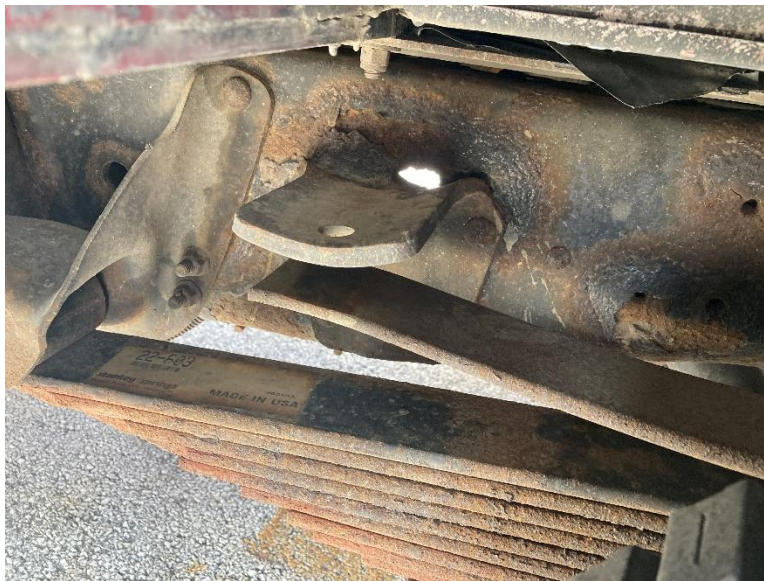
The frame is rusted out in the rear at the suspension mounts creating an unsafe failure point that cannot be repaired without replacing the frame rails. The frame rails behind the rear axle are twisted and the cross member mounts are rust jacking away from the frame.

The riveted body panels have been loosened over time causing the body panels to shift making the doors misaligned. The misaligned doors do not close properly.

Twenty-two years of heavy use has attributed to all of the seating upholstery being torn and the seat pads being worn flat.
