PROJECT MEMORANDUM

OWNER: Village of Orland Park

RE: Cultural Arts Center – Dance Studio Wood Flooring

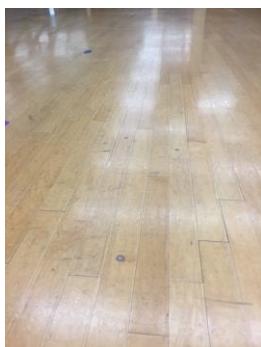
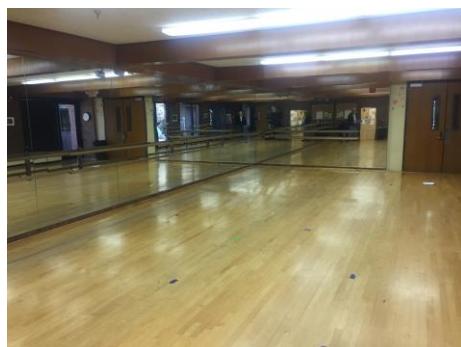
Photos of Existing Conditions

Over the last several months, The Village of Orland has noticed that the expansion and contraction of the Dance Studio wood floor has triggered multiple areas to "buckle" and cause a bump/rise in the flooring. This results in a tripping / safety hazard for any users that occupy the space. They have since repaired these locations by nailing those boards to the concrete subfloor to remove any difference in height. Since this is only a temporary solution, other locations have and will continue to "buckle" resulting in safety concerns for the occupants.

- The existing wood flooring is directly adhered / glued to the concrete sub floor. Concrete produces moisture that eventually comes up through the slab. In this case there was no vapor retardant barrier system originally installed between the wood floor and the concrete slab. Over the years the moisture has caused the flooring adhesive to fail and lose its bond to the concrete resulting in the buckling of the boards.
- Solution: Remove existing flooring. Test existing concrete slab for moisture. Install vapor retardant moisture barrier if concrete is above 85% relative humidity. Install new flooring system as required.
- On behalf of the Village of Orland, StudioGC was authorized to acquire at least (3) proposals beginning on June 13th 2016, to remove and replace the flooring system. Currently (3) proposals are in hand.
