# THE VILLAGE OF ORLAND PARK BASIN BEST PRACTICES PROGRAM

## BASIN ASSESSMENT AND MANAGEMENT PLAN REPORT

Report Date:  
June 30, 2011

Prepared by:  
V3 COMPANIES

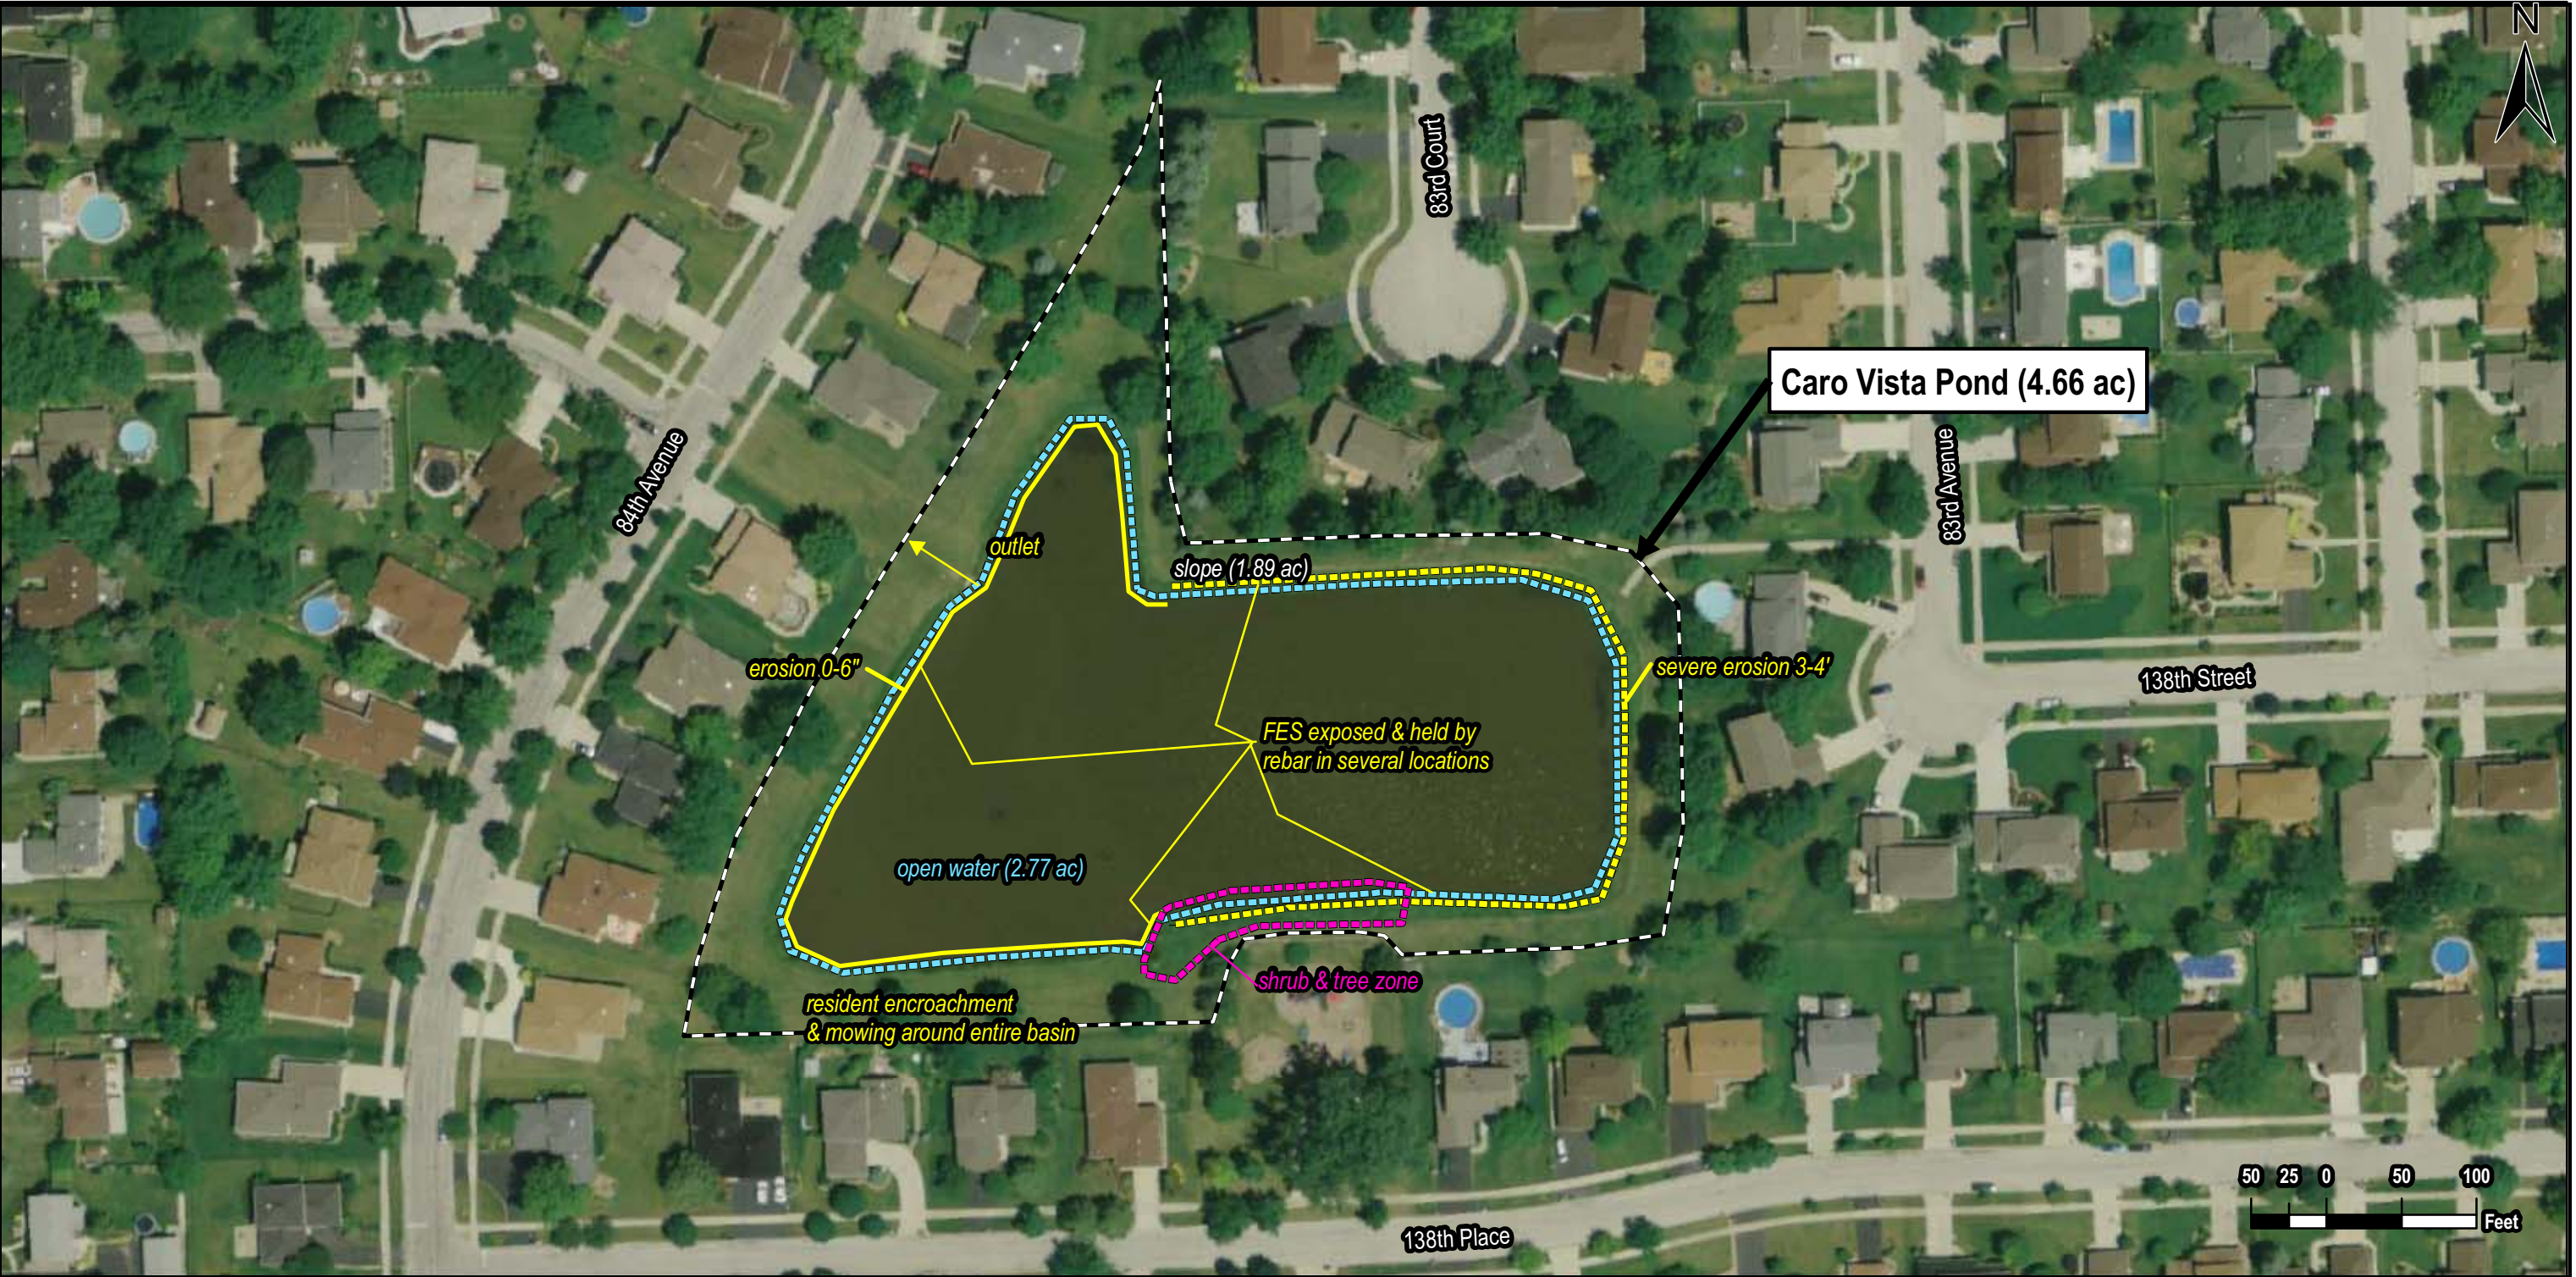
INLET PROBLEMS: Erosion is exposing FES. Rebar used to hold them in place. Failed FES should be repaired

MUSKRAT DAMAGE OBSERVED (YES/NO): Yes - Various, 5 Muskrats trapped recently

Typical 25' - 35' of mow with 5' - 10' of buffer

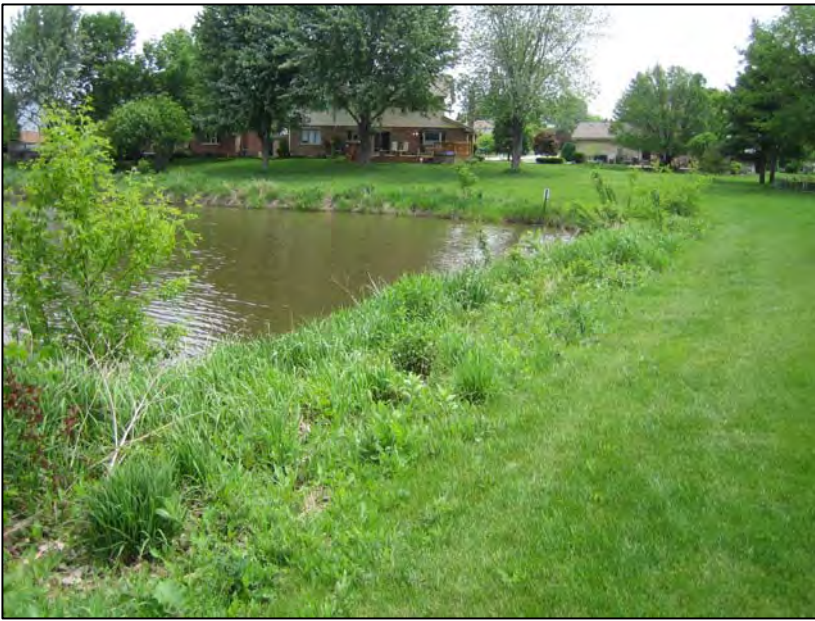
Eastern Portion of Caro Vista Pond: View east. Significant toe erosion along far slope.

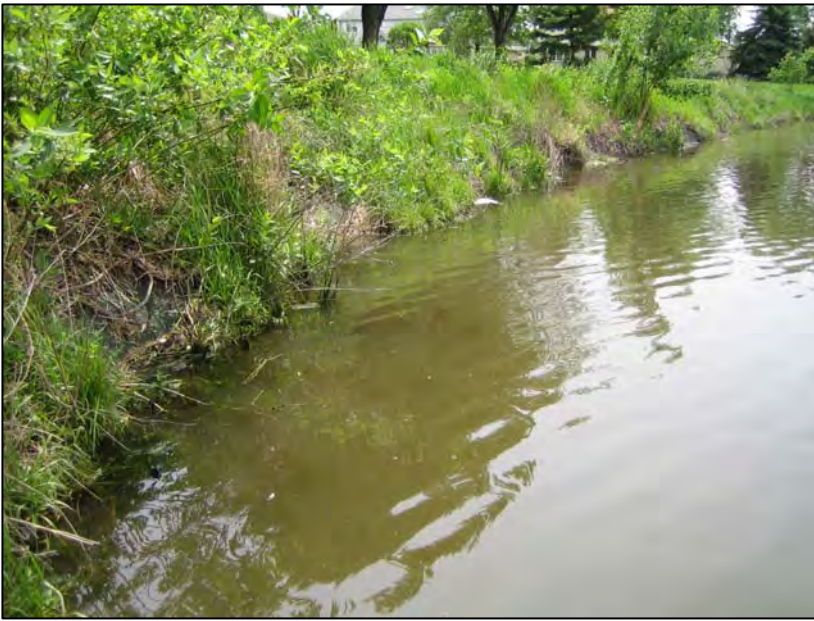
Permanent blanket  
exposed – minimal  
vegetative growth
