# Village of Orland Park, Illinois Historic Buildings Survey

**Address** 9999 143rd Street

**Common Name** Old Methodist Church

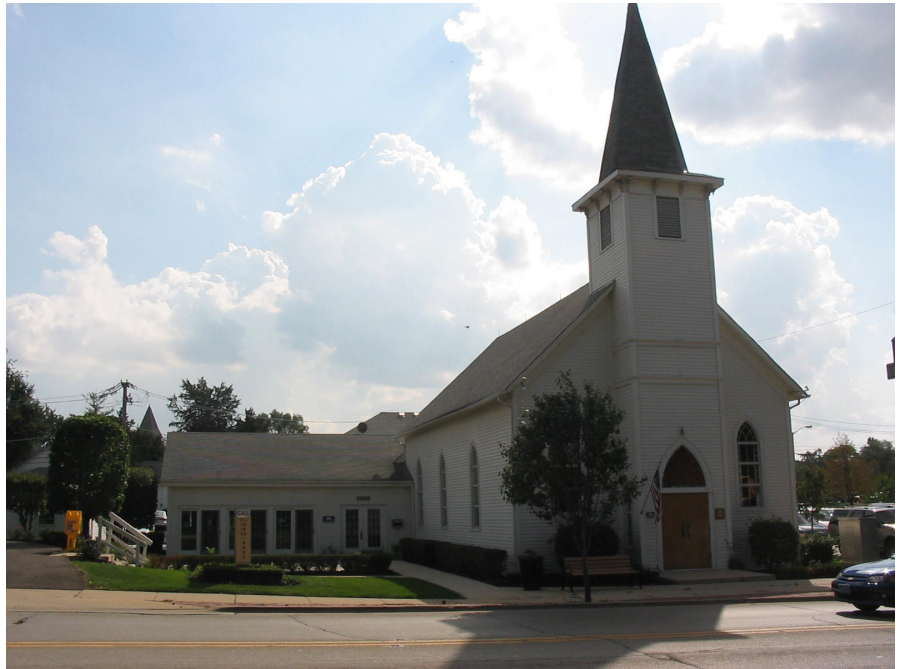
9999 143rd St\_3.jpg

**Window Type & Materials** Original stained glass within the gothic arched window above door; remaining gothic arched windows are replacements with applied muntins

**Alterations** Synthetic siding; windows have been replaced; front door has been altered; there is a large addition at the side toward the rear

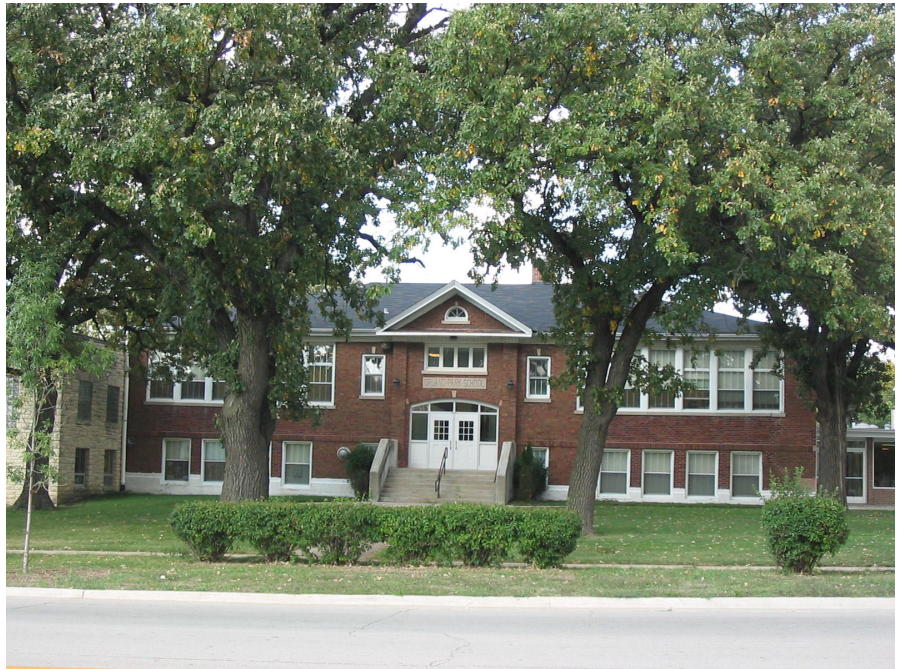
9960 143rd St\_9.jpg

**Alterations** There is a 1940 Joliet limestone gymnasium addition to the west and a steel and glass, International style addition to the east

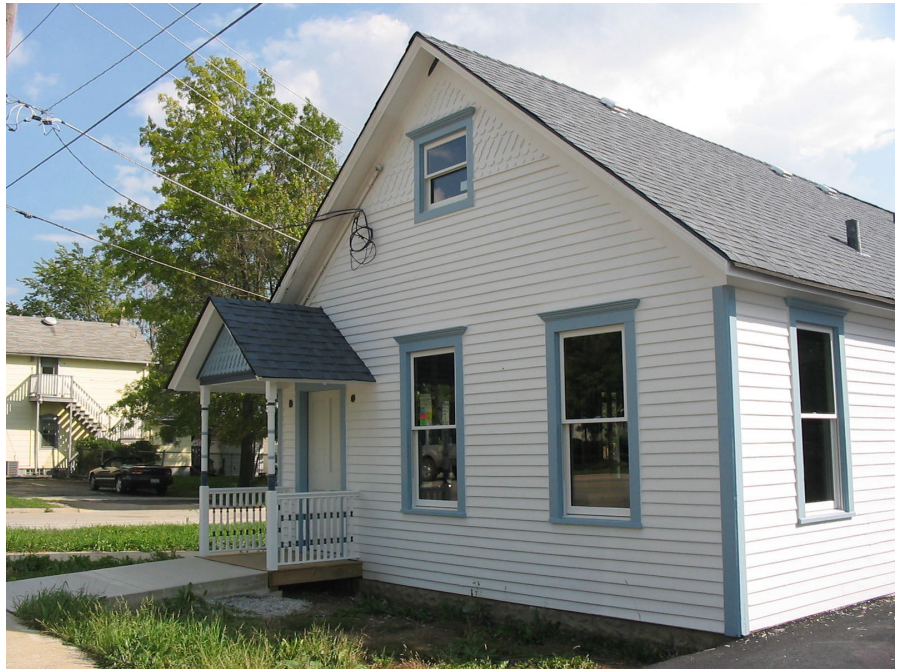
9953 143rd St.jpg

**Alterations** New front door; replacement windows; new concrete ramp from sidewalk to front door

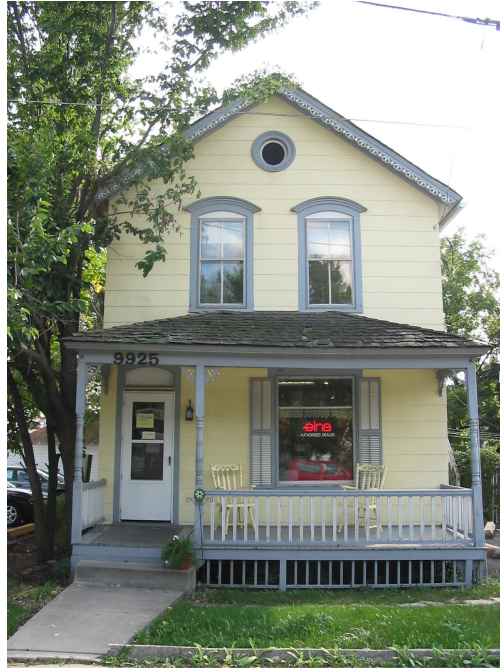
9925 143rd St\_4.jpg

**Alterations** Composition siding; non-original shutters

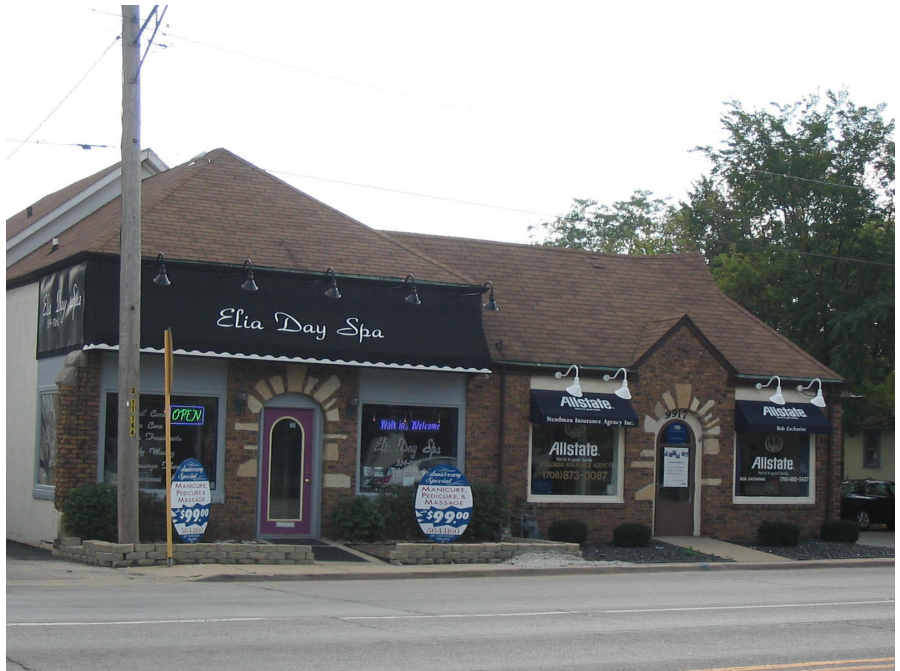
9917 143rd St\_3.jpg

**Alterations** Transoms blocked; new awnings and lighting mounted to the brick facade; doors replaced

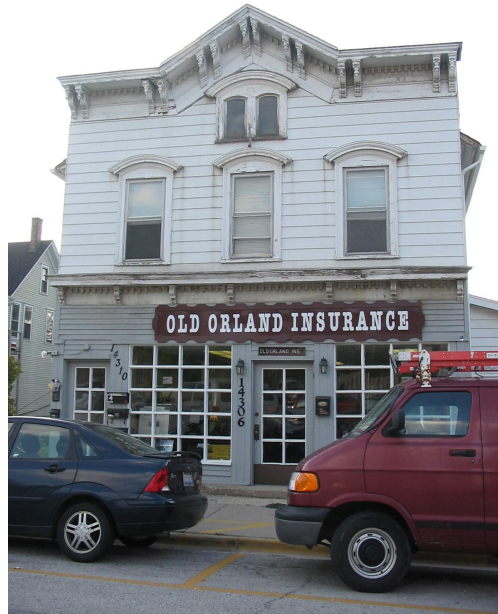
14306-10 Union Ave.jpg

**Alterations** Synthetic siding; storefronts have been altered; doors altered; transom over door covered

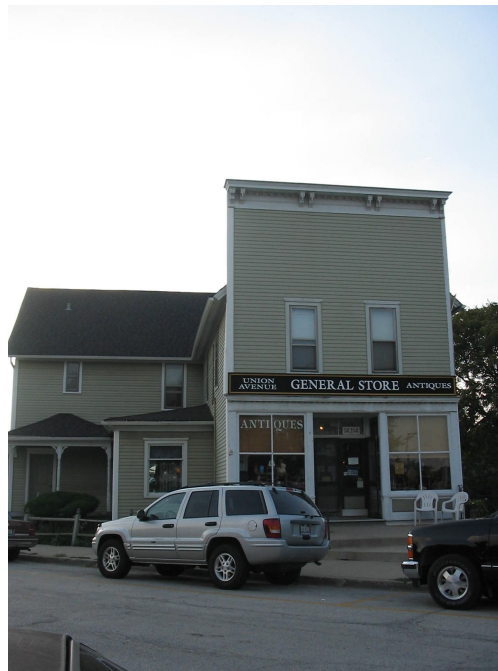
14314 Union Ave\_2.jpg

**Alterations** Synthetic siding; window hoods have been removed; early residential addition

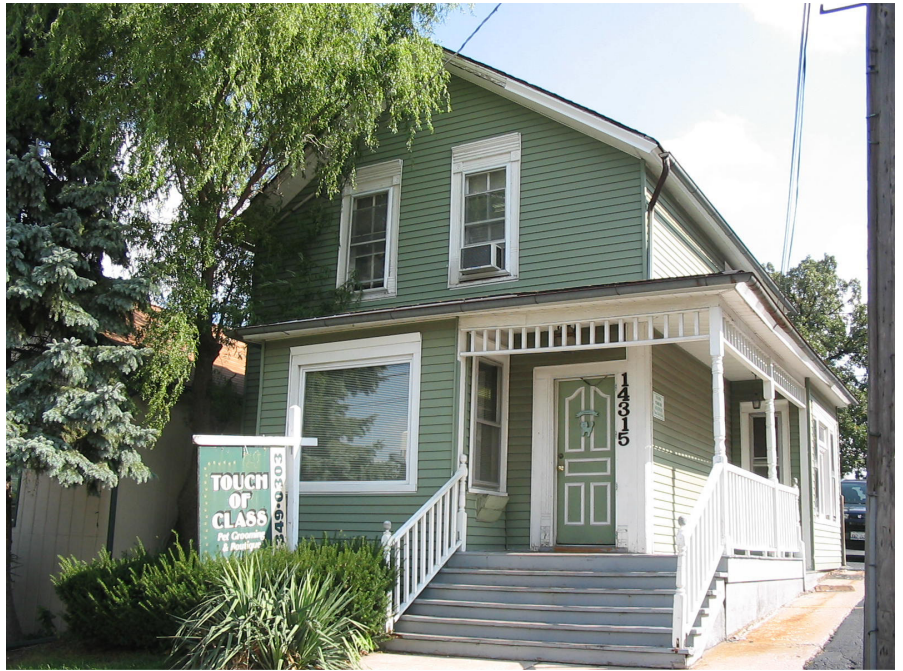
14315 Beacon.jpg

**Alterations** Siding altered; some windows replaced

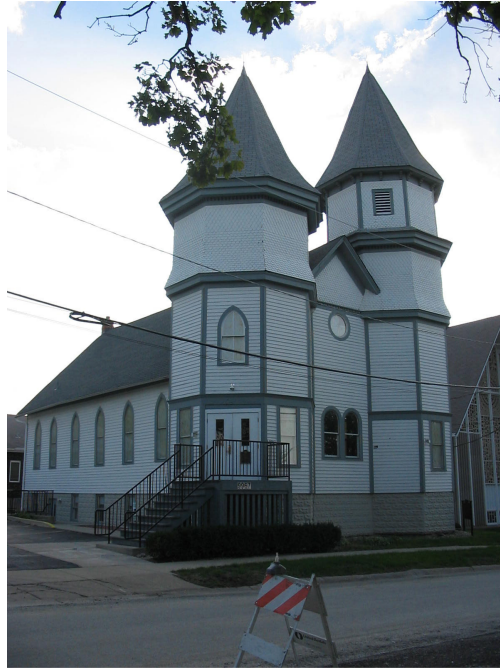
9967 144th St\_2.jpg

**Alterations** Foundation raised (1918), stone foundation replaced with concrete block raised foundation; center entry constructed in 1942 and removed sometime after 1991; large snactuary addition to the west (1961); raised east entry added sometime after 1991

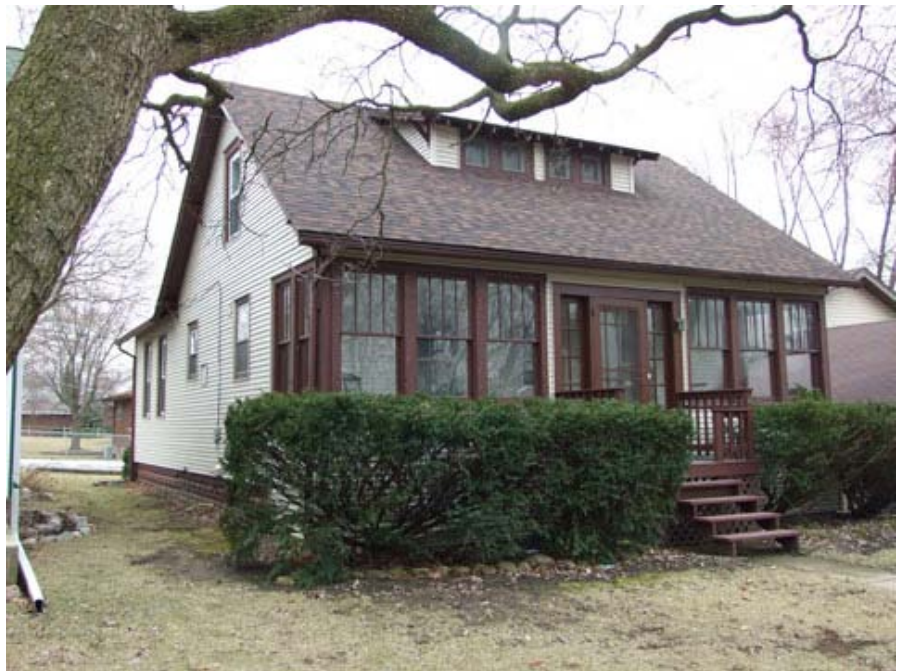
10117 143rd Street.jpg

**Alterations** Siding, front deck and steps
