THE VILLAGE OF ORLAND PARK BASIN BEST PRACTICES PROGRAM

BASIN ASSESSMENT AND MANAGEMENT PLAN REPORT

Report Date:
June 30, 2011

Prepared by:
V3 COMPANIES

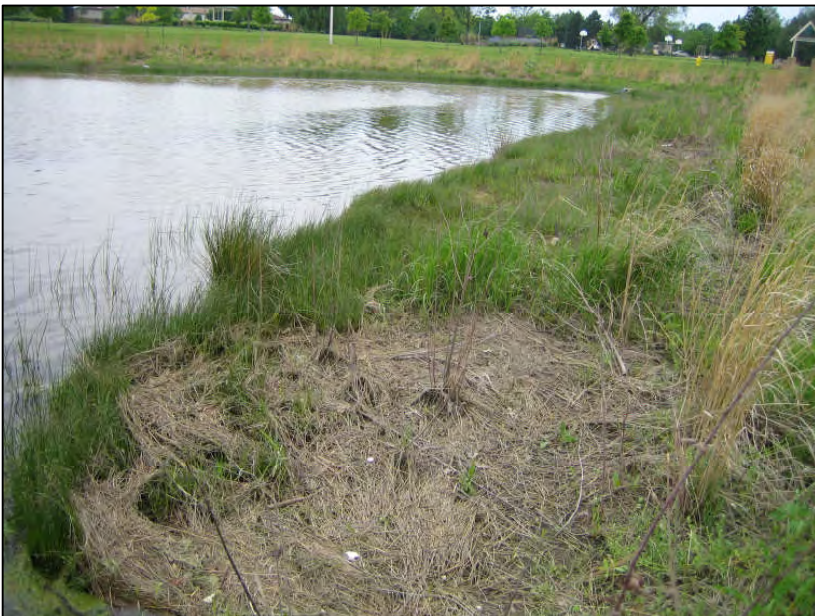
Wetland shelf – some debris piled up from a recent storm and wind fetch. Wetland vegetation generally in excellent condition and very little shoreline erosion.

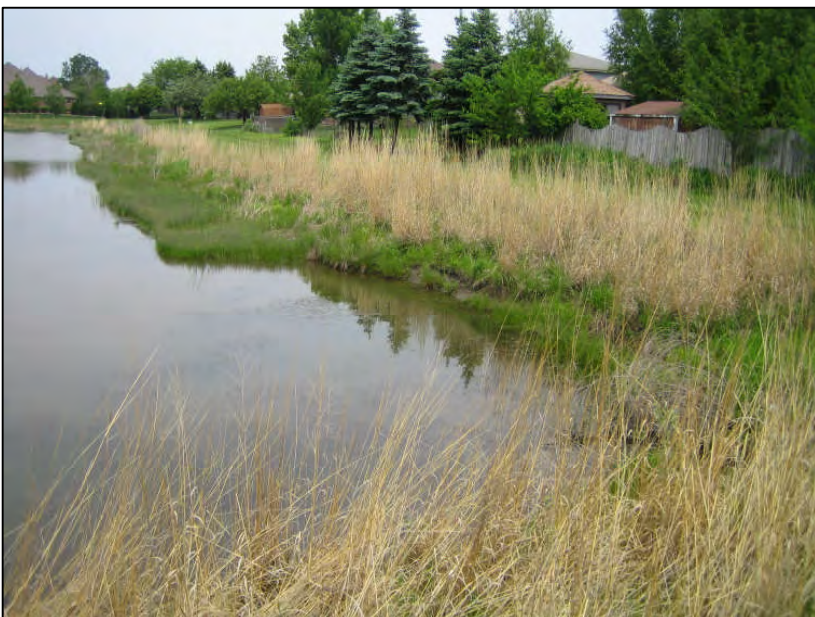
PHOTO 3

Southeast corner. Possible historic muskrat or outlet scour damage. Appears stable now.

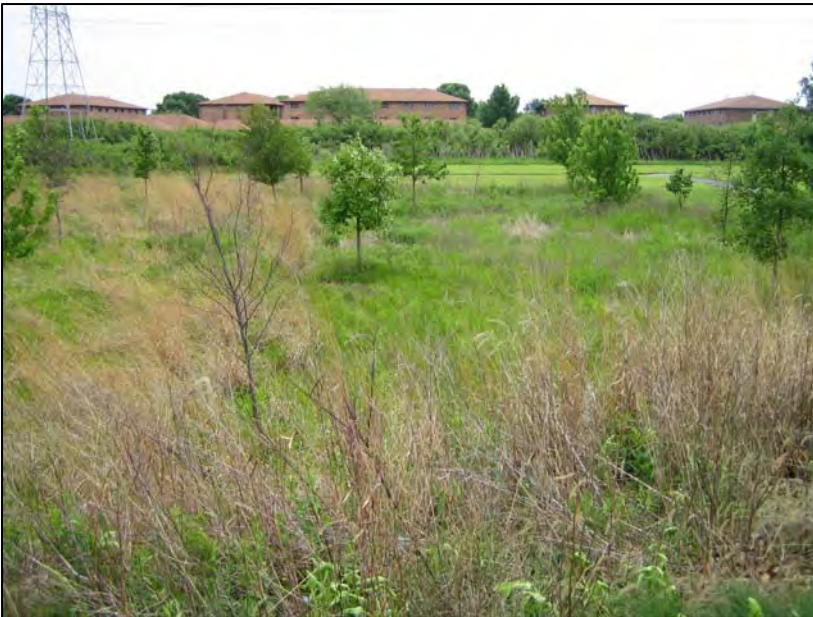
Western slope – Wetland shelf and native slopes in good condition.

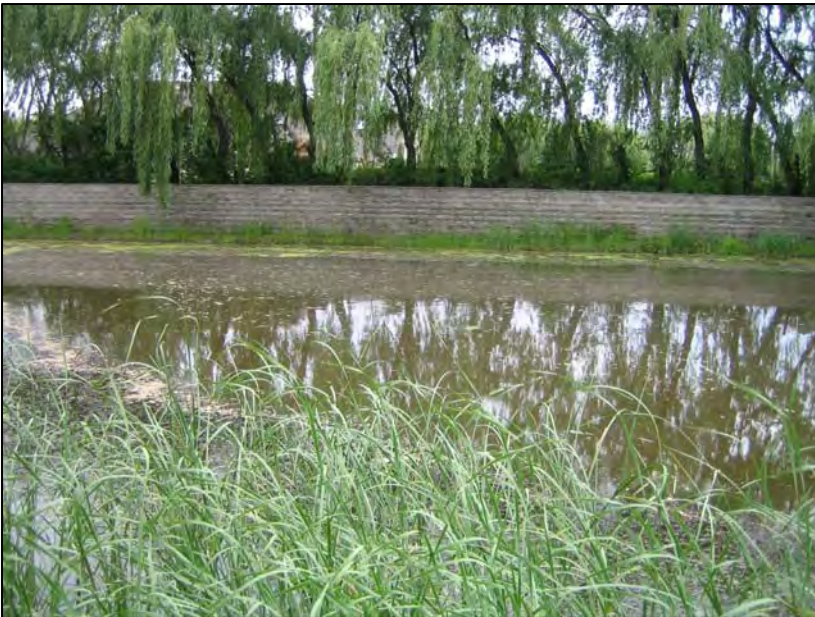
North Slope – Unmowed turf grass and emergent shoreline in good condition. Minimal erosion or scour on toe of slope.

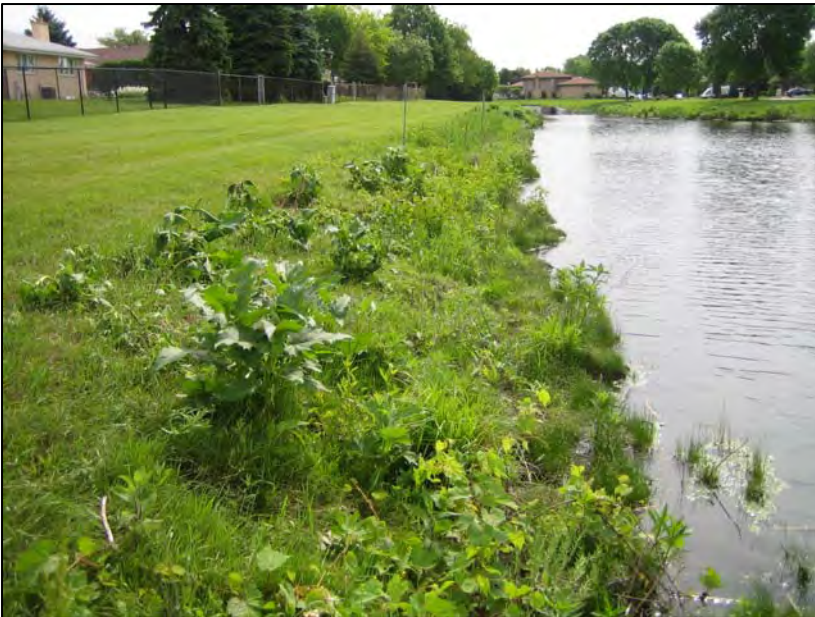
Signs of native plant damage due to Weed & Feed application on turf grass.

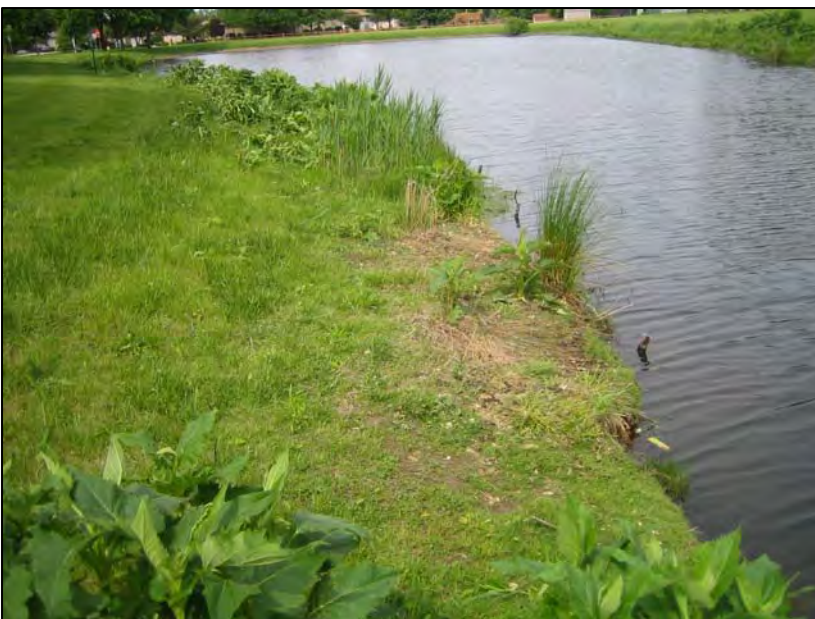
PHOTO 5

South bank – mowed turf along fences and turf/native buffer along shoreline. Signs of historic muskrat damage. Minimal shore erosion on toe of slope.

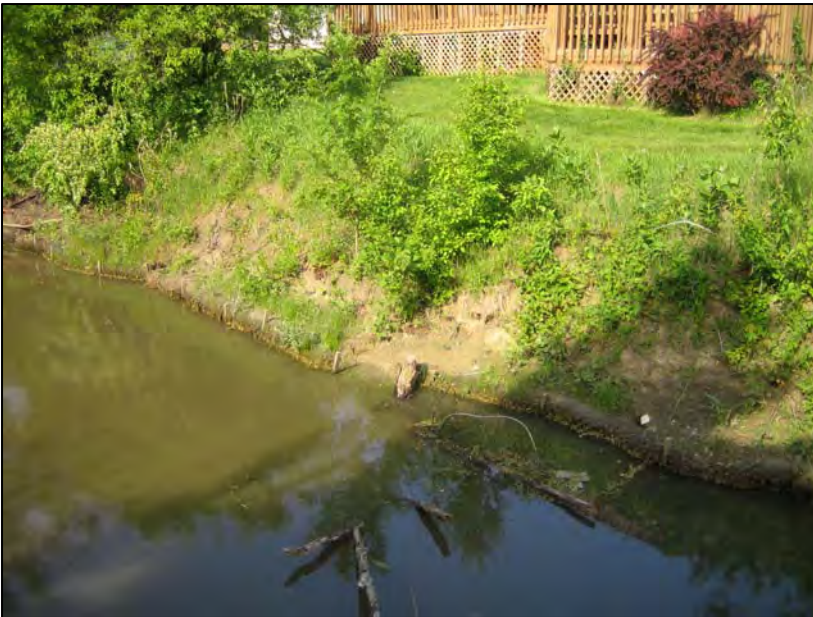
Locations of Village installed fiber roll still in place along outlet channel of Pond. Bare slopes above fiber roll will be a concern once the fiber roll degrades and is gone.

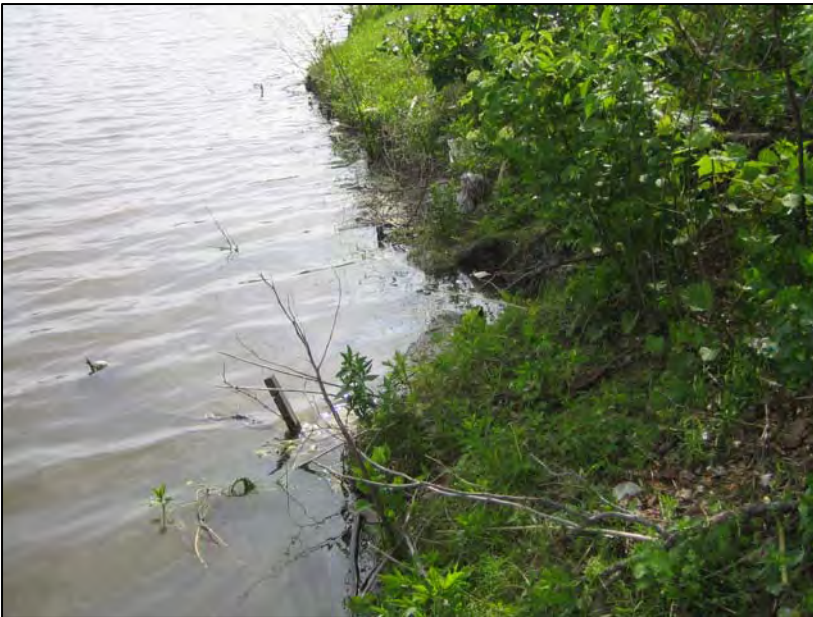
Locations of FES Failure. Left – Exposed FES on south shoreline. Right – FES dropped into water on north shoreline.

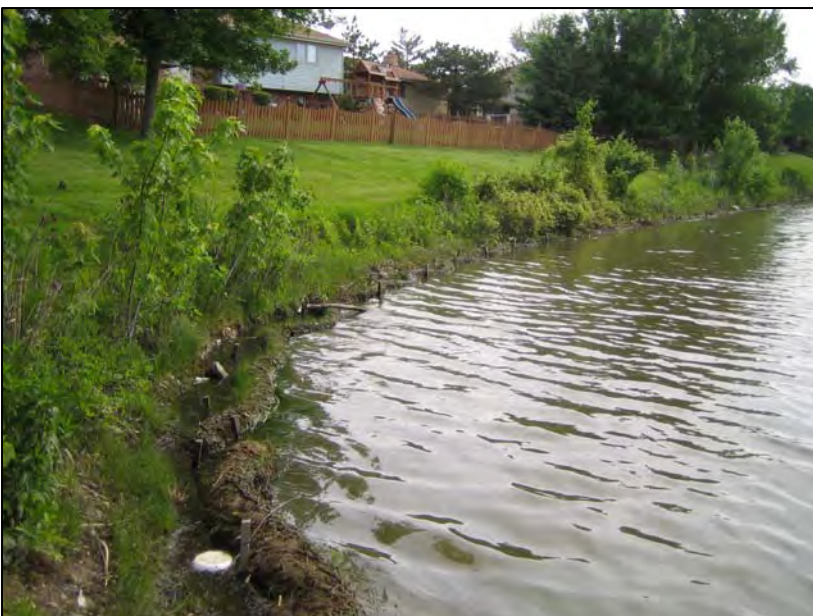
PHOTO 7

South shoreline – entire shore was repaired in past two years but signs of significant muskrat damage is prevalent along entire shore similar to shown in photo.

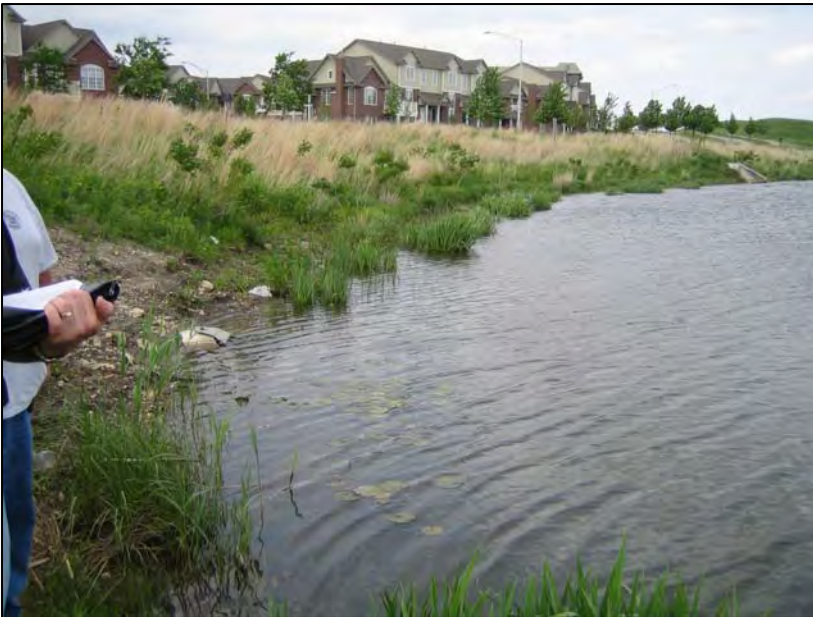
West slope – Transition from sidewalk to mowed turf to native prairie slope to emergent shoreline. Slopes in good condition and excellent mix of natives.
