RE: Village of Orland Park High Service Pump No. 5 – Recommended Repairs

Water Well Solutions is pleased to quote the repairs to Orland Park's High Service Pump No. 5's Pumping Equipment. The following is an inspection report on motor inspection, column pipe, shafting and bowl inspection.

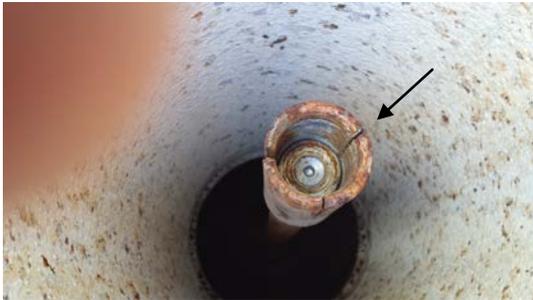
When removing the pump for inspection, we found that the lineshaft coupling directly under the discharge head had split in three different places. (See Figure 1) This would have caused the initial pump failure since the lineshaft is what enables the motor to spin the pump impellers sending water to distribution. Our concern is that the coupling may have failed as a result of a torque snap instead of stress corrosion cracking.

(Figure 1 – Split Lineshaft Coupling)

One of the things that lead us to believe that the coupling failed due to a torque snap is that we observed the inline check valve is leaking very badly even when the gate valve is fully closed. If the gate valve is allowing enough water to back flow down the pumping equipment, this could lead to a torque snap if the pump were to come online in this condition. When I first came out to diagnosis the failure of the pump, I did see evidence that the check valve is allowing several hundred gallons per minute flow back through the pump when we tried to start it. The check valve will need to be replaced prior to placing the pump back into service. We would be happy to provide a quote to replace the check valve at your request.

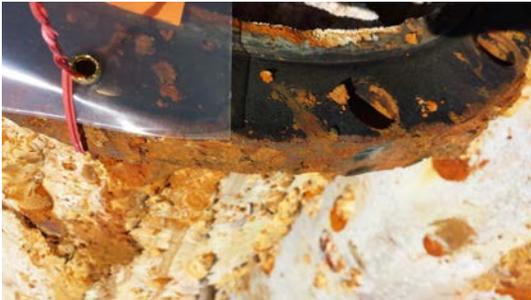
Figure 2

The 12" flanged column pipe is deeply pitted (Figure 2) and there is severe corrosion on the mating flange faces of the column pipe as well as the centering spiders (Figure 3 & 4). Pitting is a destruction form of corrosion as it will limit the life of the column pipe. The 5ft section of pipe above the water level that bolts to the discharge head appears to be in the worst condition. (Figure 5) Due to present condition of the 12 inch flanged column pipe, (Figure 6) it would be our recommendation to replace it all with new at this time.
