# Village of Orland Park, Illinois

## Historic Buildings Survey

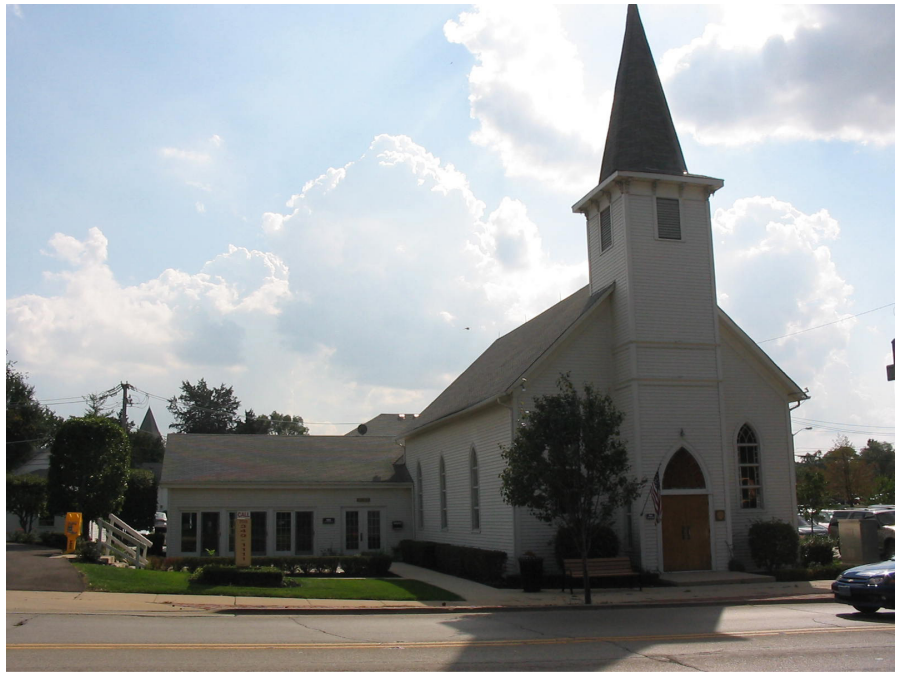
9999 143rd St\_3.jpg

**Condition** Good

**Alterations** Synthetic siding; windows have been replaced; front door has been altered; there is a large addition at the side toward the rear

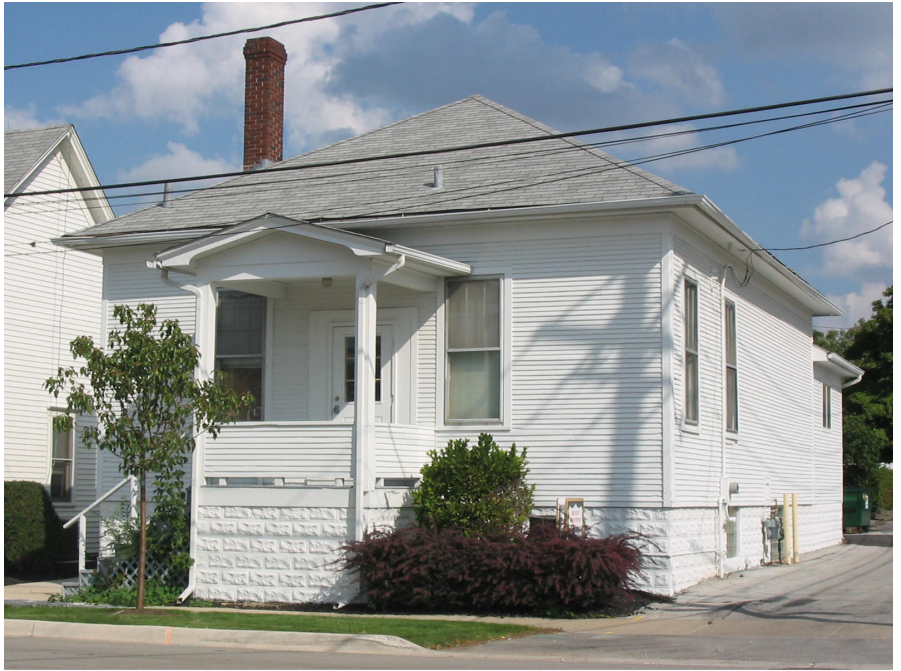
9999 143rd St\_rectory.jpg

**Condition** Excellent

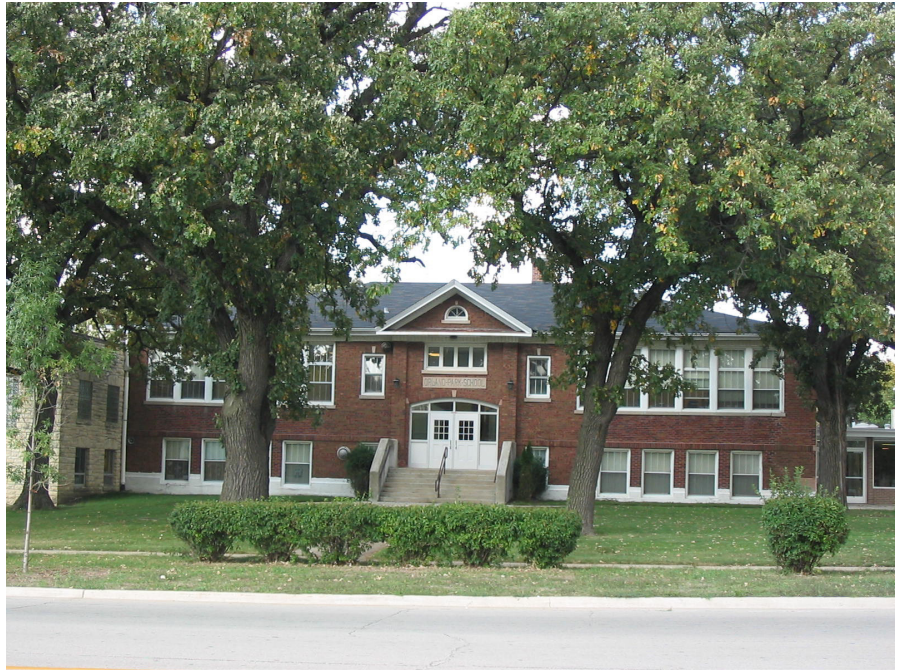
9960 143rd St\_9.jpg

**Condition** Excellent

**Alterations** There is a 1940 Joliet limestone gymnasium addition to the west and a steel and glass, International style addition to the east

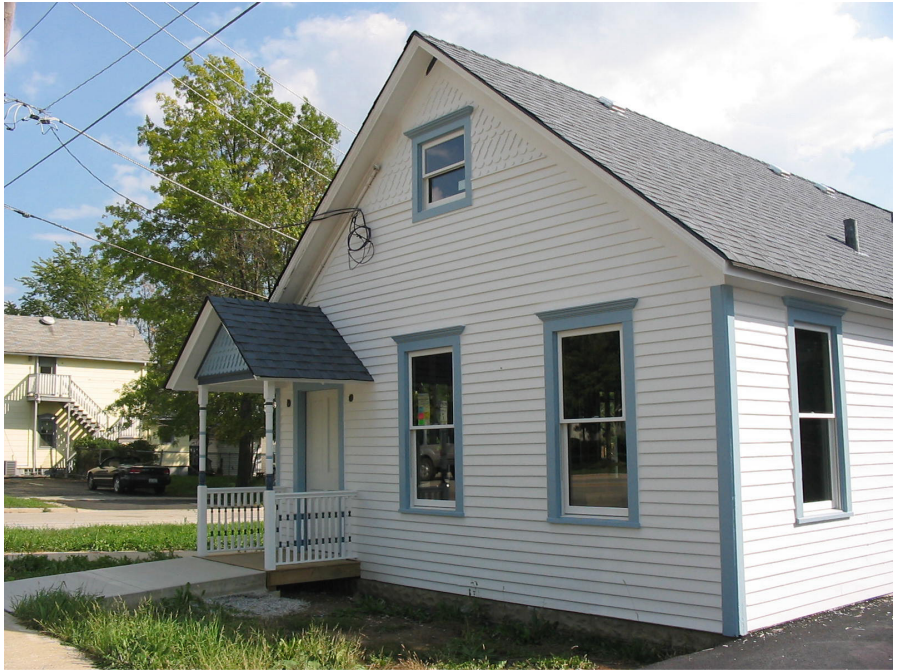
9953 143rd St.jpg

**Condition** Excellent

**Alterations** New front door; replacement windows; new concrete ramp from sidewalk to front door

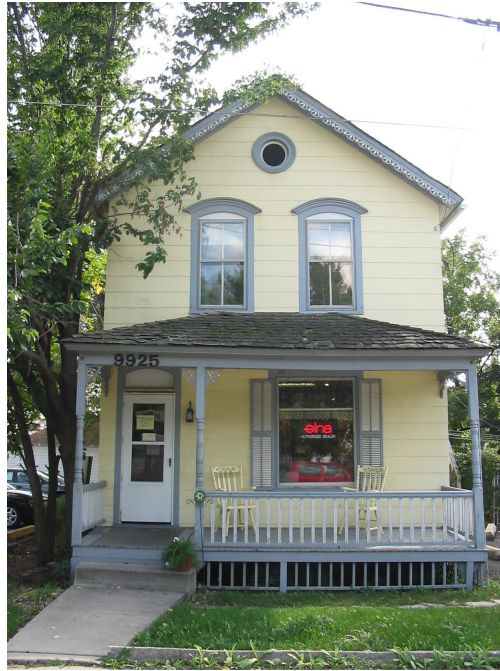
9925 143rd St\_4.jpg

**Condition** Good

**Alterations** Composition siding; non-original shutters

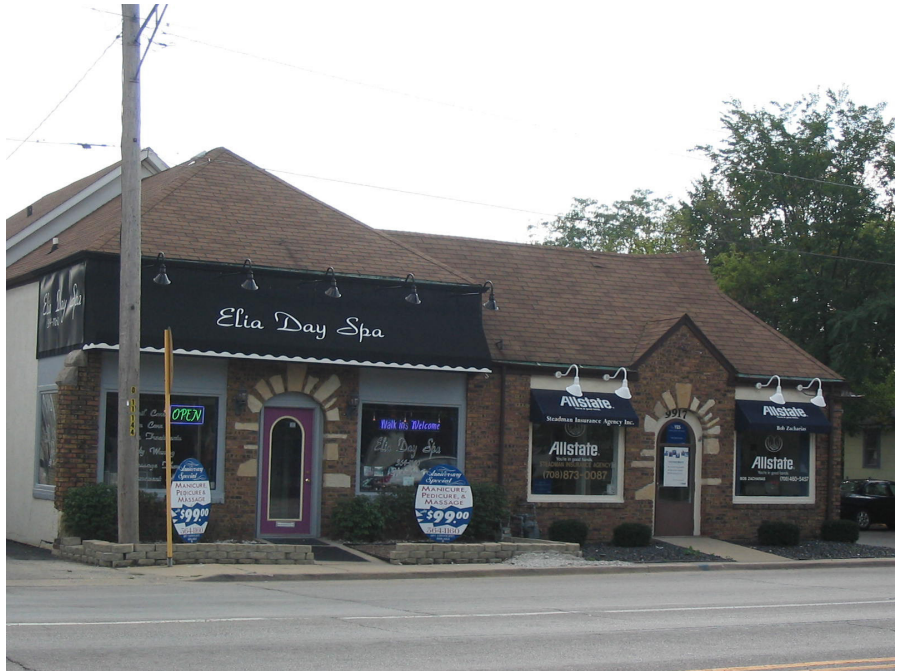
9917 143rd St\_3.jpg

**Condition** Good

**Alterations** Transoms blocked; new awnings and lighting mounted to the brick facade; doors replaced

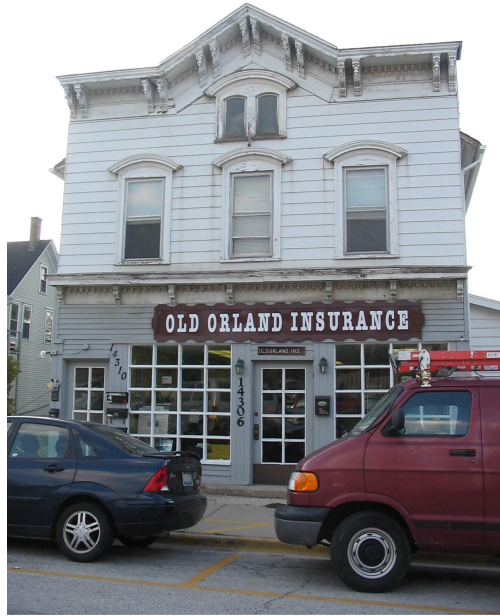
14306-10 Union Ave.jpg

**Condition** Good

**Alterations** Synthetic siding; storefronts have been altered; doors altered; transom over door covered

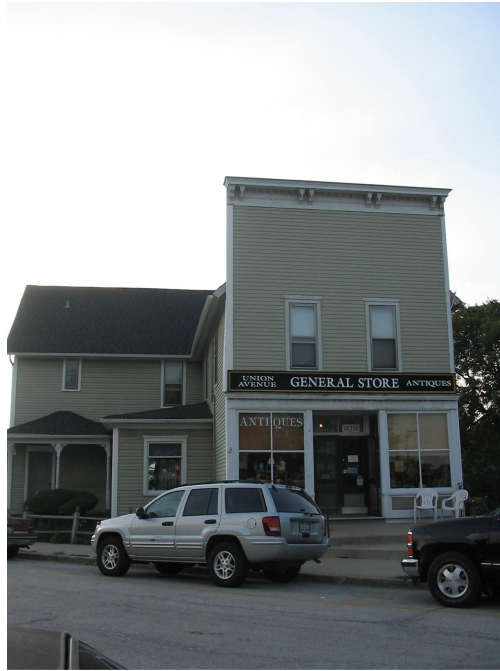
14314 Union Ave\_2.jpg

**Condition** Good

**Alterations** Synthetic siding; window hoods have been removed; early residential addition

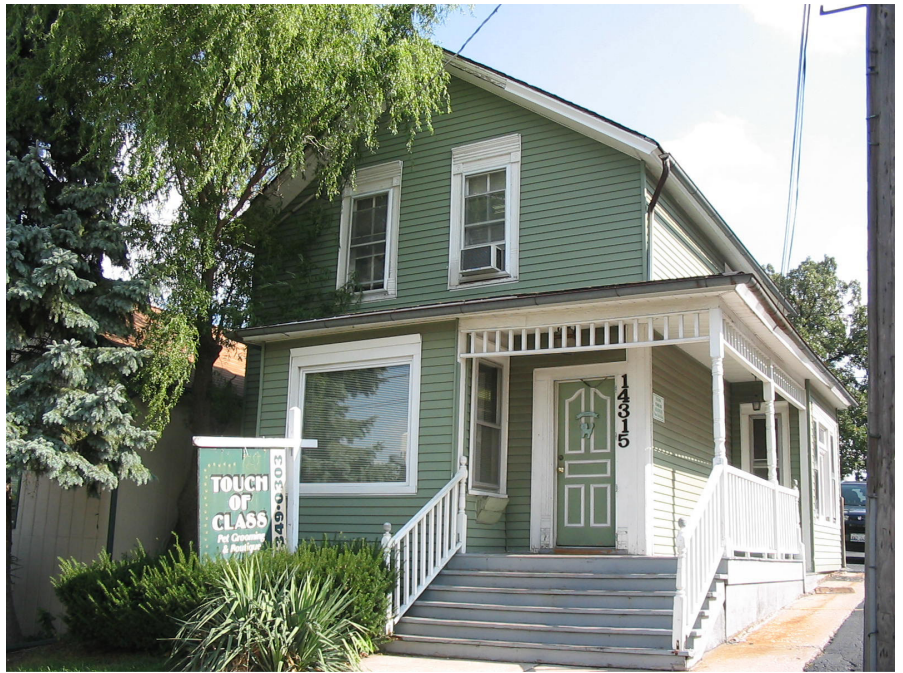
14315 Beacon.jpg

**Condition** Good

**Alterations** Siding altered; some windows replaced

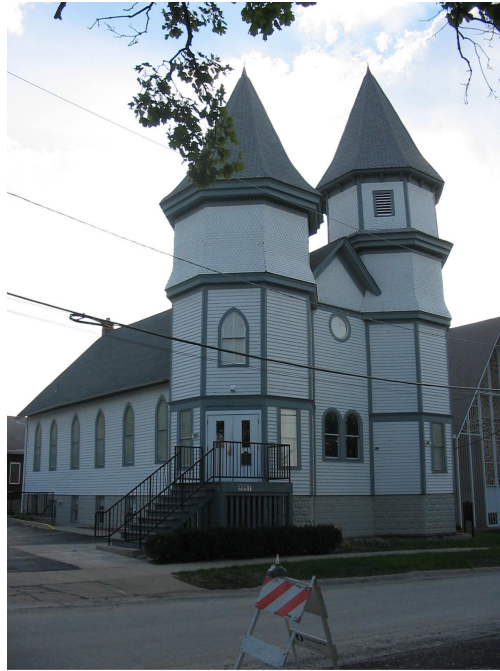
9967 144th St\_2.jpg

**Condition** Good

**Alterations** Foundation raised (1918), stone foundation replaced with concrete block raised foundation; center entry constructed in 1942 and removed sometime after 1991; large snactuary addition to the west (1961); raised east entry added sometime after 1991

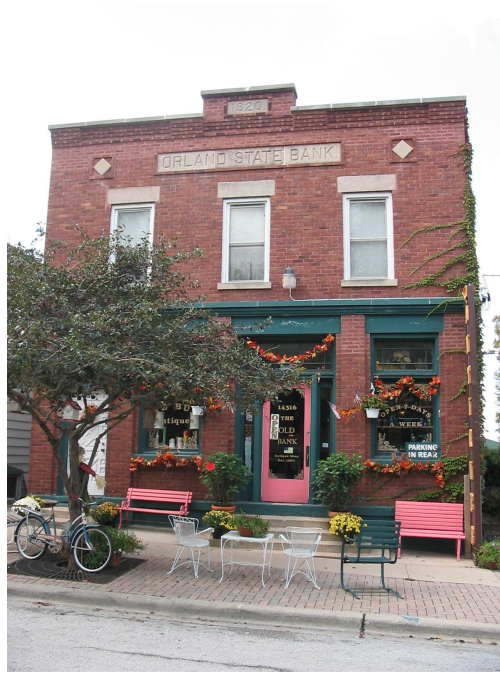
14316 Beacon\_7.jpg

**Condition** Excellent

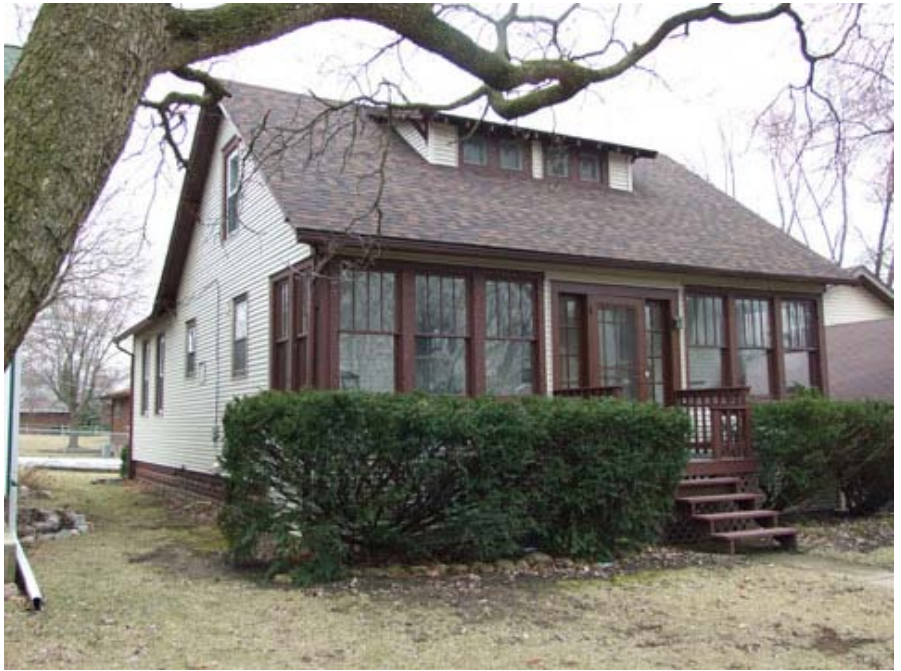
10117 143rd Street.jpg

**Condition** Good

**Alterations** Siding, front deck and steps
