ORLAND  
PARK

# Emergency repairs to Wedgewood Forcemain Discharge manhole and piping

# Executive Summary of Emergency Repairs to Sewer main

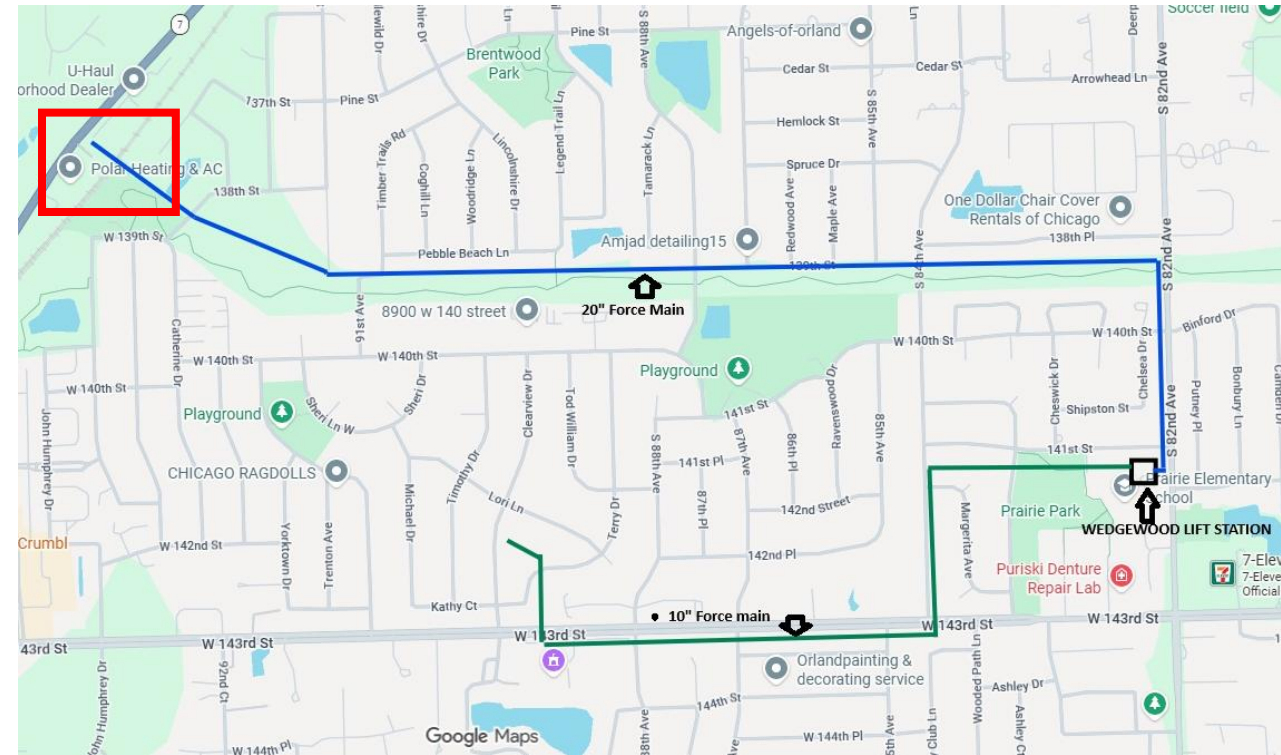
Due to drop of elevation from ComEd easement to MWRD interceptor and to go under Railroad tracks, the force main transitions to a gravity main. This portion of the line (red box) is the area we are addressing in the repairs.

- In planning our new water rates next year for FY28-FY33, we were planning a project already to install a liner in the remaining portions of 20" pipe.
- There are other sewer projects planned as well.

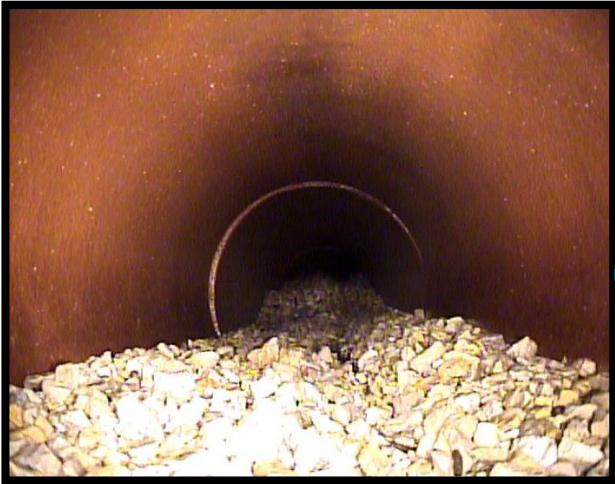
Collapsed pipe, failed liner, and cracks in pipe

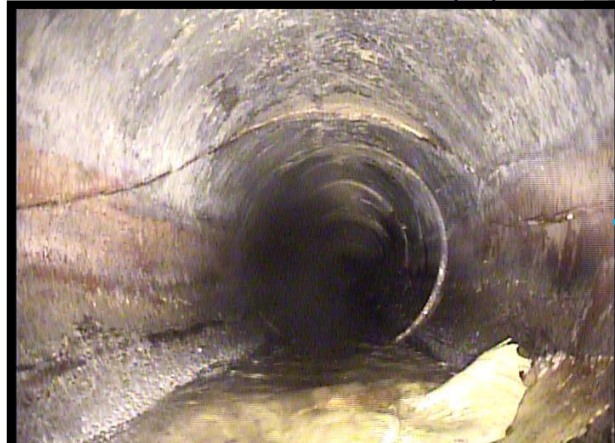
Stone Debris found in pipe

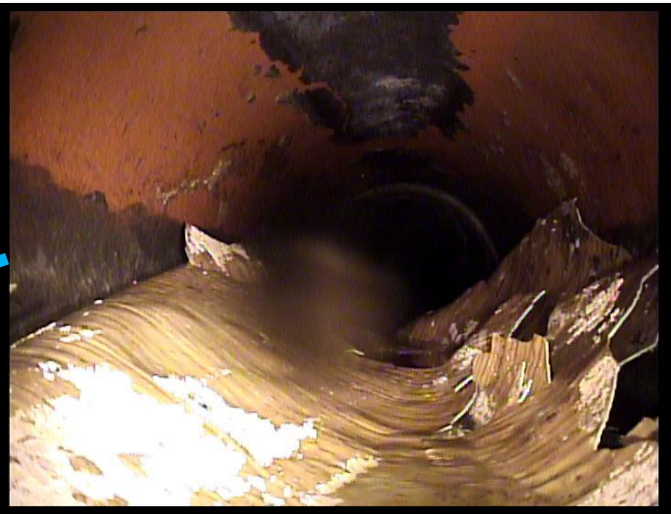
Previous 2004 repairs of epoxy resin liner of manholes in pipe

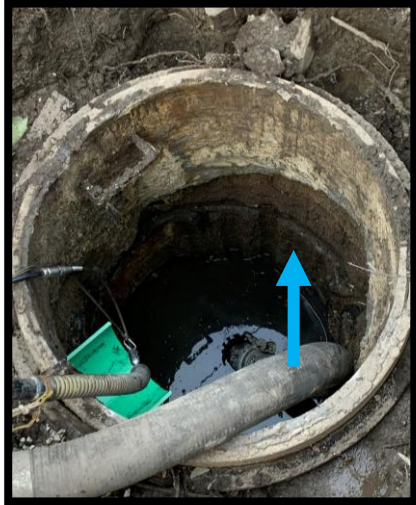
Pipe repaired, section was missing. Gases ate away top portion but since water on bottom of pipe, the bottom portion remained.

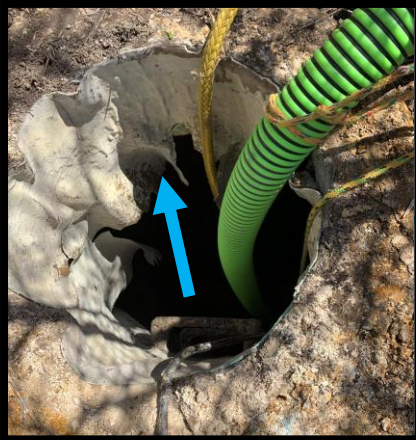
Concrete missing in manhole
