# 14497 John Humphrey Drive- Blight Analysis

14497 John Humprey Drive  
Orland, Park Illinois 60462  
PIN: 27-10-100-106-0000

- ▶ This report identifies and documents the presence of statutory blight factors, explains the economic and functional barriers to re-tenanting the site, and provides support for a 7b redevelopment incentive.

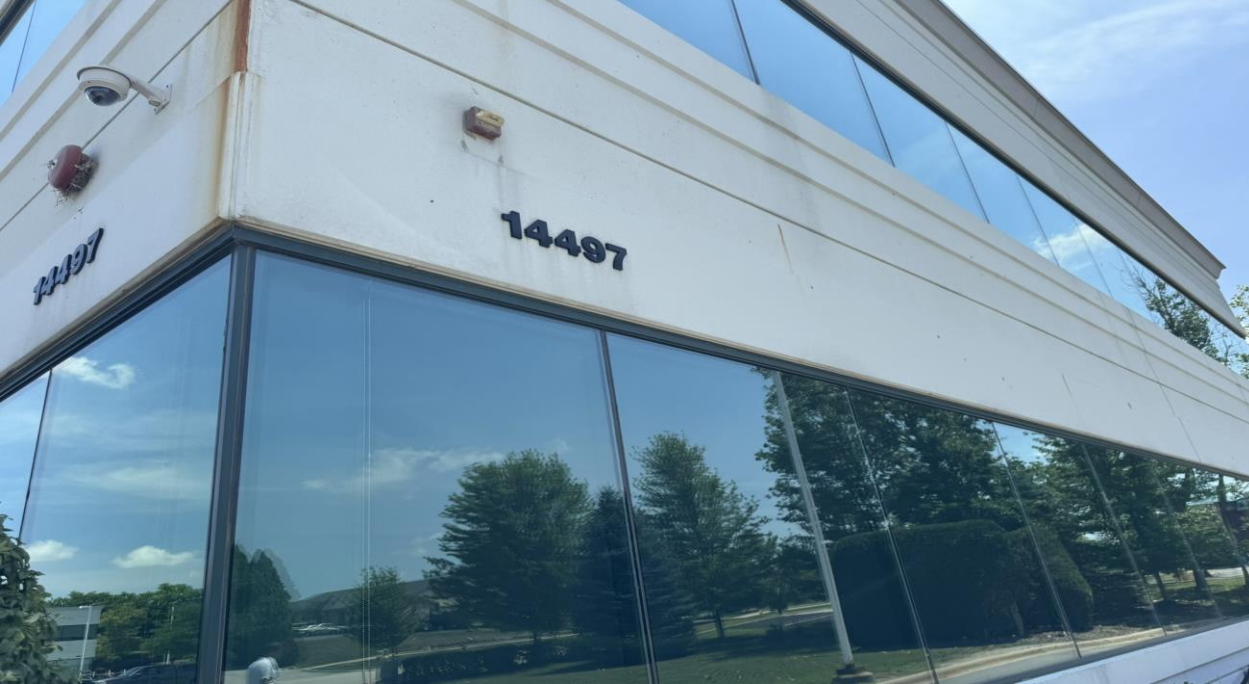
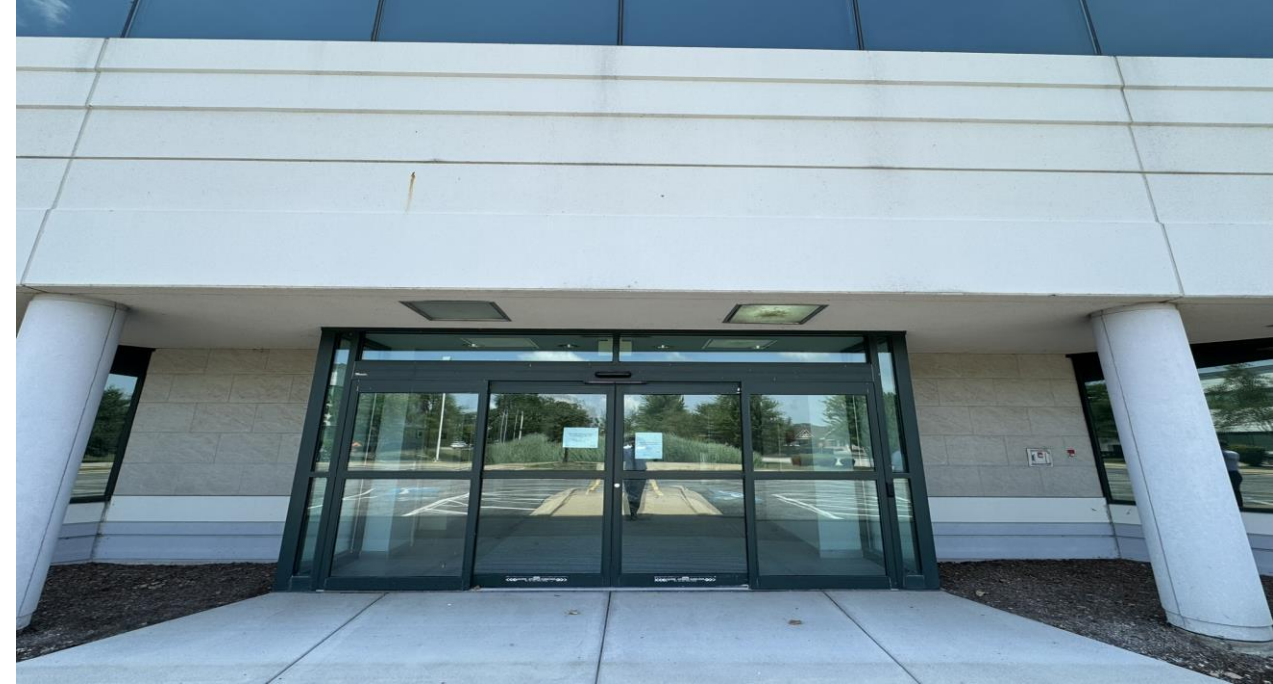
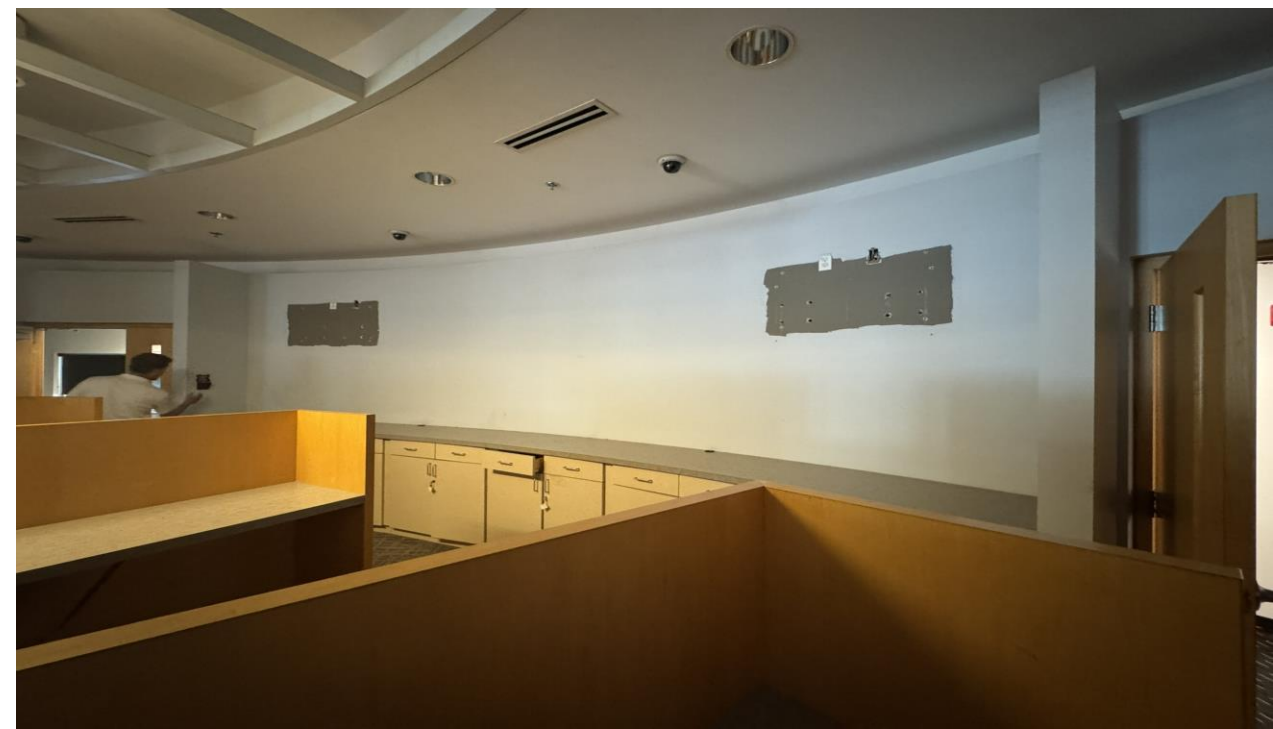
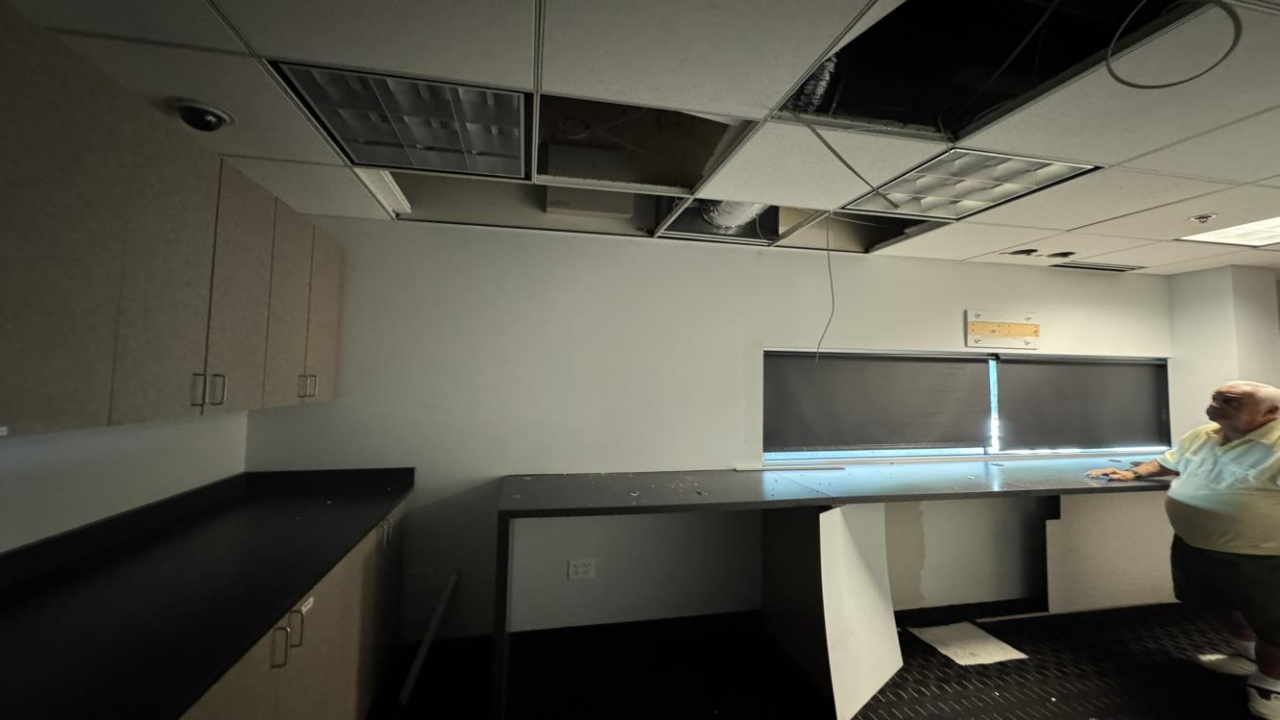
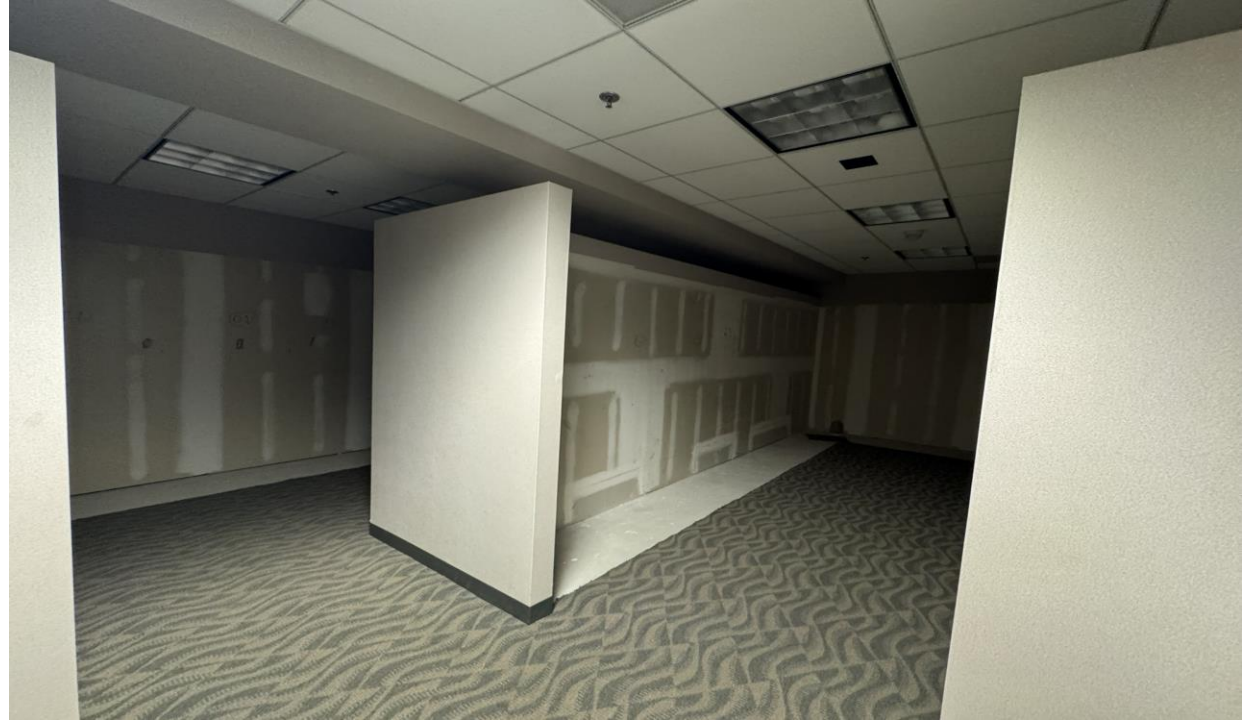
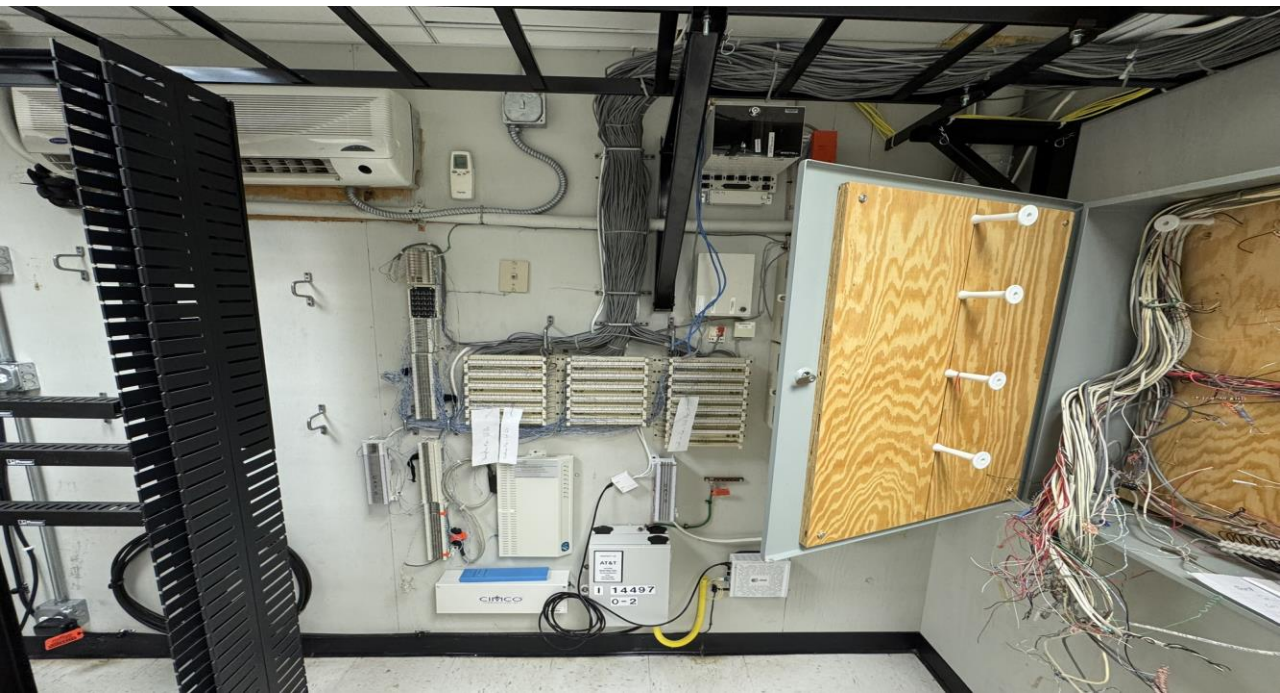
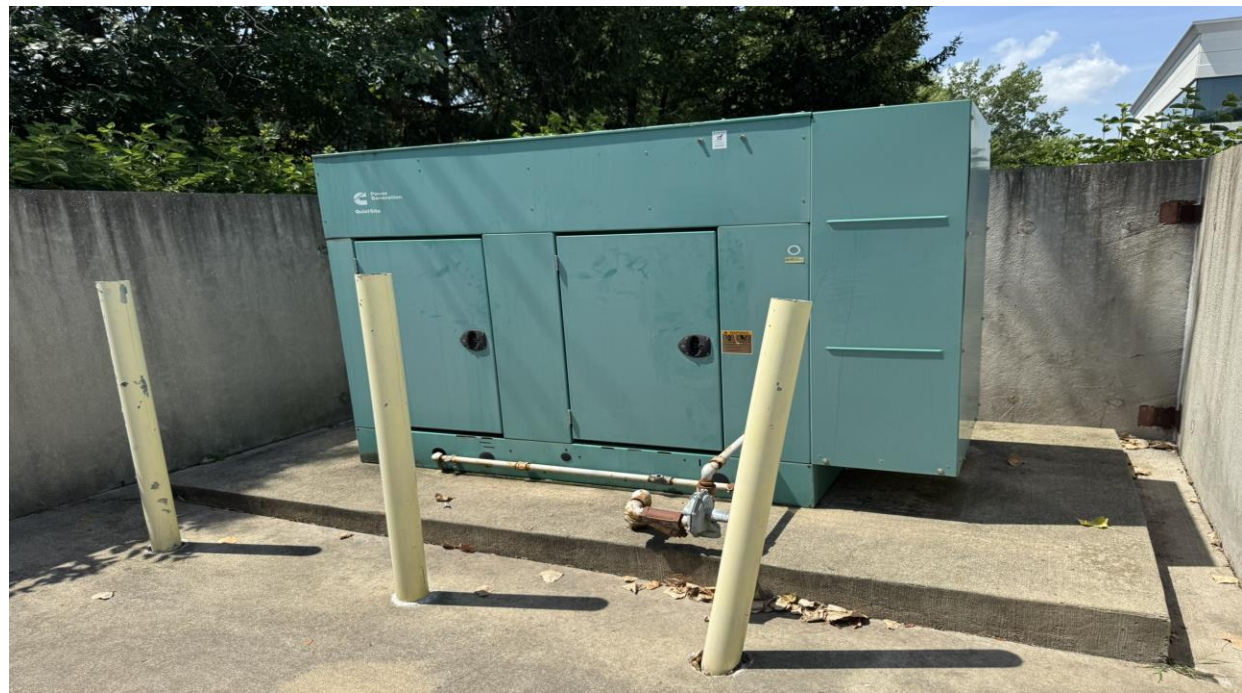
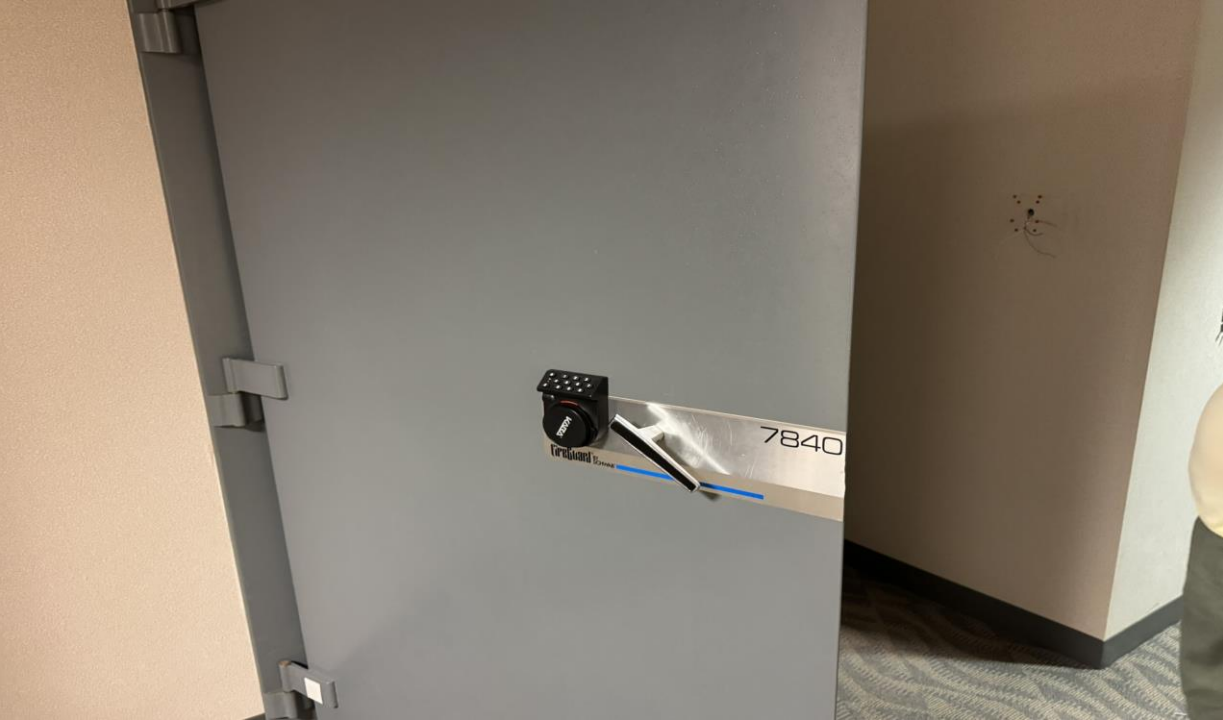
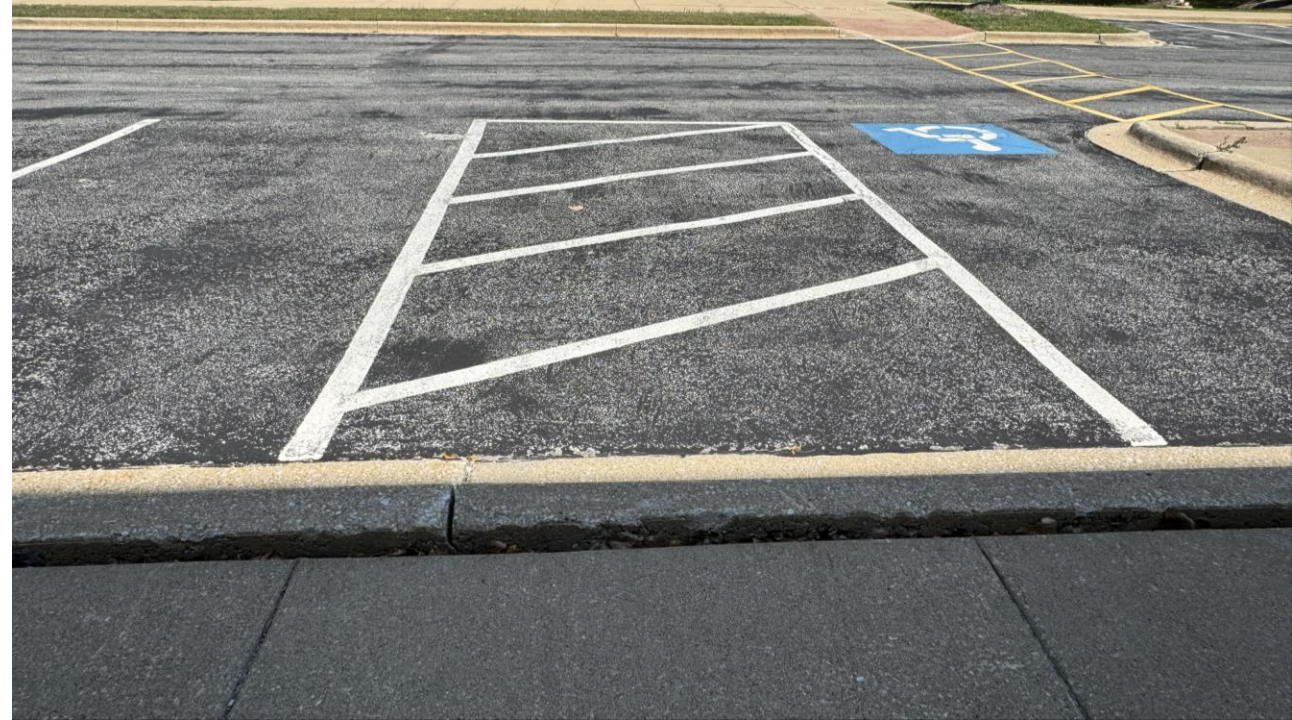
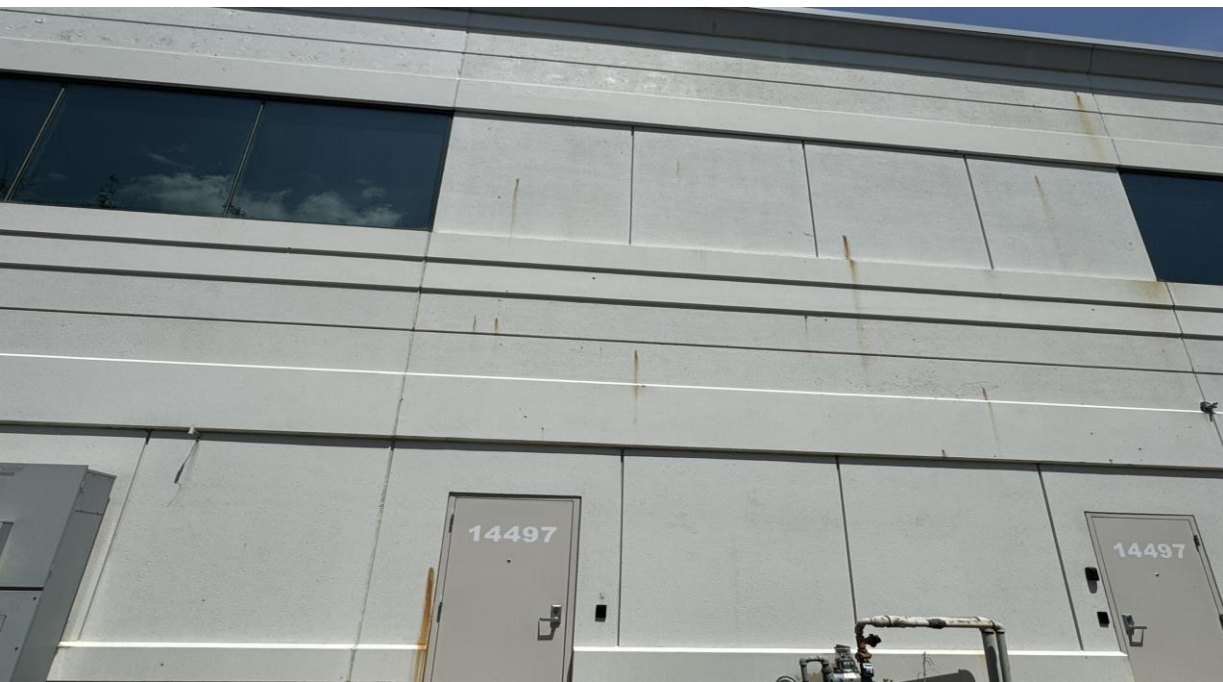
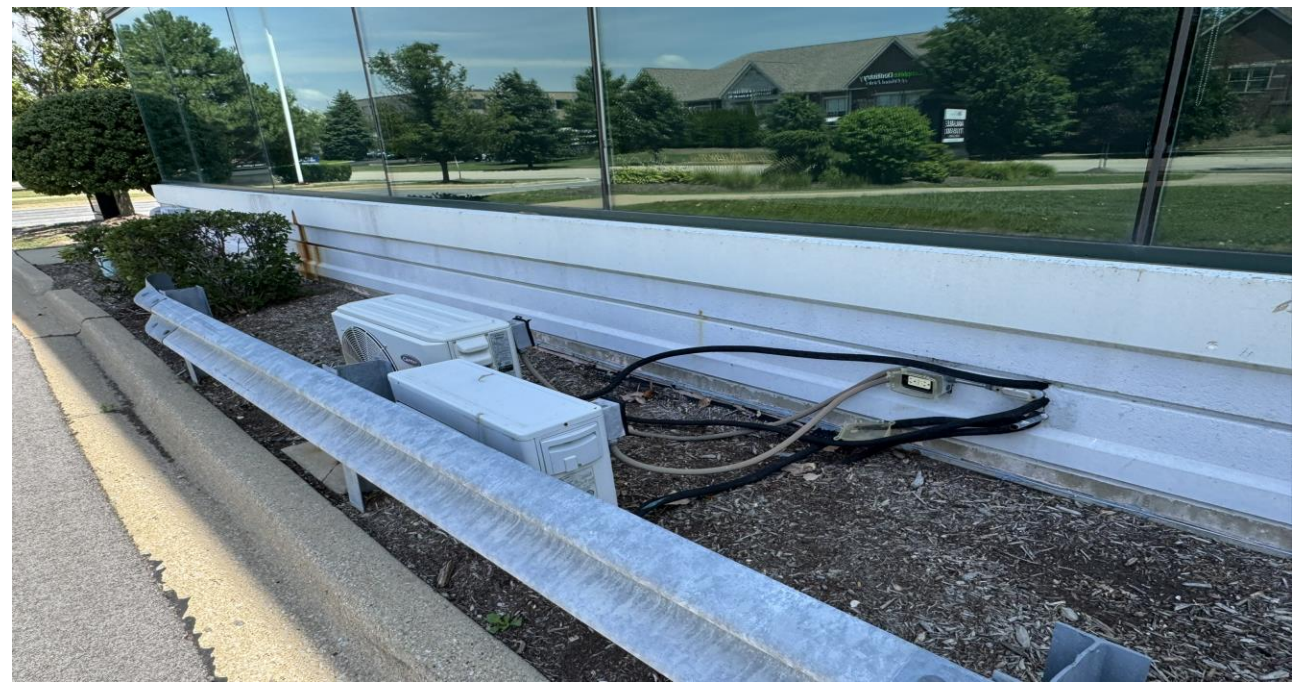
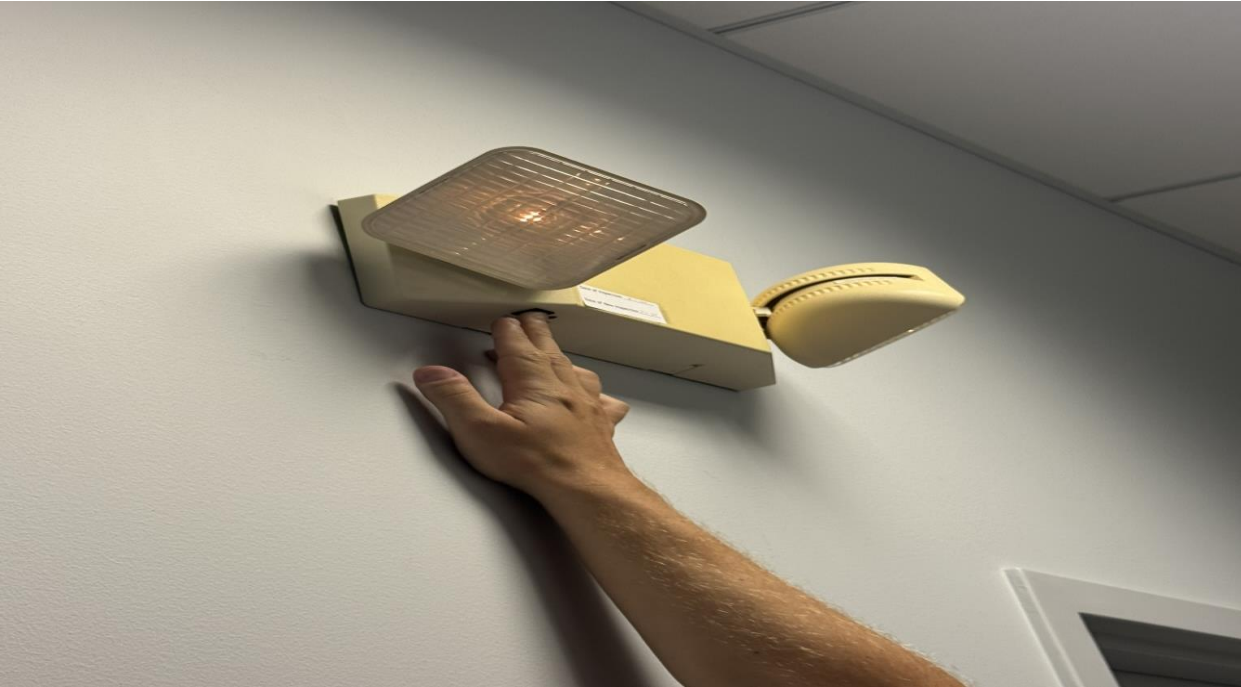
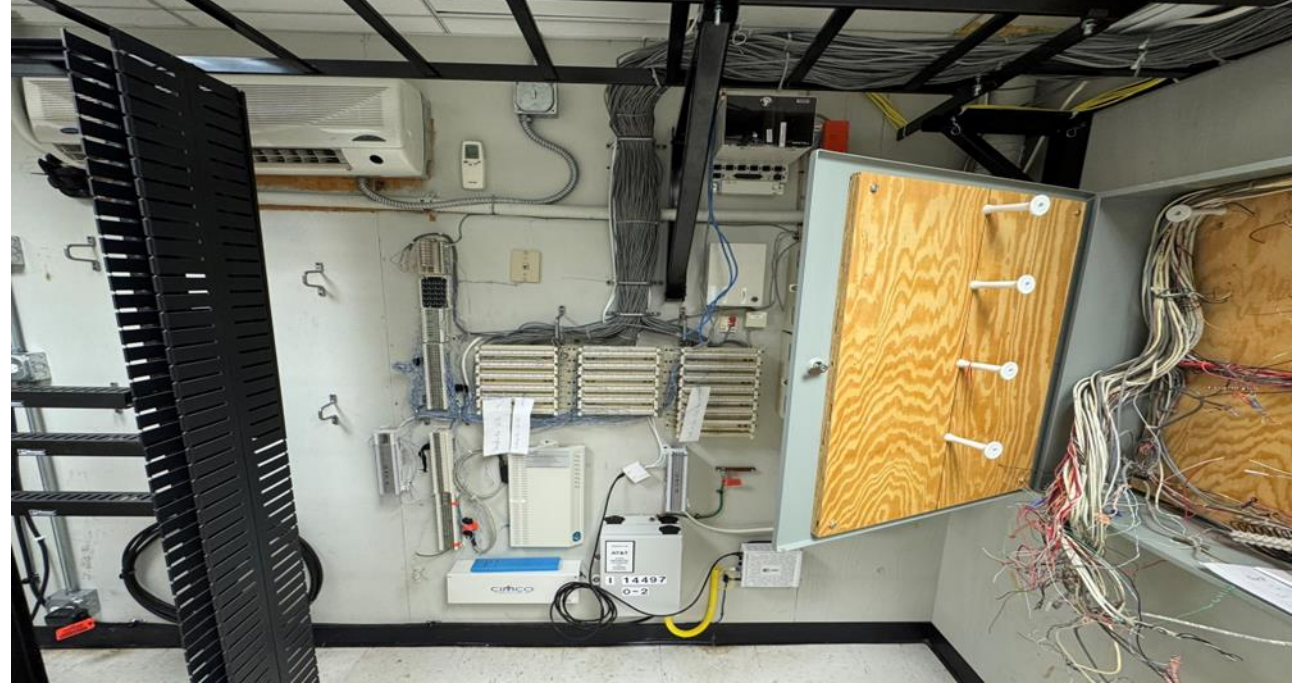
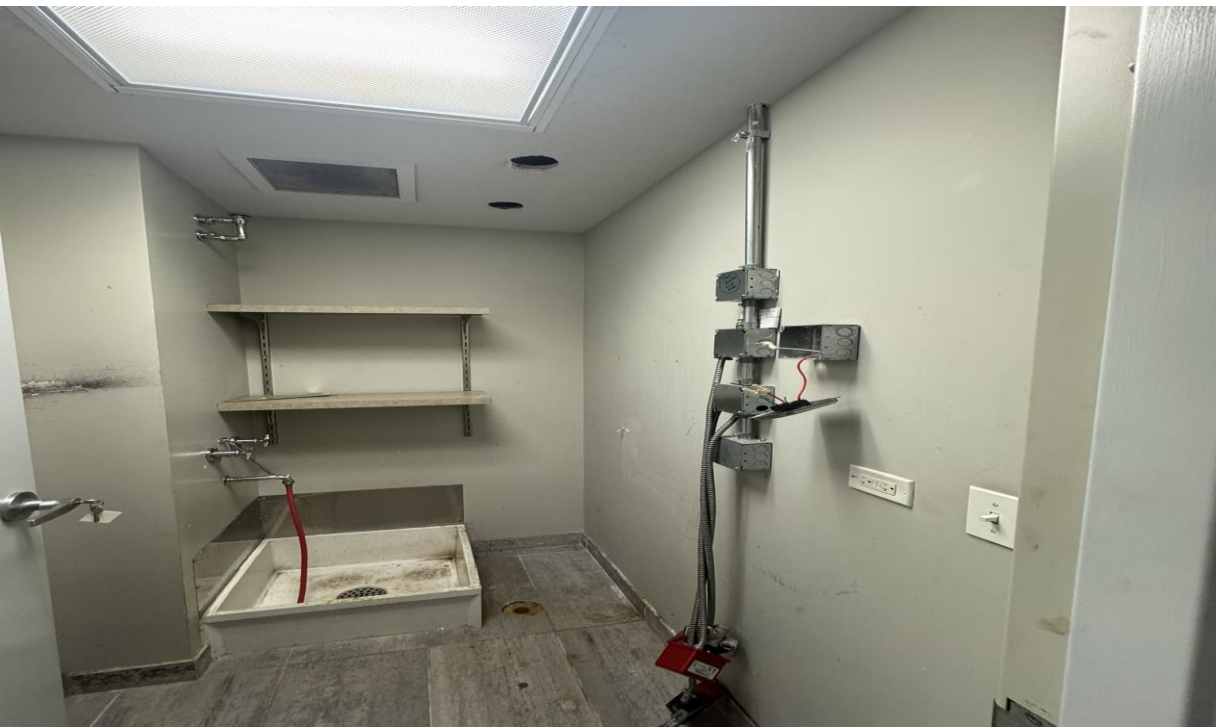
- Photos depict faded signage, aging façades, and outdated interior finishes that diminish the market appeal and create a perception of obsolescence.
- Cracked/raised concrete throughout the site, especially prevalent near the Handicap parking spots causing safety concerns. The entire front sidewalk (abutting the handicap spaces) will be mudjacked, removed and replaced.

- Numerous rust & water stains on the exterior, broken lighting, pavement cracking, exposed building systems, aging generator, etc. The Applicant is planning on repairing and repainting the entire exterior of the facility as part of the redevelopment.

- Interior deterioration insofar as the site has been gutted of former bank equipment, electronics, vaults, security systems, etc. As a result, wires have been pulled and partially disconnected, switches/plugs/various lights have been removed, minor cosmetic issues such as ripped & stained carpets, leaking sanitary/water areas, etc.

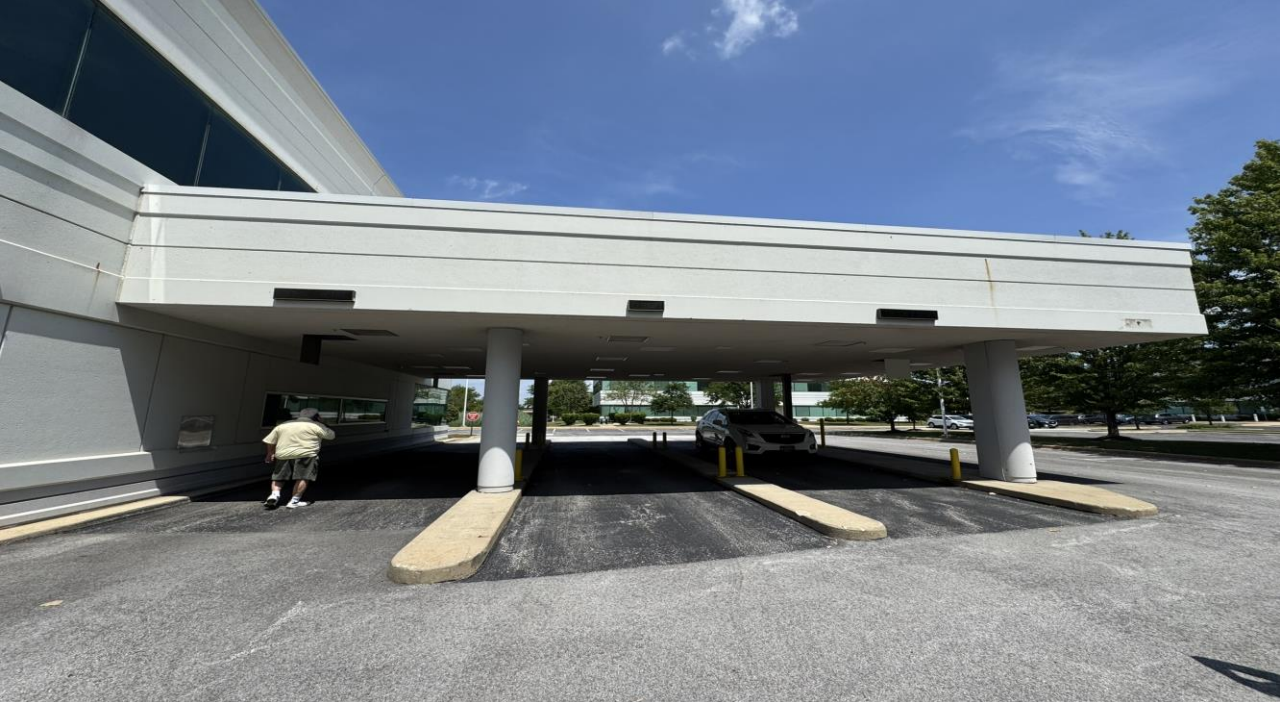
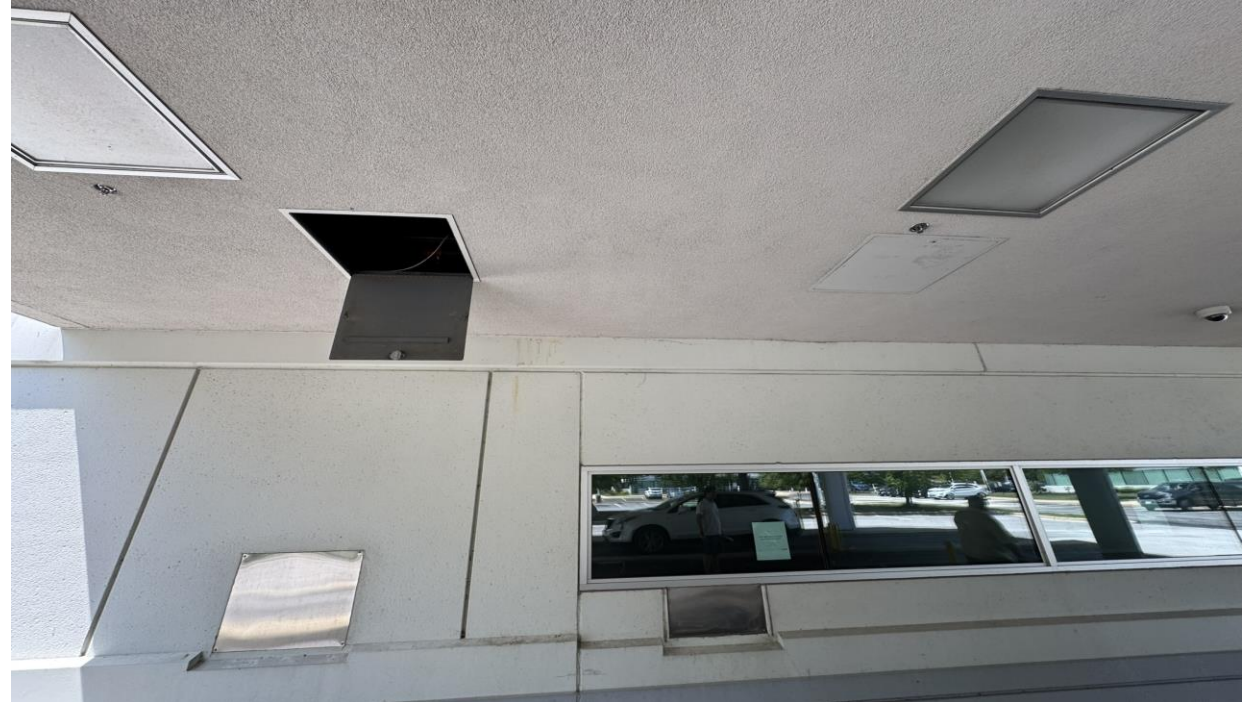
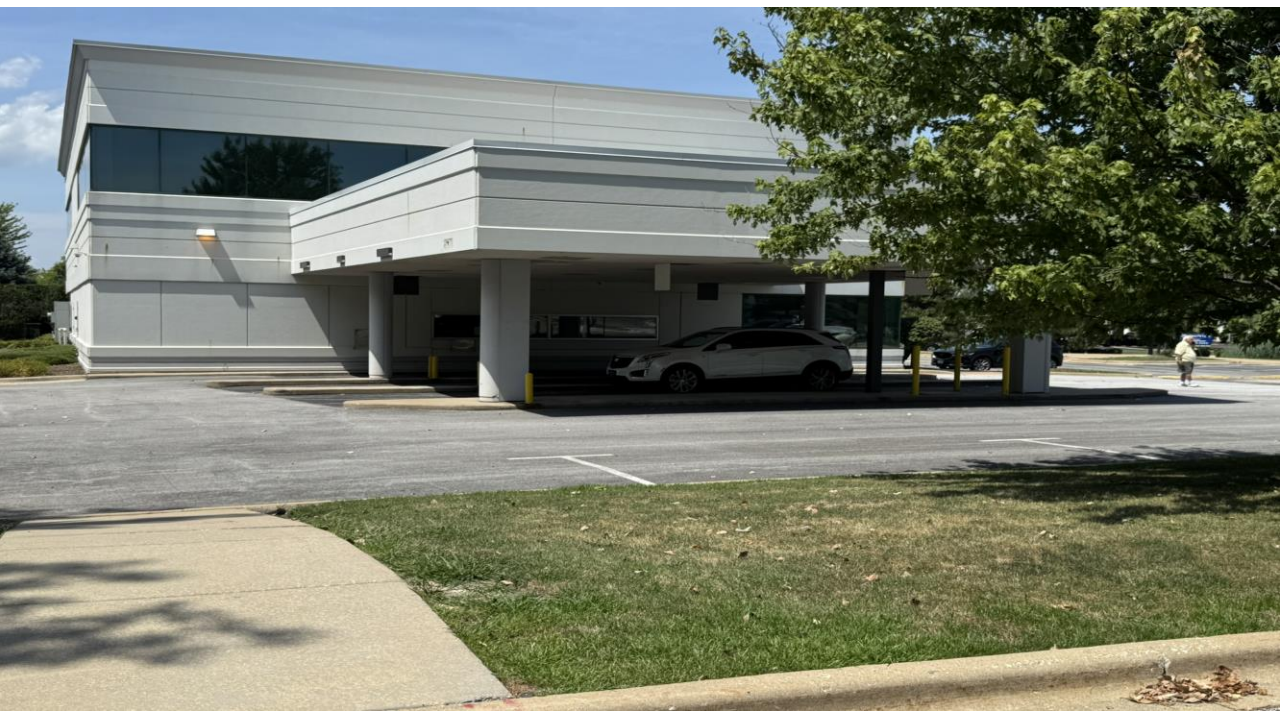
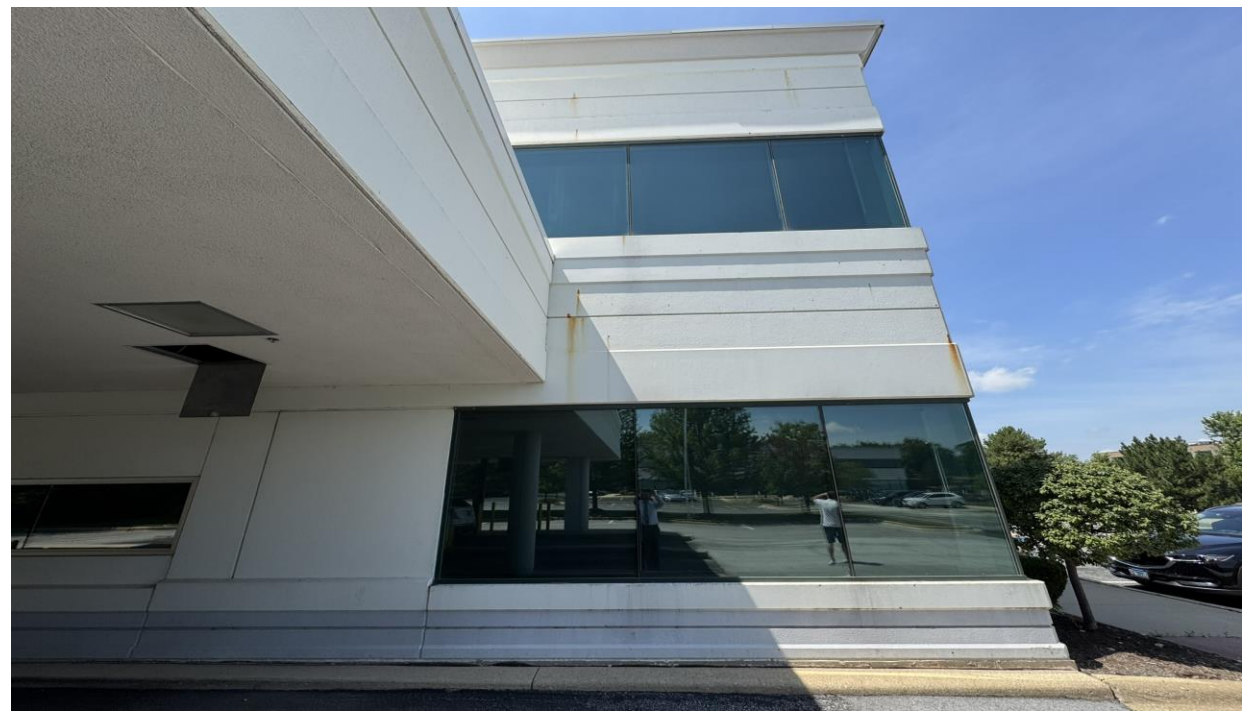
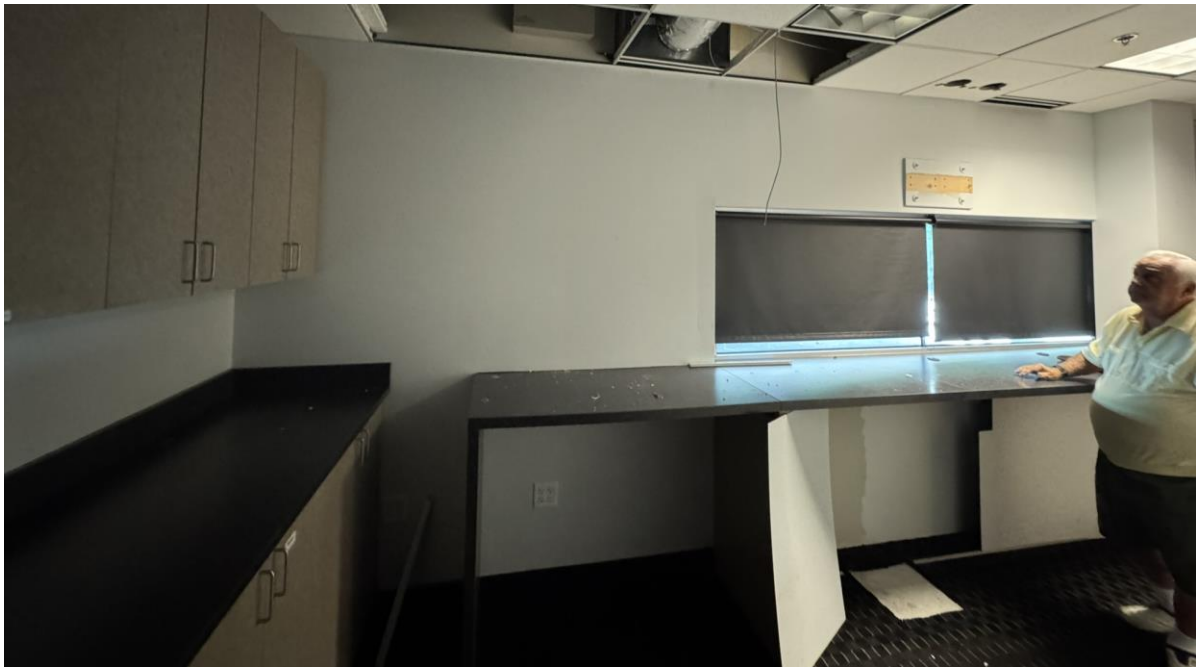
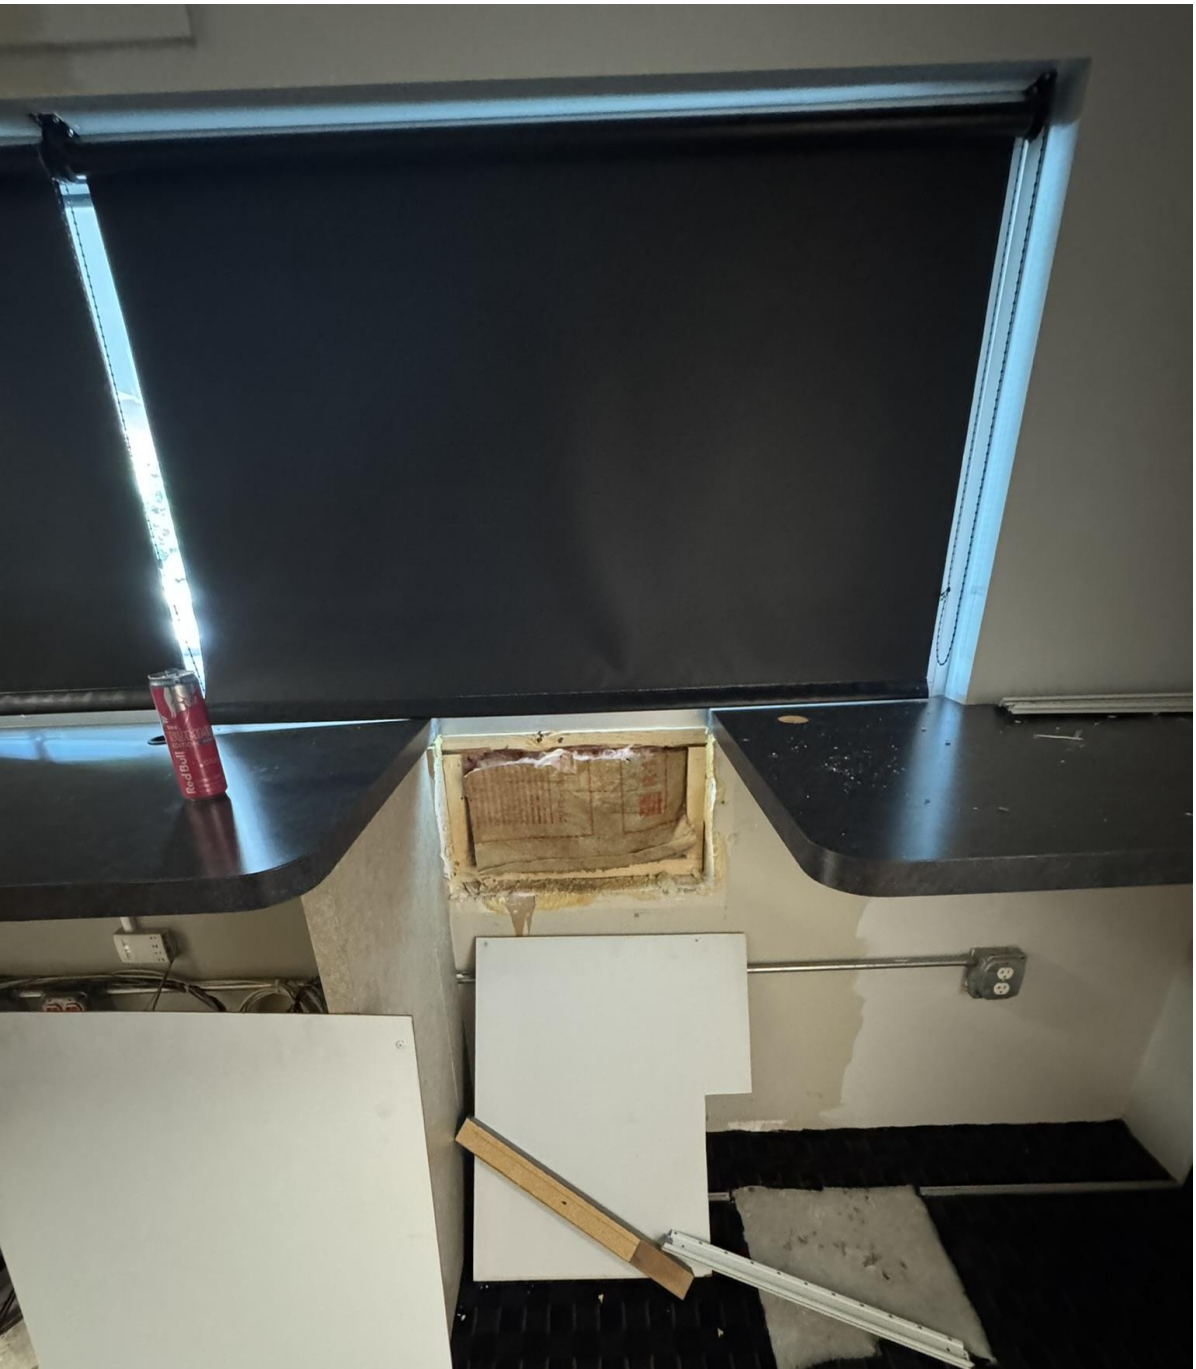
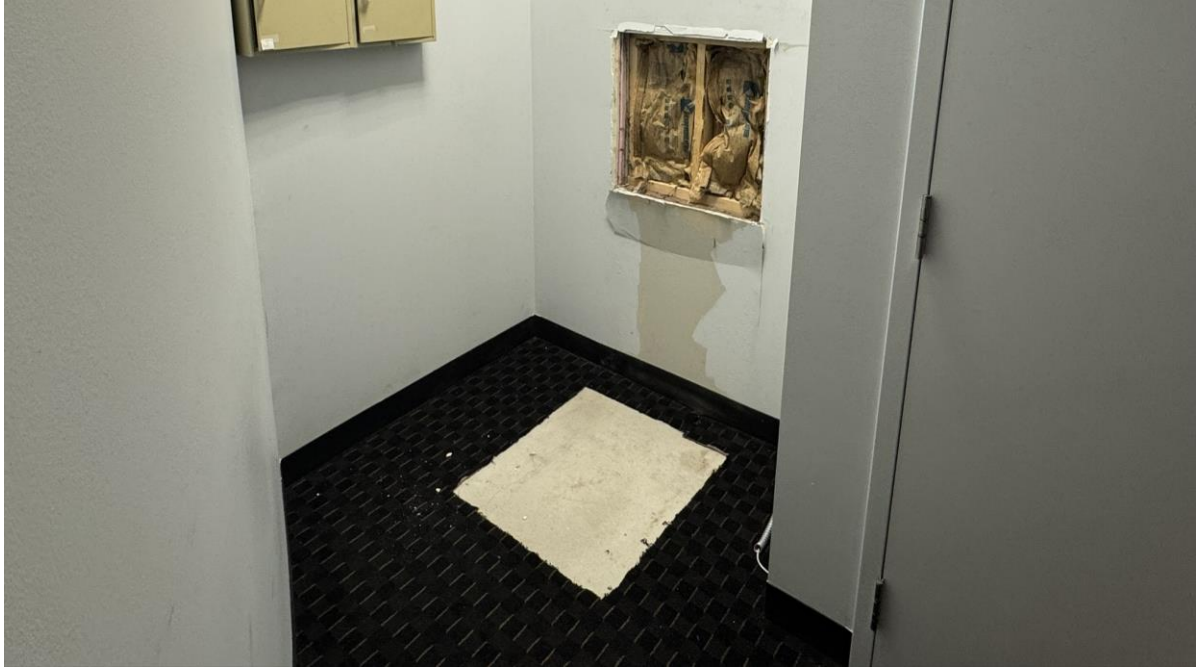
- Drive-through lanes and the oversized canopy consume substantial land area for a non-bank type use.
  - Pavement and circulation patterns are inefficient for general office use:
    - Excess pavement and tight turns serve a bank model, not multi-tenant or medical users.
    - Marketing flyer highlights that the drive-through lanes can be removed to increase parking—an explicit acknowledgment of current layout inefficiency
- As part of this redevelopment the Applicant is required to produce a new full-site landscaping plan for approval by the Village.

- The 1.52-acre site is dominated by drive-through canopy and stacking lanes & minimal green space limiting the current parking space count to only 35. After removal of the drive-through the site will be able to support additional parking, better circulation, and additional green space.
  - The redevelopment of the property will eventually result in approximately 70 car parking spaces.
- This overpaving contributes to inefficient land use and stormwater runoff while limiting alternative uses without demolition or site work.
- In TIF reports, high impervious coverage is commonly cited as a blight factor because it hinders adaptive reuse.
