PROJECT  
**LaGrange Square  
Redevelopment-  
Tree Survey &  
Tree Mitigation**

45 Orland Square Drive,  
Orland Park, Illinois 60462

SHEET TITLE  
**Tree Mitigation  
Plan**

SHEET NUMBER **L1**

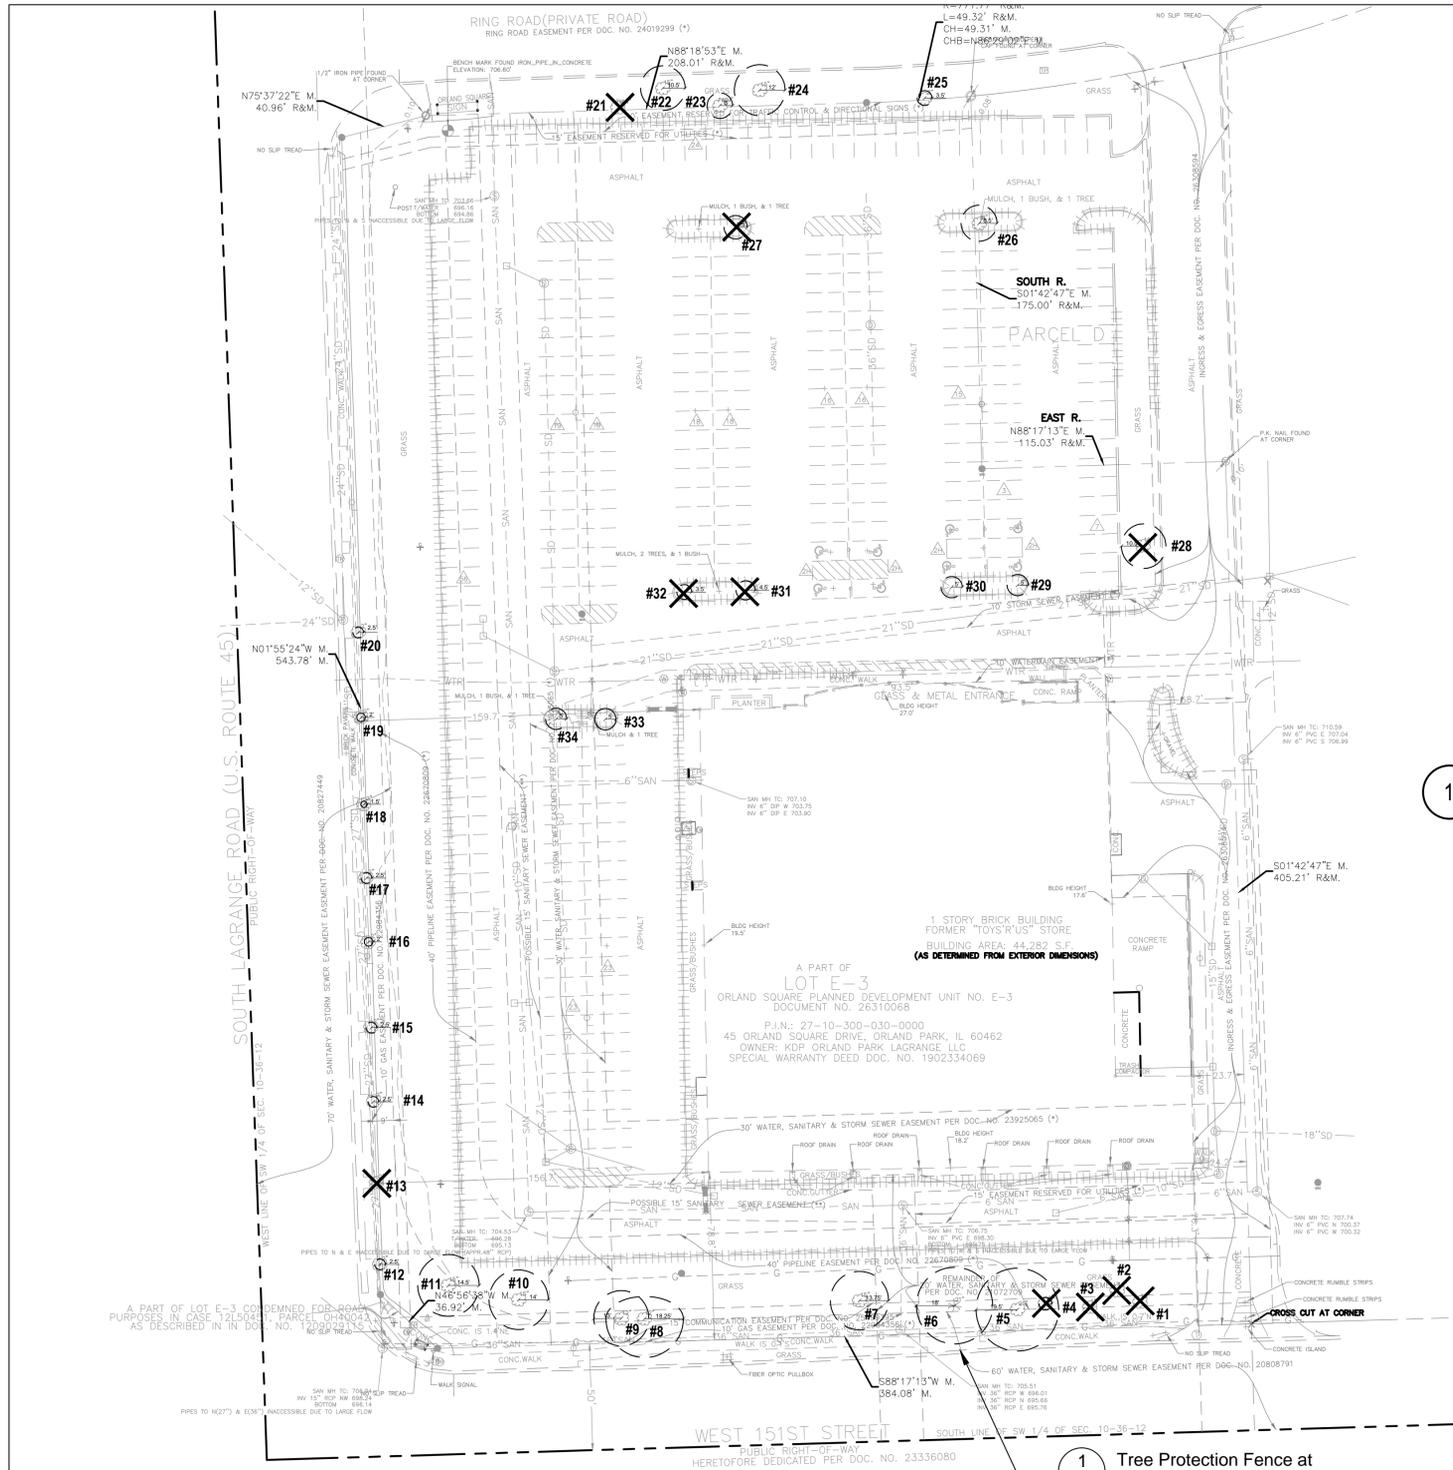
#	Botanic name	Common Name	DBH Dia.	Canopy Dia.	Rating	Preserve/Replace/Relocate / Destroy
1	Malus Species	Crabapple	8.1" / 9" / 9.3"	n/a	Dead	Destroy
2	Malus Species	Crabapple	6.5" / 7.7"	n/a	Dead	Destroy
3	Malus Species	Crabapple	4.5" / 4.6" / 6.7" / 7.5"	n/a	Dead	Destroy
4	Acer platanoides	Norway Maple	3.2"	6'	Poor	Destroy
5	Acer platanoides	Norway Maple	20.6"	39'	Good	Preserve
6	Pinus nigra	Austrian Pine	21"	36'	Fair	Preserve
7	Malus sylvestris	European Crabapple	7.6" / 10.7"	27'-6"	Fair	Preserve
8	Tilia americana	Linden	11.1"	36' ~ 5'	Good	Preserve
9	Acer platanoides	Norway Maple	11.4"	26'	Good	Preserve
10	Tilia americana	Linden	15.7"	28'	Good	Preserve
11	Tilia americana	Linden	15.3"	29'	Good	Preserve
12	Platanus x acerifolia	London planetree	2.3"	5'	Good	Preserve
13	Platanus x acerifolia	London planetree	2"	n/a	Dead	Destroy
14	Platanus x acerifolia	London planetree	2.9"	5'	Poor	Replace
15	Platanus x acerifolia	London planetree	2.6"	5'	Poor	Replace

16	Platanus x acerifolia	London planetree	2.6"	4'	Poor	Replace
17	Platanus x acerifolia	London planetree	2.7"	5'	Good	Preserve
18	Acer platanoides	Norway Maple	2.1"	3'	Good	Preserve
19	Acer platanoides	Norway Maple	2"	4'	Good	Preserve

#	Botanic name	Common Name	DBH Dia.	Canopy Dia.	Rating	Preserve/Replace/Relocate / Destroy
20	Acer platanoides	Norway Maple	1.8"	5'	Good	Preserve
21	Malus Species	Crabapple	5.8" / 7"		Dead	Destroy
22	Crataegus phaenopyrum	Washington Hawthorn	3" / 4.4" / 6.9" / 8.2"	21'	Poor	Preserve
23	Malus Species	Crabapple	4.2" / 4.6"	12'	Poor	Preserve
24	Celtis occidentalis	Hackberry	12.7"	24'	Good	Preserve
25	Tilia americana	Linden	3.5"	7'	Poor	Preserve
26	Gleditsia triacanthos	Honeylocust	4.3"	17'	Good	Preserve
27	Gleditsia triacanthos	Honeylocust	3"	11'	Poor	Destroy
28	Malus Species	Crabapple	2.6" / 4" / 4" / 4.1" / 4.2" / 5.6"	21'	Poor	Destroy
29	Gleditsia triacanthos	Honeylocust	2.8"	10'	Good	Preserve
30	Gleditsia triacanthos	Honeylocust	2.2"	10'	Good	Preserve
31	Gleditsia triacanthos	Honeylocust	2.8"	9'	Poor	Destroy
32	Gleditsia triacanthos	Honeylocust	2"	7'	Poor	Destroy
33	Gleditsia triacanthos	Honeylocust	2.5"	10'	Good	Preserve

34	Gleditsia triacanthos	Honeylocust	2.5"	10'	Good	Preserve

B) None of the trees marked for removal (destroy) require mitigation per village Code Section 6-305: Landscape and Tree Preservation.

NOTE: Trees marked as "preserve" are to be surrounded at the dripline with 4' tall tree protection fencing (where dripline extends over pavement, place fence at edge of paving).
