PROJECT
LaGrange Square Redevelopment- Tree Survey & Tree Mitigation
45 Orland Square Drive, Orland Park, Illinois 60462

SHEET TITLE
Tree Mitigation Plan

SHEET NUMBER
L1

HW/ZIP	Tree Survey	26NOV2019

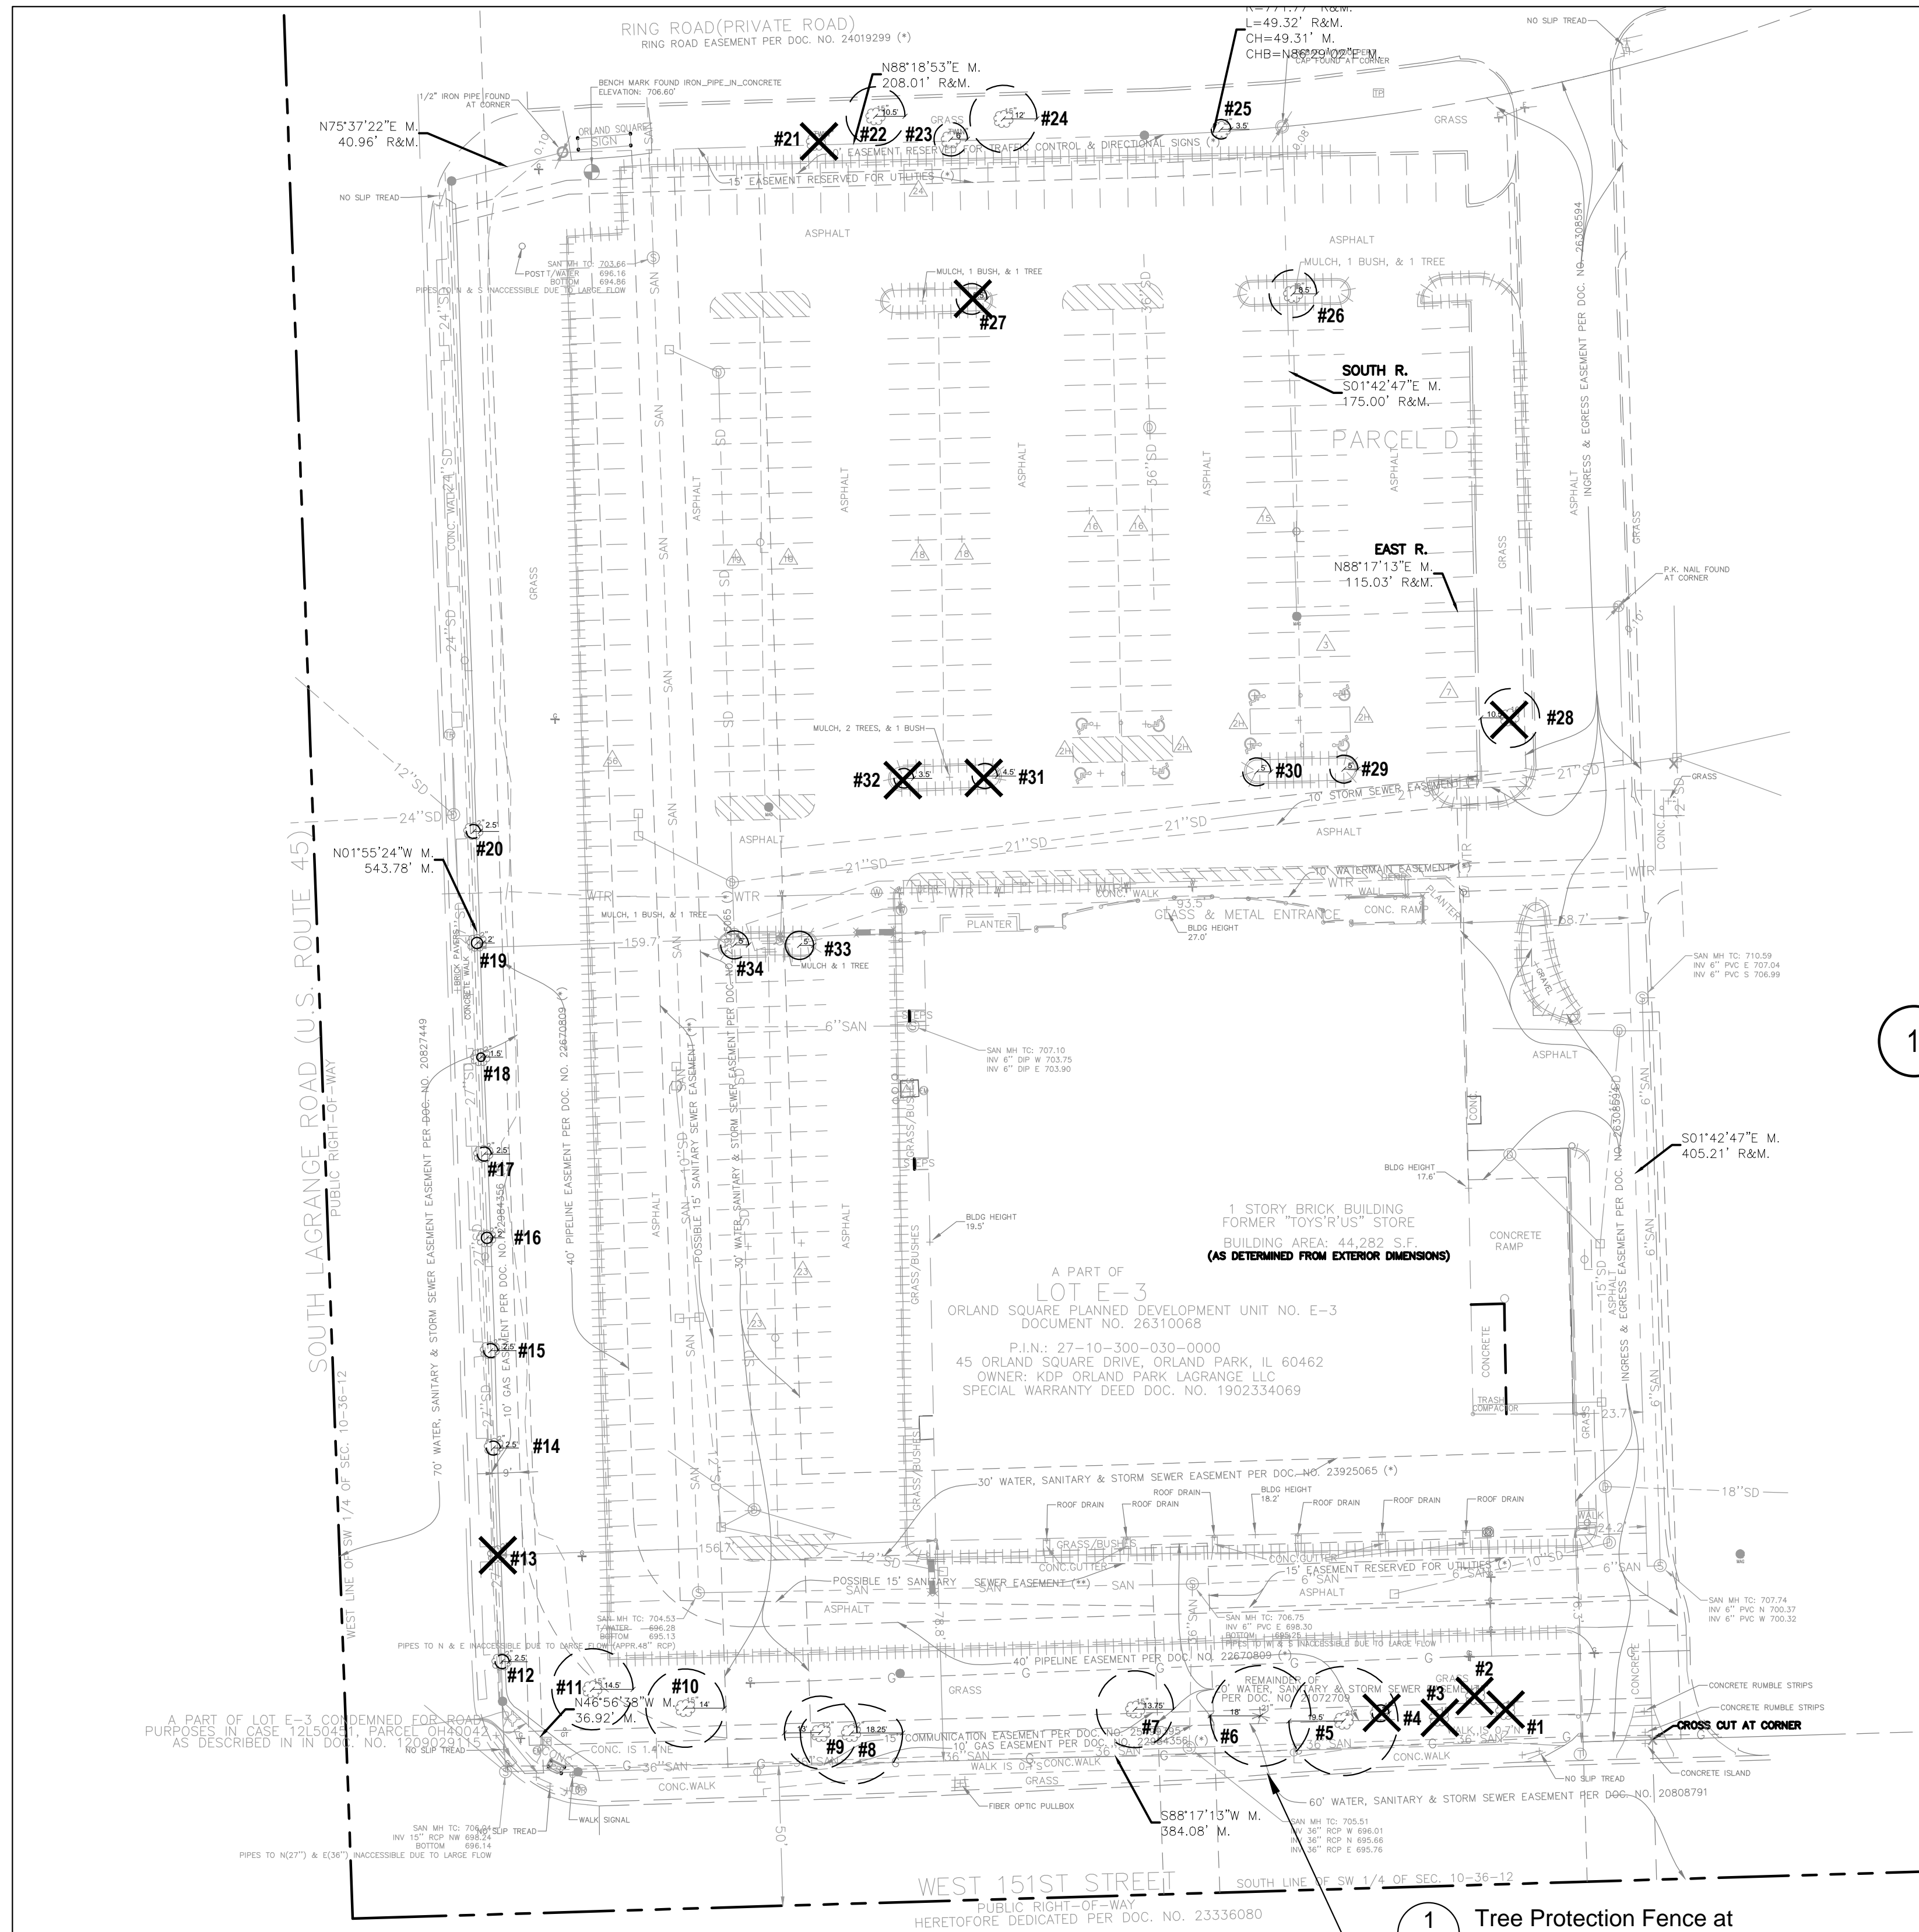
#	Botanic name	Common Name	DBH Dia.	Canopy Dia.	Rating	Preserve/Replace/Relocate / Destroy
1	Malus Species	Crabapple	8.1" / 9" / 9.3"	n/a	Dead	Destroy
2	Malus Species	Crabapple	6.5" / 7.7"	n/a	Dead	Destroy
3	Malus Species	Crabapple	4.5" / 4.6" / 6.7" / 7.5"	n/a	Dead	Destroy
4	Acer platanoides	Norway Maple	3.2"	6'	Poor	Destroy
5	Acer platanoides	Norway Maple	20.6"	39'	Good	Preserve
6	Pinus nigra	Austrian Pine	21"	36'	Fair	Preserve
7	Malus sylvestris	European Crabapple	7.6" / 10.7"	27'-6"	Fair	Preserve
8	Tilia americana	Linden	11.1"	36' ~ 5'	Good	Preserve
9	Acer platanoides	Norway Maple	11.4"	26'	Good	Preserve
10	Tilia americana	Linden	15.7"	28'	Good	Preserve
11	Tilia americana	Linden	15.3"	29'	Good	Preserve
12	Platanus x acerifolia	London planetree	2.3"	5'	Good	Preserve
13	Platanus x acerifolia	London planetree	2"	n/a	Dead	Destroy
14	Platanus x acerifolia	London planetree	2.9"	5'	Poor	Replace
15	Platanus x acerifolia	London planetree	2.6"	5'	Poor	Replace

16	Platanus x acerifolia	London planetree	2.6"	4'	Poor	Replace
17	Platanus x acerifolia	London planetree	2.7"	5'	Good	Preserve
18	Acer platanoides	Norway Maple	2.1"	3'	Good	Preserve
19	Acer platanoides	Norway Maple	2"	4'	Good	Preserve

#	Botanic name	Common Name	DBH Dia.	Canopy Dia.	Rating	Preserve/Replace/Relocate / Destroy
20	Acer platanoides	Norway Maple	1.8"	5'	Good	Preserve
21	Malus Species	Crabapple	5.8" / 7"		Dead	Destroy
22	Crataegus phaenopyrum	Washington Hawthorn	3" / 4.4" / 6.9" / 8.2"	21'	Poor	Preserve
23	Malus Species	Crabapple	4.2" / 4.6"	12'	Poor	Preserve
24	Celtis occidentalis	Hackberry	12.7"	24'	Good	Preserve
25	Tilia americana	Linden	3.5"	7'	Poor	Preserve
26	Gleditsia triacanthos	Honeylocust	4.3"	17'	Good	Preserve
27	Gleditsia triacanthos	Honeylocust	3"	11'	Poor	Destroy
28	Malus Species	Crabapple	2.6" / 4" / 4" / 4.1" / 4.2" / 5.6"	21'	Poor	Destroy
29	Gleditsia triacanthos	Honeylocust	2.8"	10'	Good	Preserve
30	Gleditsia triacanthos	Honeylocust	2.2"	10'	Good	Preserve
31	Gleditsia triacanthos	Honeylocust	2.8"	9'	Poor	Destroy
32	Gleditsia triacanthos	Honeylocust	2"	7'	Poor	Destroy
33	Gleditsia triacanthos	Honeylocust	2.5"	10'	Good	Preserve

34	Gleditsia triacanthos	Honeylocust	2.5"	10'	Good	Preserve

Date of Tree Survey Field Work: 11/22/2019

NOTE: Trees marked as "preserve" are to be surrounded at the dripline with 4' tall tree protection fencing (where dripline extends over pavement, place fence at edge of paving).

B) None of the trees marked for removal (destroy) require mitigation per village Code Section 6-305: Landscape and Tree Preservation.
