**VILLAGE OF ORLAND PARK  
WATERSHED  
MANAGEMENT ORDINANCE  
(WMO) WETLAND, BUFFER,  
& RIPARIAN ENVIRONMENT  
SUBMITTAL**

**Estates at Ravinia Meadows**  
Orland Park, Cook County, Illinois

**November 8, 2024**

# WETLAND & WATERS DELINEATION REPORT

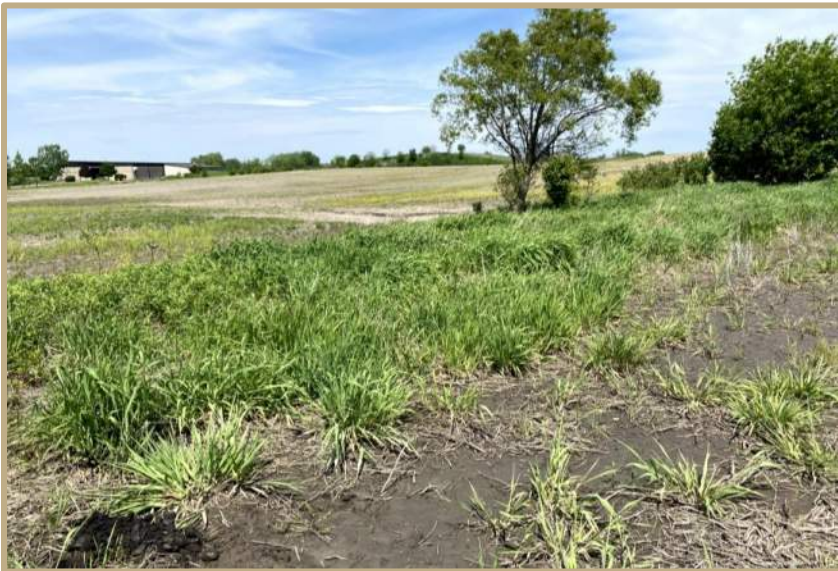
**PHOTO #2**

View of Area 1 at Data Point X07 facing northwest.

**Hydrology:** The presence of three secondary wetland hydrology indicators, B6, Surface Soil Cracks, D2, Geomorphic Position, and D5, FAC-neutral Test, satisfies the hydrology criterion at Data Point X07.

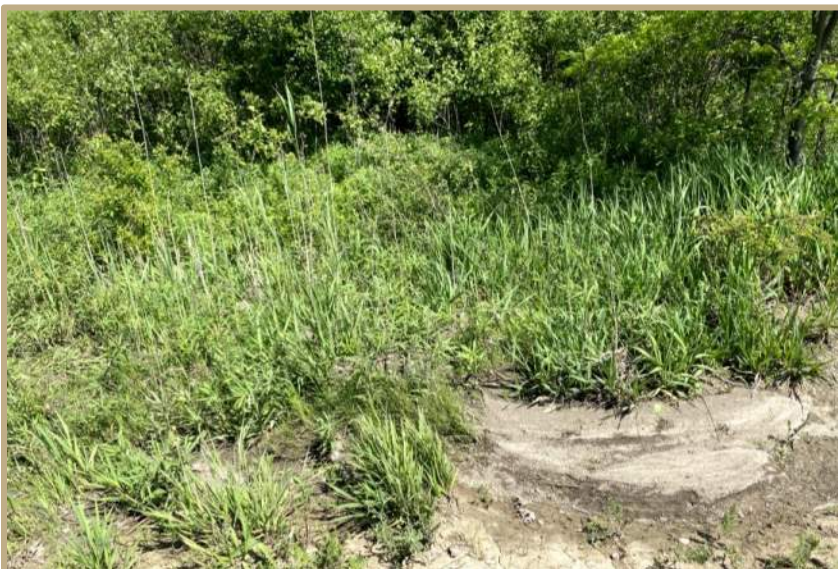
**PHOTO #6**

View of drainage patterns observed in Area 2.

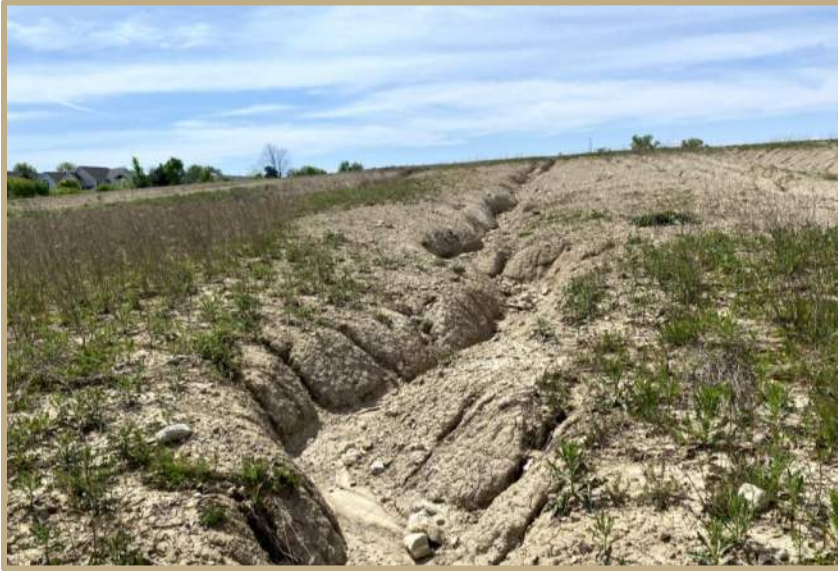
**PHOTO # 19**

View of upland at Data Point X01 facing south.

- The soil profile at Data Point X01 consisted of 0-6 inches of very dark grayish brown (10YR 3/2) silty clay loam underlain by 6 inches, to a depth of 12+ inches below the surface, of brown (10YR 4/3) silty clay loam with 10% dark yellowish brown (10YR 4/6) redoximorphic concentrations and 5% gray (10YR 5/1) redoximorphic depletions. Hydric soil indicators were not observed, so the soils criterion is not satisfied.

- The presence of one secondary wetland hydrology indicator, B10, Drainage Patterns, is not enough to satisfy the hydrology criterion at Data Point X01.
- Neither primary nor secondary wetland hydrology indicators were observed, so the hydrology criterion is not satisfied at Data Point X02.
- The presence of one secondary wetland hydrology indicator, B10, Drainage Patterns, is not enough to satisfy the hydrology criterion at Data Point X05.
- The presence of one secondary wetland hydrology indicator, B10, Drainage Patterns, is not enough to satisfy the hydrology criterion at Data Point X08.
- The presence of one secondary wetland hydrology indicator, B6, Surface Soil Cracks, is not enough to satisfy the hydrology criterion at Data Point X10.

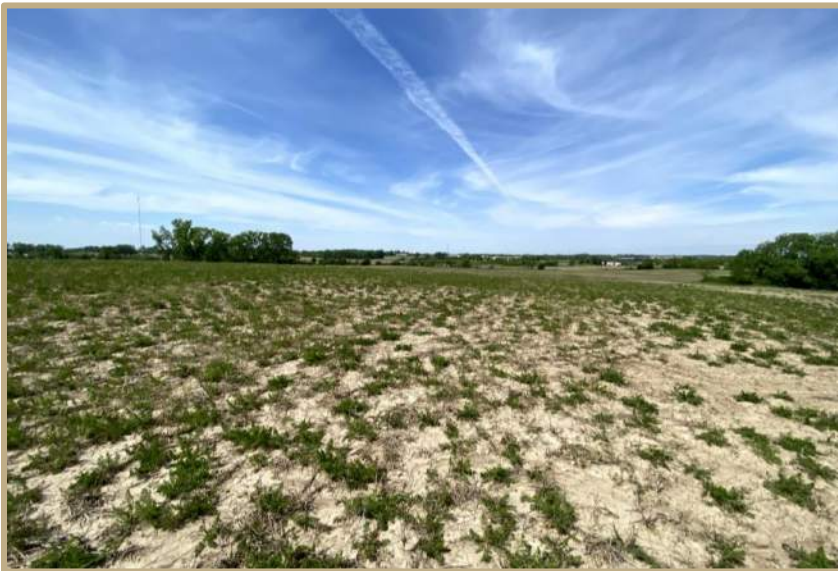
**PHOTO #20**

View of upland at Data Point X02 facing southwest.

- The soil profile at Data Point X02 consisted of 0-6 inches of very dark grayish brown (10YR 3/2) silty clay loam underlain by 8+ inches, to a depth of 14+ inches below the surface, of brown (10YR 4/3) silty clay loam with 10% dark yellowish brown (10YR 4/6) redoximorphic concentrations. Hydric soil indicators were not observed, so the soils criterion is not satisfied.

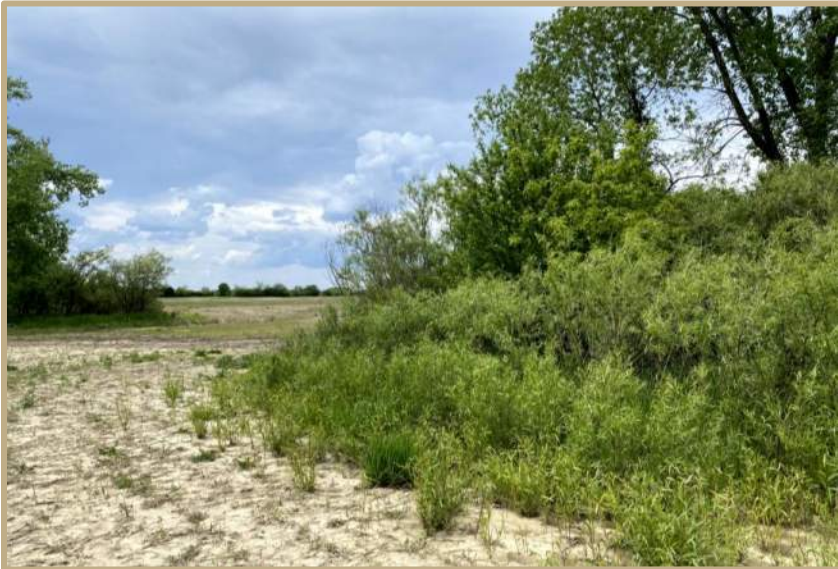
**PHOTO #26**

View of upland at Data Point X14 facing south.

- The soil profile at Data Point X14 consisted of 0-14+ inches of brown (10YR 4/4) silty clay loam. Hydric soil indicators were not observed, so the soils criterion is not satisfied.

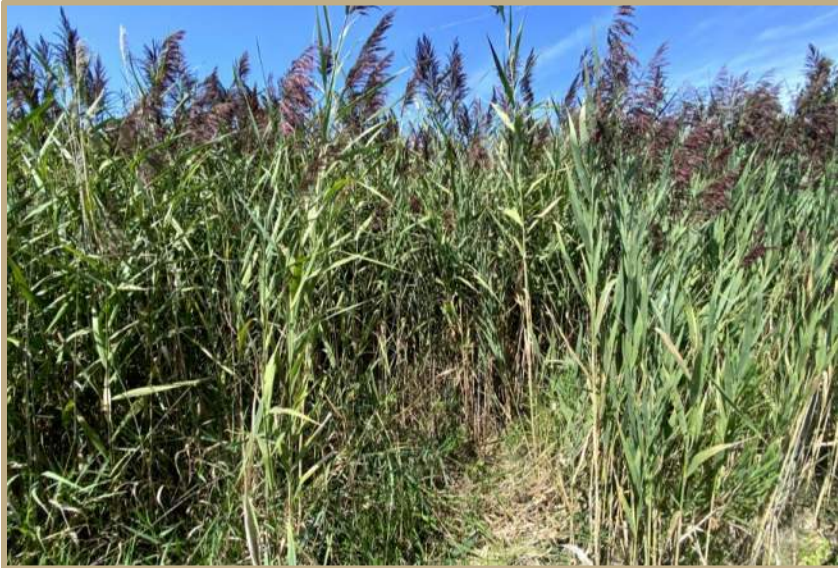
**PHOTO # 31**

View of upland near Data Point X19, facing north.

- The soil profile at Data Point X19 consisted of 0-8 inches of brown (10YR 5/4) silty clay loam, underlain by 8-15+ inches of dark brown (10YR 4/4) silty clay loam. Hydric soil indicators were not observed, so the soils criterion is not satisfied.

- Neither primary nor secondary wetland hydrology indicators were observed, so the hydrology criterion is not satisfied at Data Point X18.
- The presence of three secondary wetland hydrology indicators, D2 Geomorphic Position, D5 FAC-Neutral Test, and B6 Surface Soil Cracks, satisfies the hydrology criterion at Data Point X19.

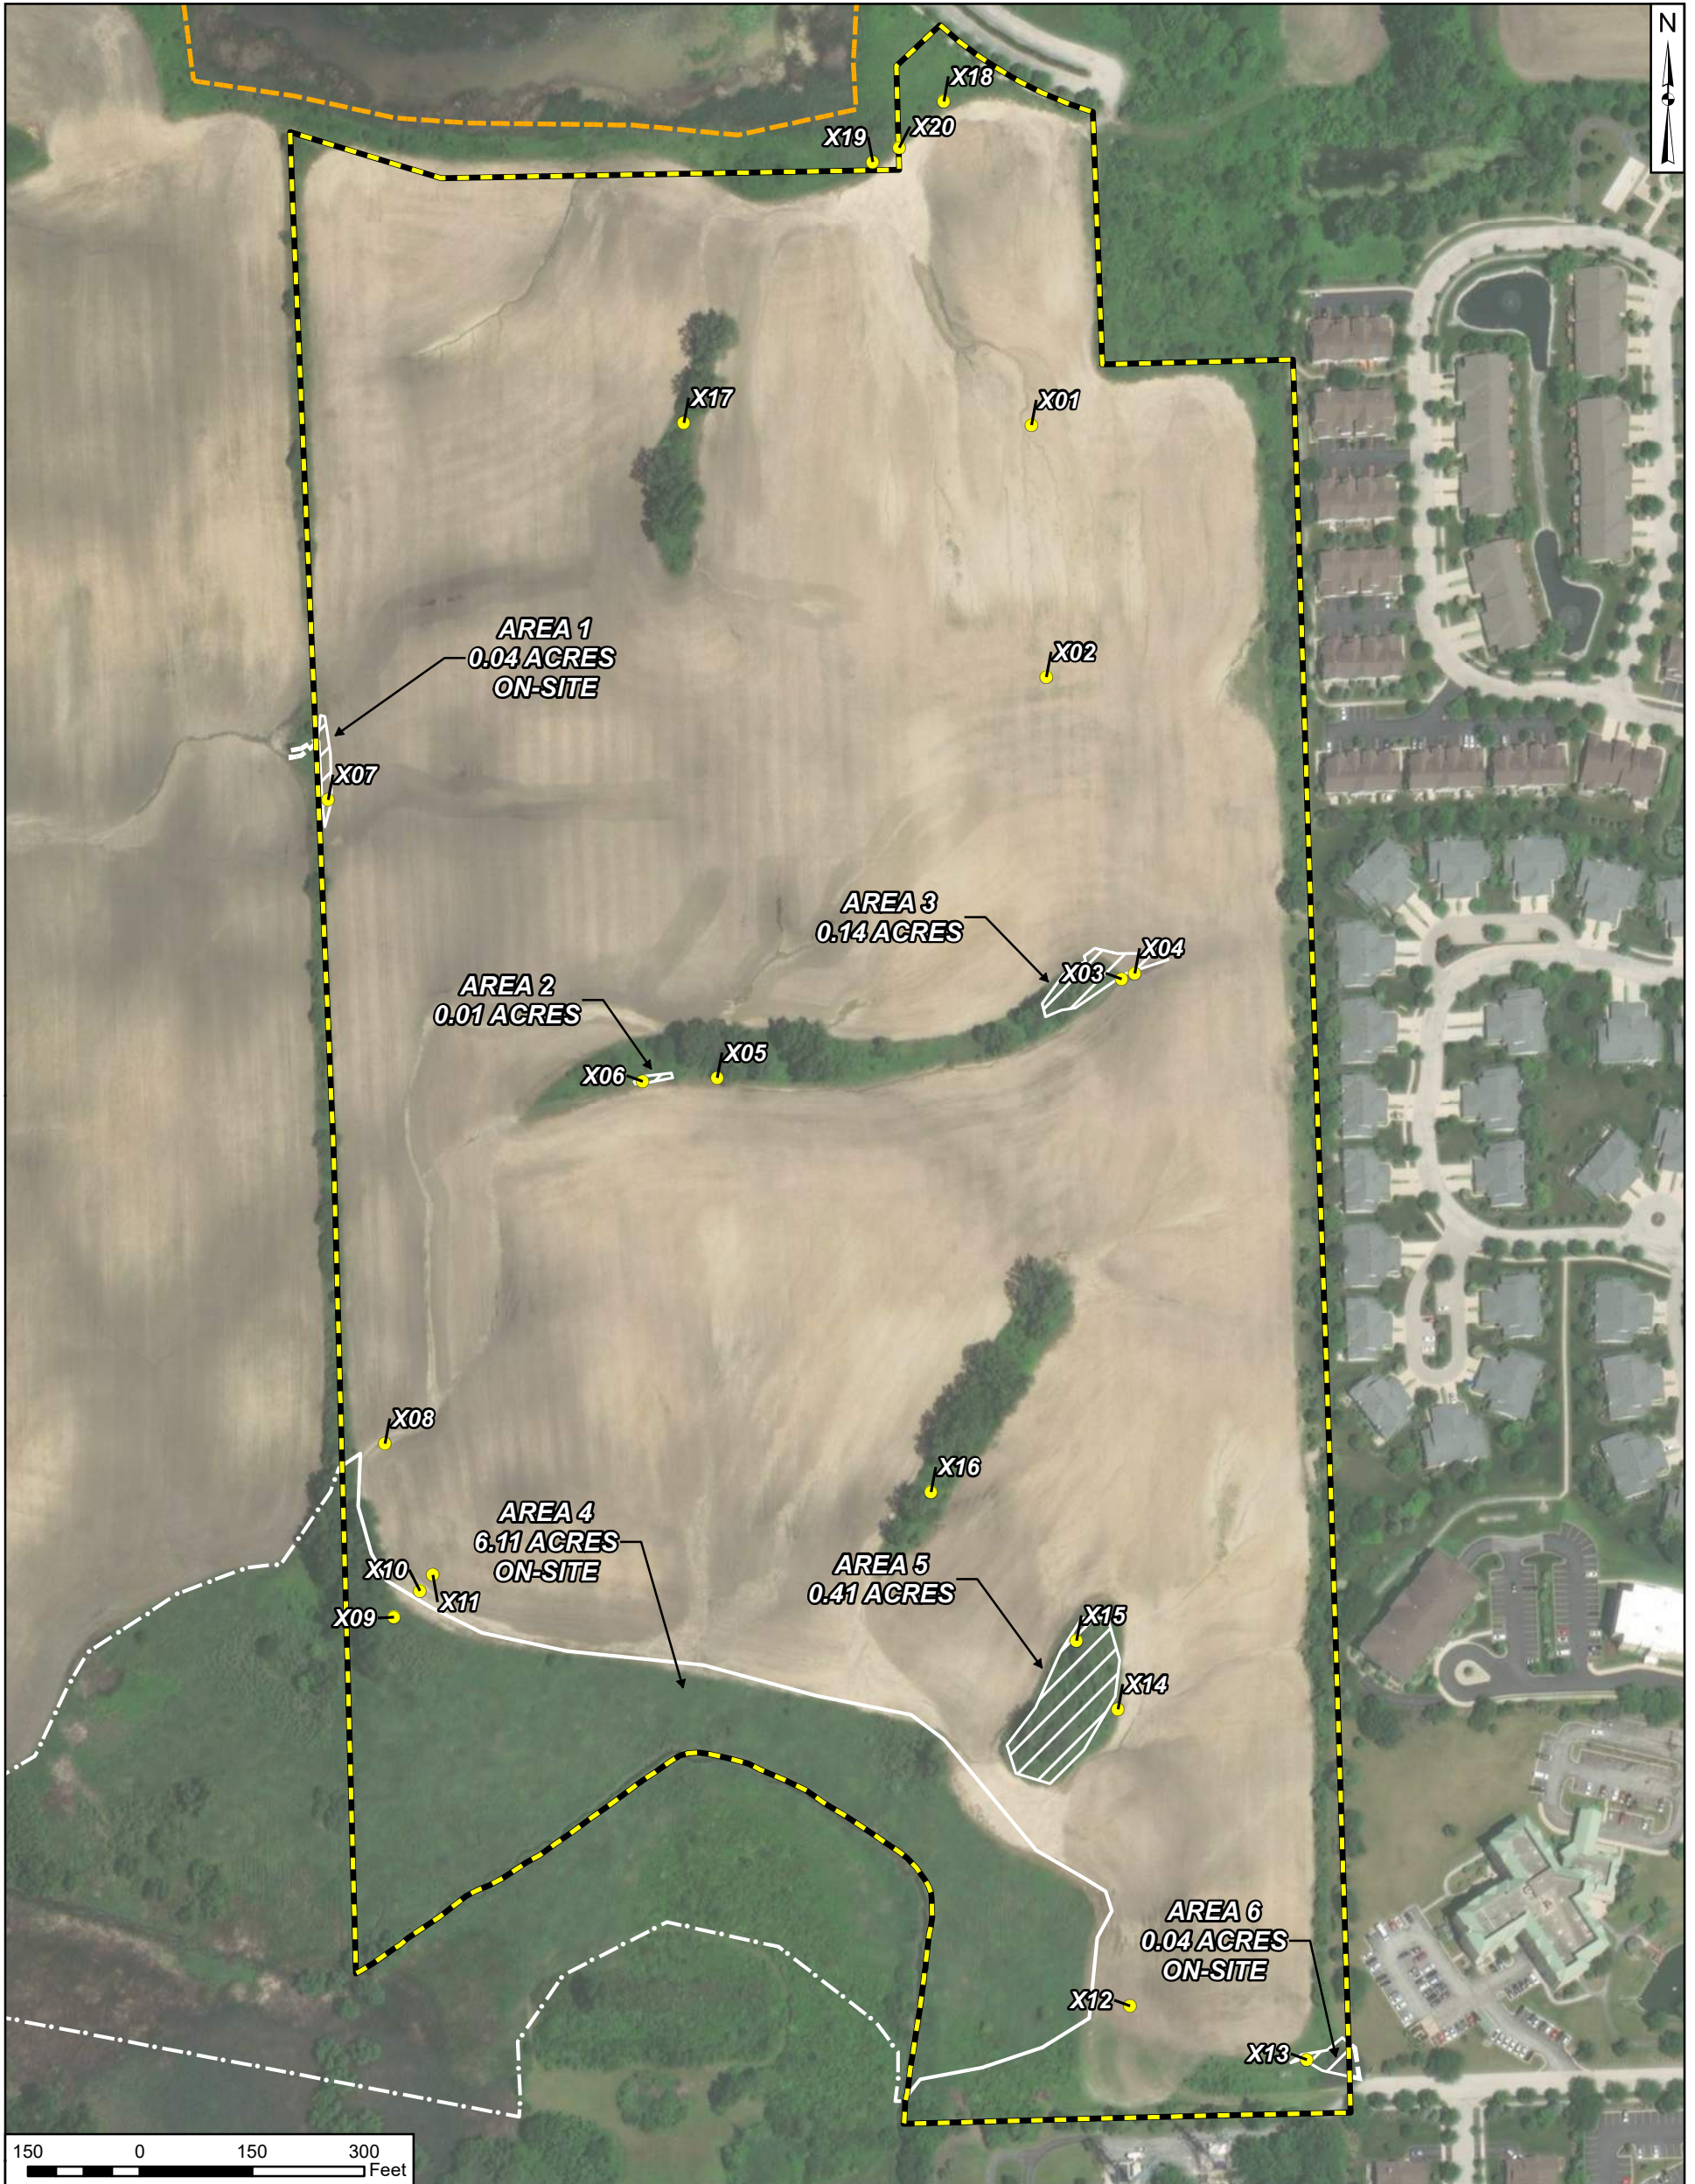
- Data Points
- Project Location
- On-Site USACE Jurisdictional Wetland (6.11 acres)
- Off-Site USACE Jurisdictional Wetland (>11.00 acres)
- On-Site Non-USACE Jurisdictional Wetland (0.64 acres)
- Off-Site Non-USACE Jurisdictional Wetland (0.02 acres)
- Off-Site Exempt Stormwater Basin

<p>7325 Janes Avenue Woodridge, IL 60517 630.724.9200 phone www.v3co.com</p>	PROJECT NO.:	240548	CLIENT:	<h2 style="margin: 0;">WETLAND &amp; WATERS DELINEATION</h2>	
	CREATED BY:	AMM	1900 E. Golf Road, Suite 300 Schaumburg, IL 60173		
DATE:	08/22/2024	BASE LAYER:	<p>Estates at Ravinia Meadow Orland Park, Cook County, Illinois</p>		FIGURE:
SCALE:	See Scale Bar	Cook County Aerial Imagery (2023)			8

In V3's professional opinion, Areas 1, 2, 3, 5, and 6 are isolated, non-USACE jurisdictional wetlands as they are not adjacent to a Waters of the U.S., and qualify as Standard Isolated Wetlands under MWRD jurisdiction. Area 4 is a wetland adjacent to a Waters of the U.S. and is subject to USACE jurisdiction. V3 recommends a No Permit Required (NPR) with Approved Jurisdictional Determination (AJD) request be submitted to USACE to confirm the jurisdiction of the identified areas.

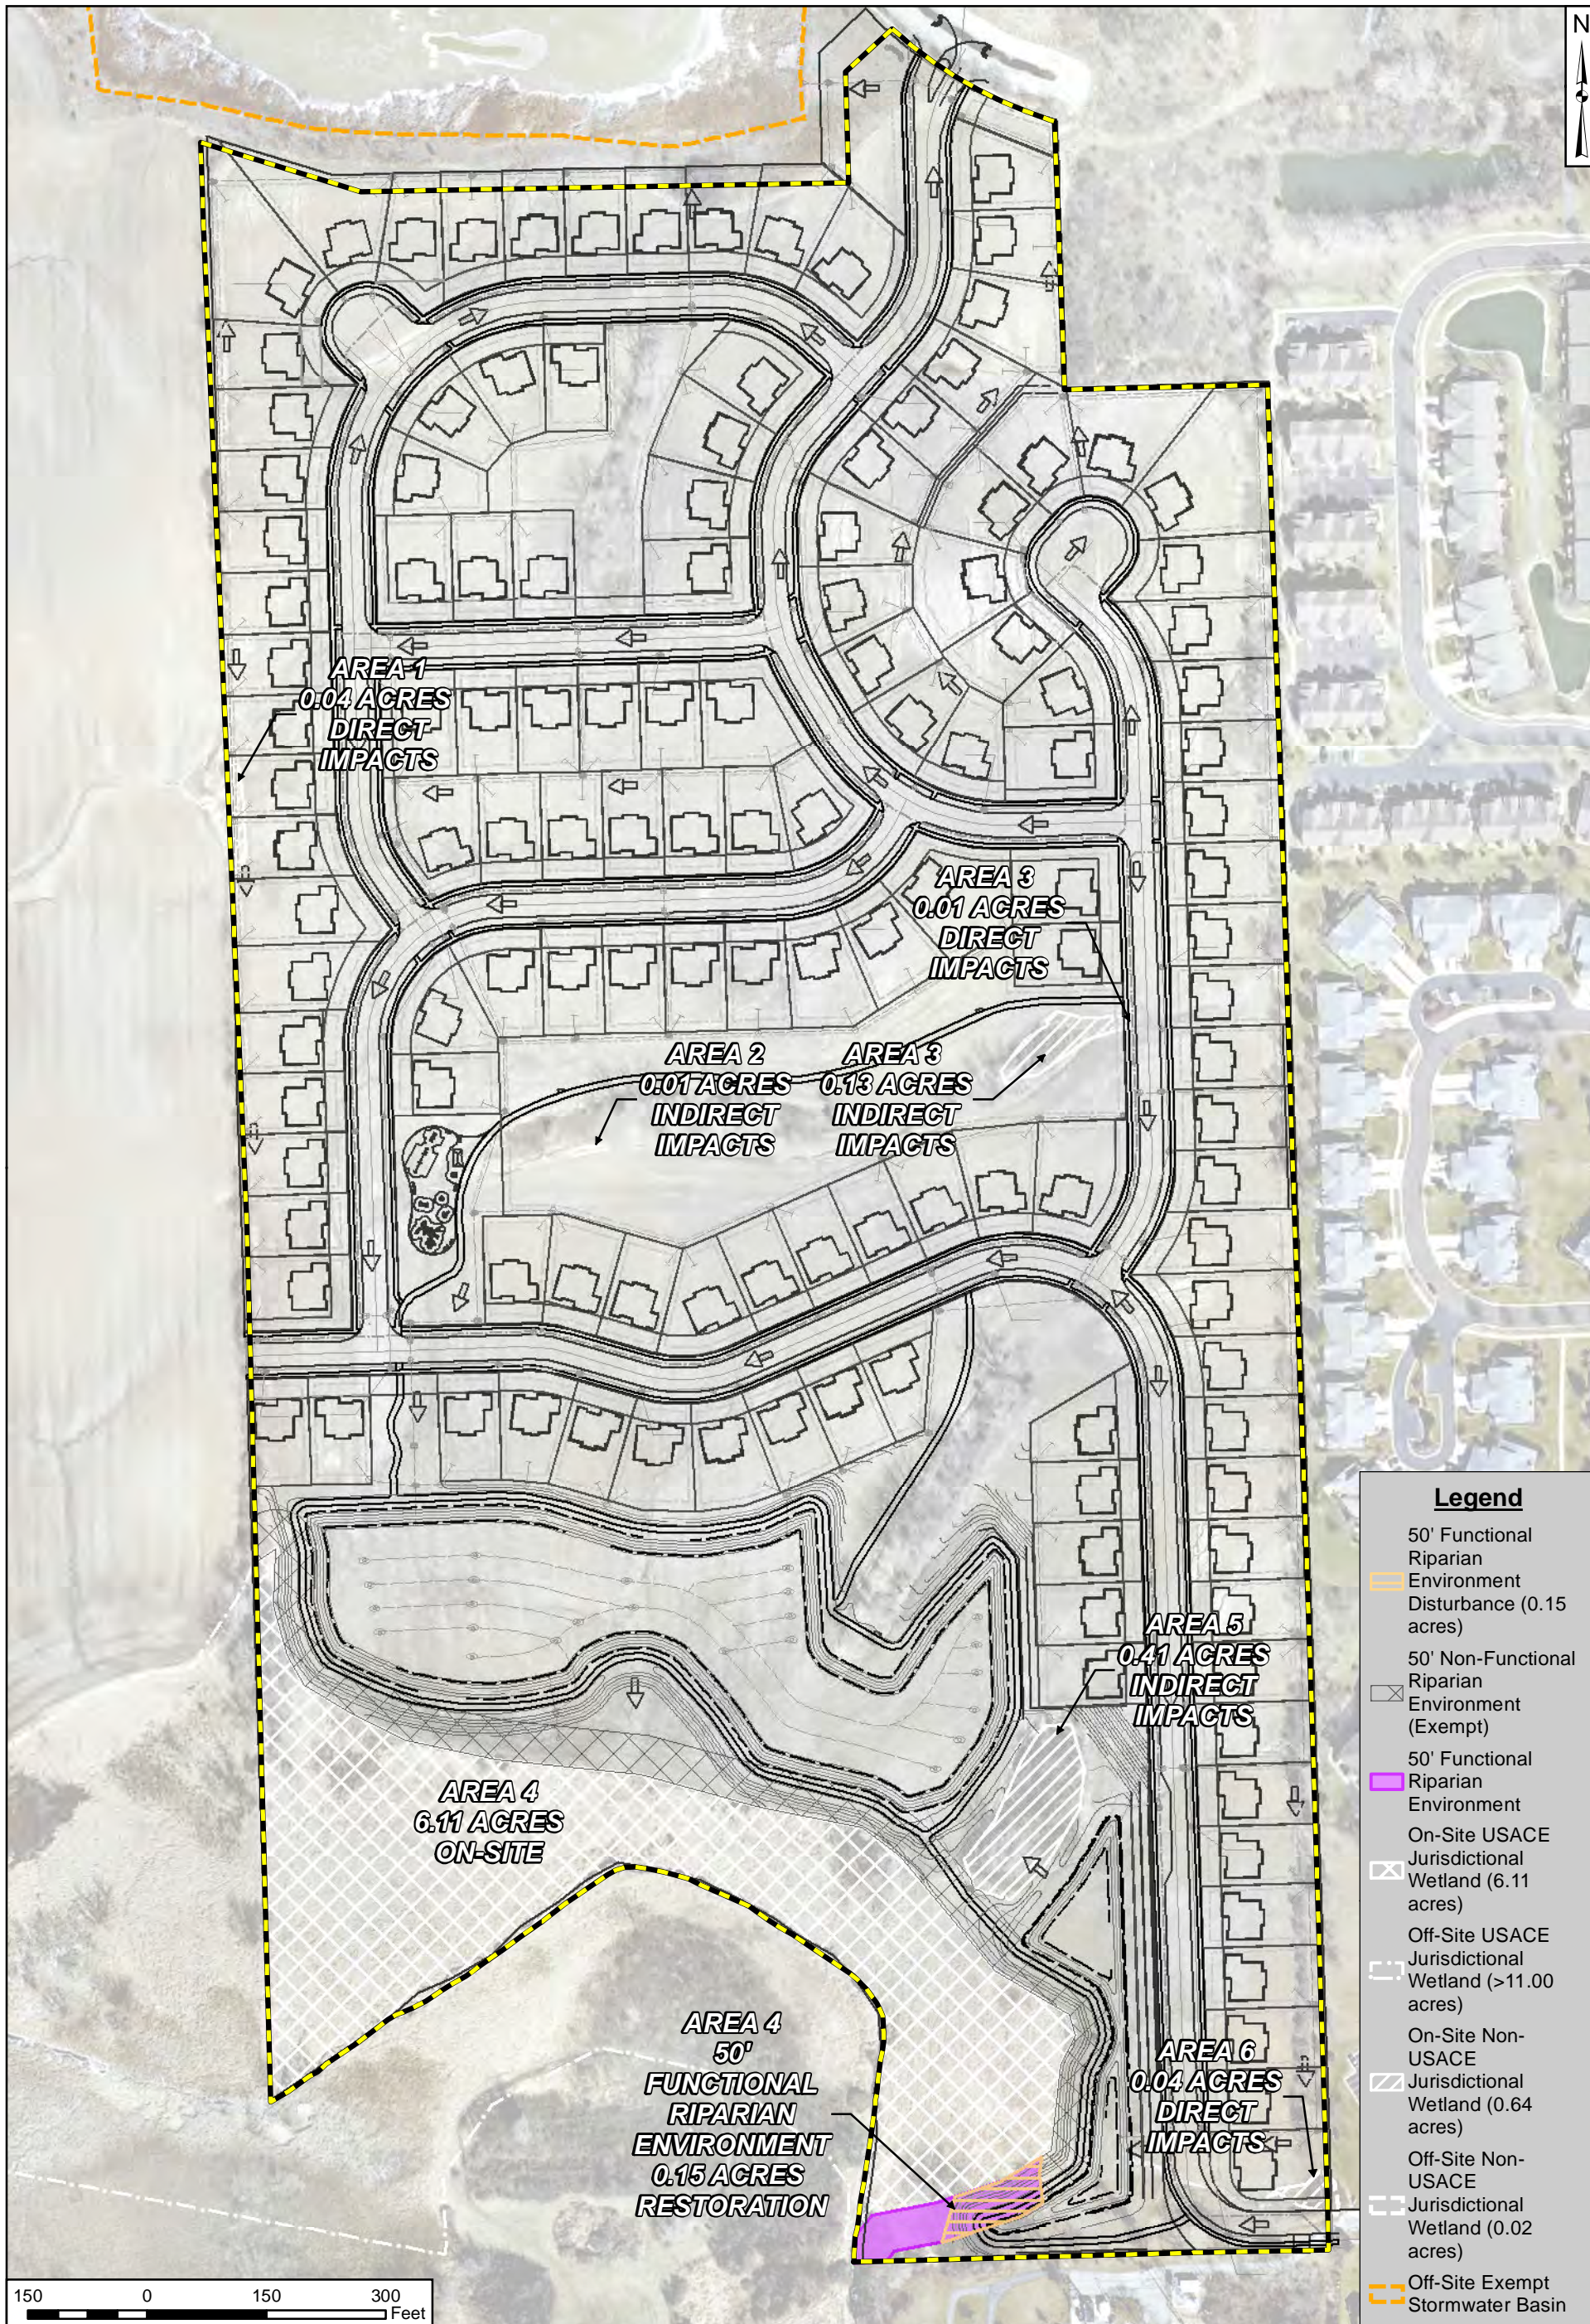
- Legend**
- 50' Functional Riparian Environment Disturbance (0.15 acres)
  - 50' Non-Functional Riparian Environment (Exempt)
  - 50' Functional Riparian Environment
  - On-Site USACE Jurisdictional Wetland (6.11 acres)
  - Off-Site USACE Jurisdictional Wetland (>11.00 acres)
  - On-Site Non-USACE Jurisdictional Wetland (0.64 acres)
  - Off-Site Non-USACE Jurisdictional Wetland (0.02 acres)
  - Off-Site Exempt Stormwater Basin

PROJECT NO.: 240548	CLIENT: Pulte Home Corporation 1900 E. Golf Road, Suite 300 Schaumburg, IL 60173	<b>PROPOSED CONDITIONS</b>
	CREATED BY: AMM	DATE: 11/08/2024	BASE LAYER: Cook County Aerial Imagery (2023)
Visio, Vertere, Virtute... "The Vision To Transform With Excellence"	SCALE: See Scale Bar		FIGURE: <b>B</b>

The proposed project will impact 0.64 acres total of standard isolated wetland Areas 1, 2, 3, 5, and 6 (Figure B, **Appendix D**), which are subject to Village of Orland Park jurisdiction. The 0.64 acres of impacts includes 0.09 acres of direct wetland impacts and 0.55 acres of indirect wetland impacts for the development of the residential subdivision and stormwater management basins. Impacts to standard isolated wetland Areas 1, 2, 3, 5, and 6 will be mitigated for through the purchase of credits from an USACE approved off-site mitigation bank.

A total of 0.15 acres of temporary disturbance to the functional riparian environment of Area 4 will occur for grading of the native stormwater management basin as shown on Figure B and as described below. The areas of temporary disturbance will be restored with native vegetation upon completion of the project, as shown on the Planting Plan (Figure C, **Appendix D**).

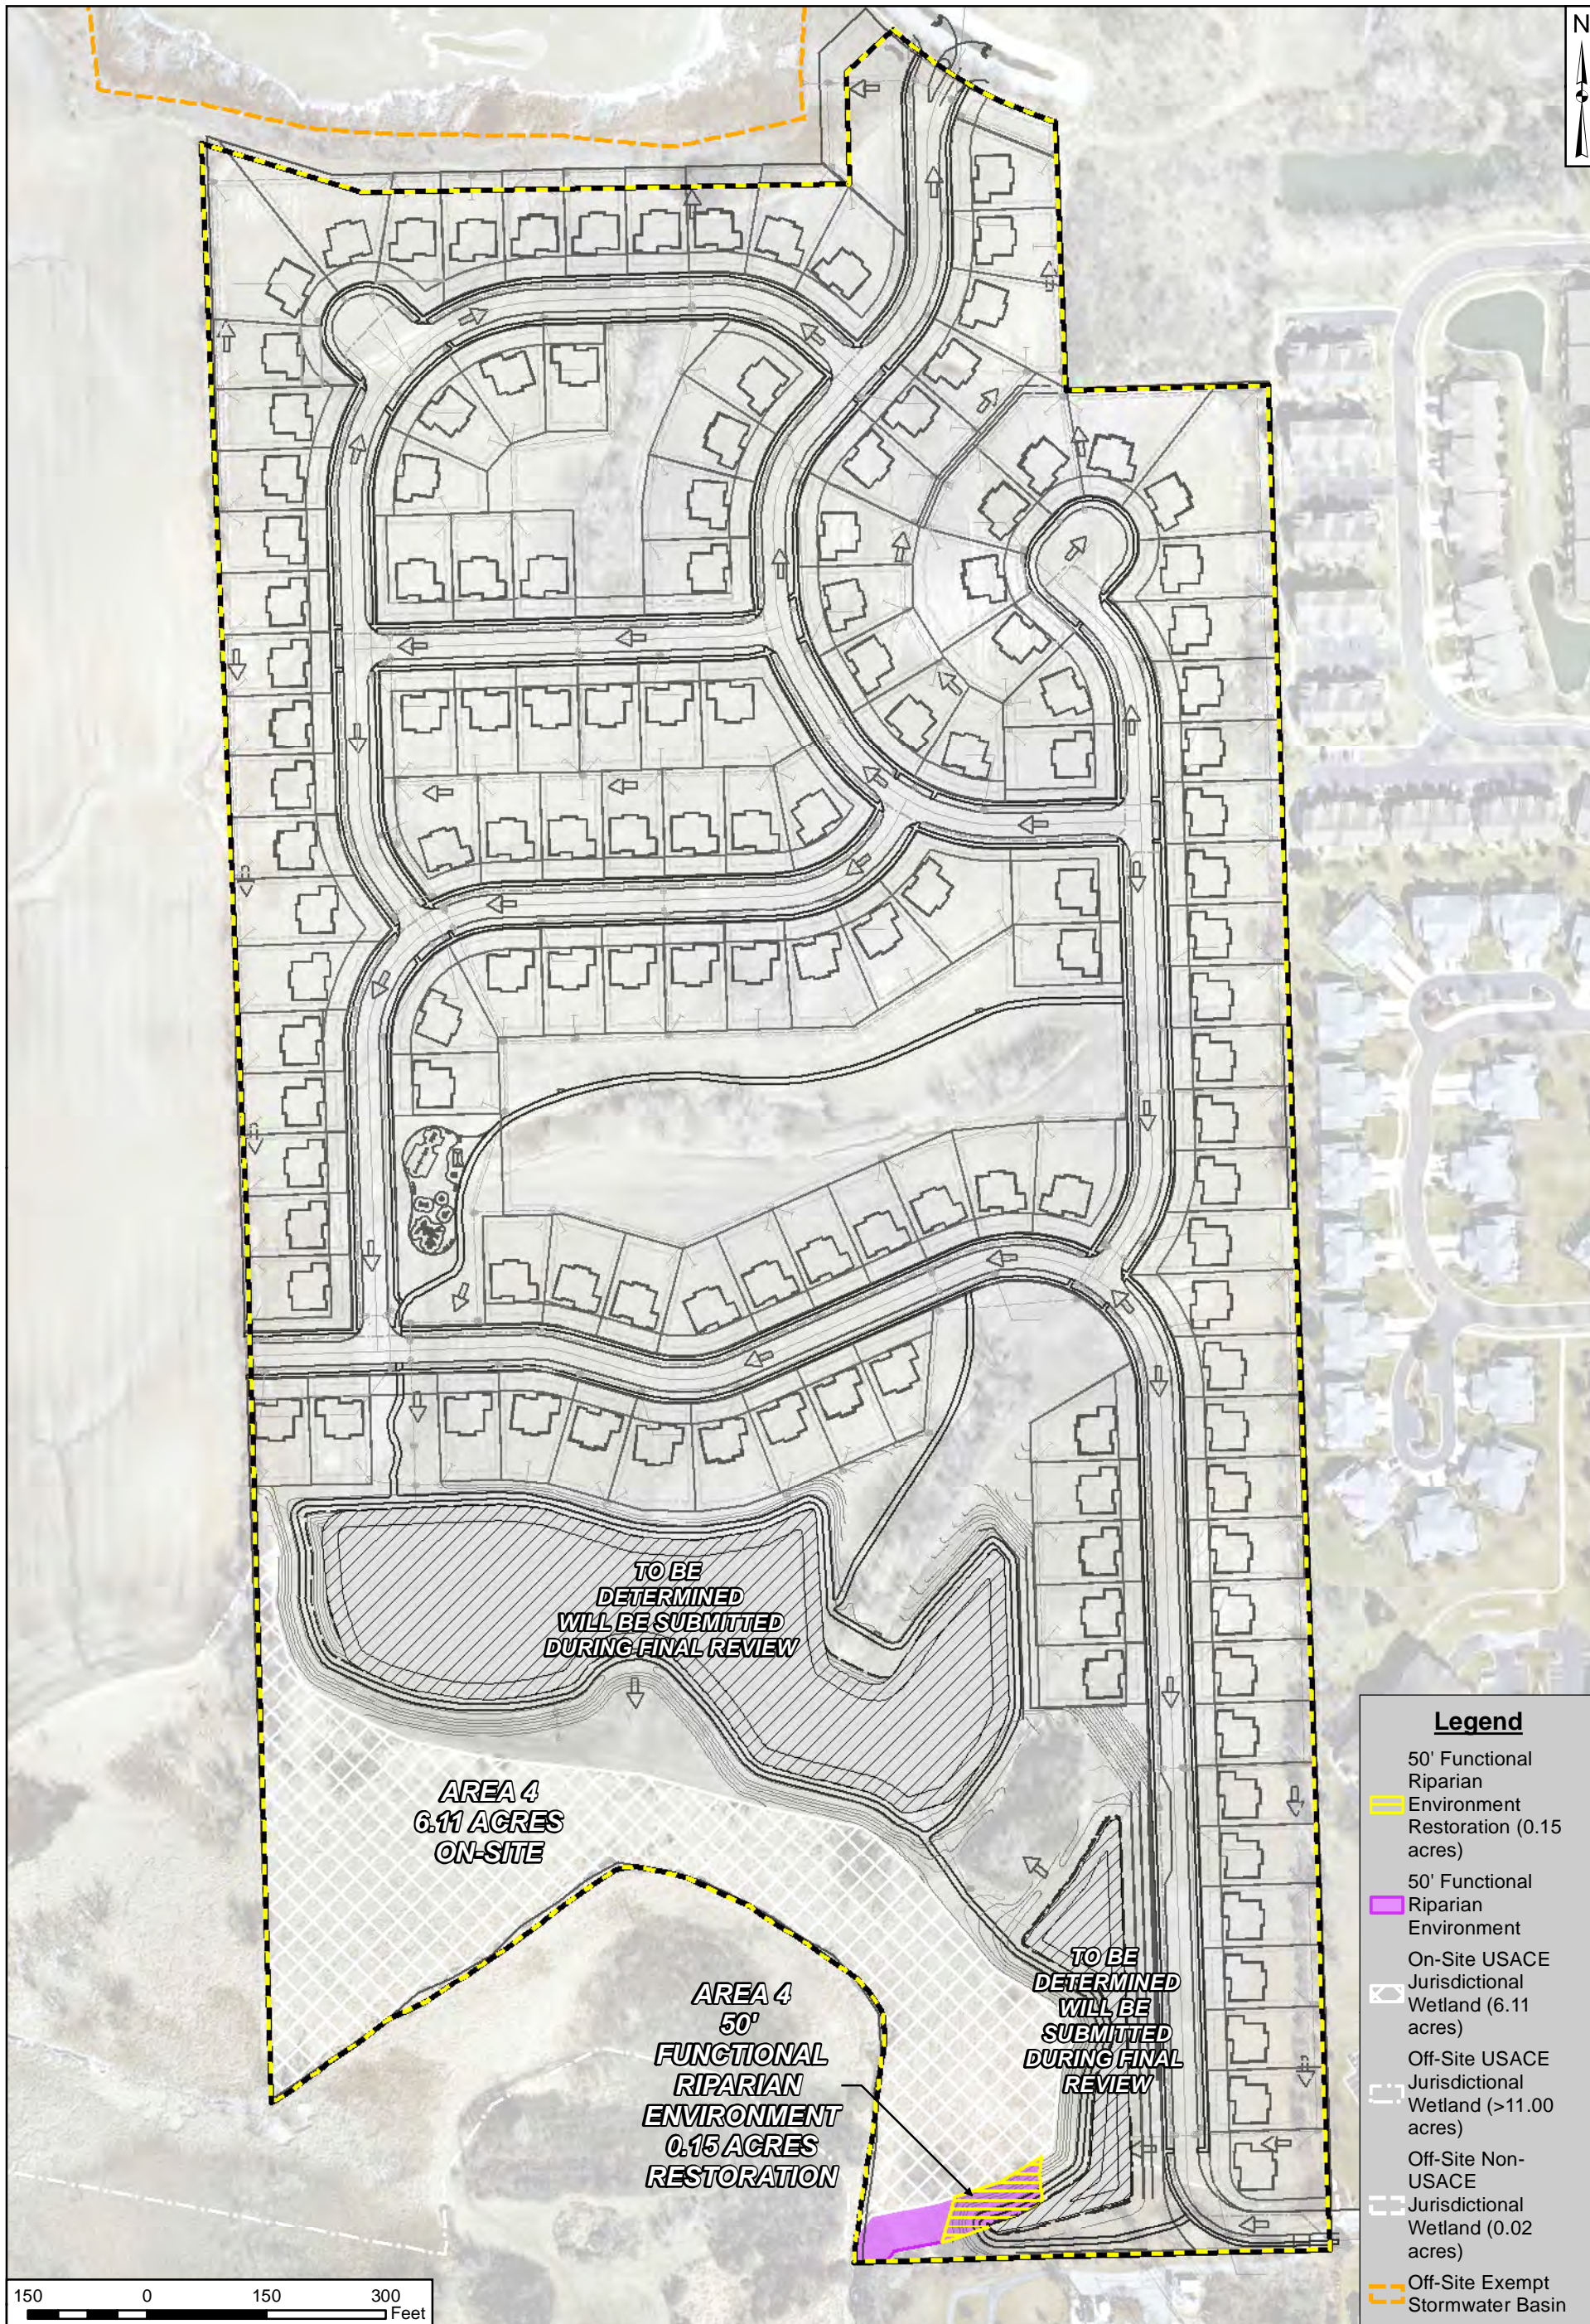
Legend	
	50' Functional Riparian Environment Restoration (0.15 acres)
	50' Functional Riparian Environment
	On-Site USACE Jurisdictional Wetland (6.11 acres)
	Off-Site USACE Jurisdictional Wetland (>11.00 acres)
	Off-Site Non-USACE Jurisdictional Wetland (0.02 acres)
	Off-Site Exempt Stormwater Basin

<p>7325 Janes Avenue Woodridge, IL 60517 630.724.9200 phone www.v3co.com</p>	PROJECT NO.: 240548	CLIENT: Pulte Home Corporation 1900 E. Golf Road, Suite 300 Schaumburg, IL 60173	<b>PLANTING PLAN</b>
	CREATED BY: AMM	BASE LAYER: Cook County Aerial Imagery (2023)	
DATE: 11/08/2024	SCALE: See Scale Bar	SITE: Estates at Ravinia Meadow Orland Park, Cook County, Illinois	FIGURE: <b>C</b>

2. As shown on Figure A, Existing Conditions in **Appendix D**, portions of the existing 50' riparian environment for USACE jurisdictional wetland Area 4 consist of non-functional agricultural cropland that is considered exempt and not subject to jurisdiction, per the Technical Guidance Manual. Therefore, impacts and disturbance to the non-functional, agricultural cropland portion of the riparian environment of Area 4 do not require mitigation. A total of 0.15 acres of temporary disturbance to the 50' functional riparian environment of Area 4 will occur for grading of the native stormwater management basin and will be restored with native vegetation upon completion of the project as shown on the Planting Plan (Figure C, **Appendix D**).
