**WHETHER REDEVELOPMENT BLIGHTING CONDITIONS EXIST AND THE  
NEED FOR A CLASS 7(B) INCENTIVE TO BRIDGE A FEASIBILITY  
GAP FOR THE REDEVELOPMENT OF PROPERTY  
LOCATED AT 15080 SOUTH LAGRANGE ROAD, ORLAND PARK**

**GRUEN GRUEN + ASSOCIATES**

October 2021

Date: October 25, 2021  
To: Robert M. Sarnoff, Esq., President, Sarnoff and Baccash Law  
From: Gruen Gruen + Associates  
Subject: **C1578: Whether Blighting Conditions Exist and The Need for a Class 7(B) Incentive to Bridge a Feasibility Gap for the Redevelopment of the Property Located at 15080 South Lagrange Road, Orland Park, Illinois**

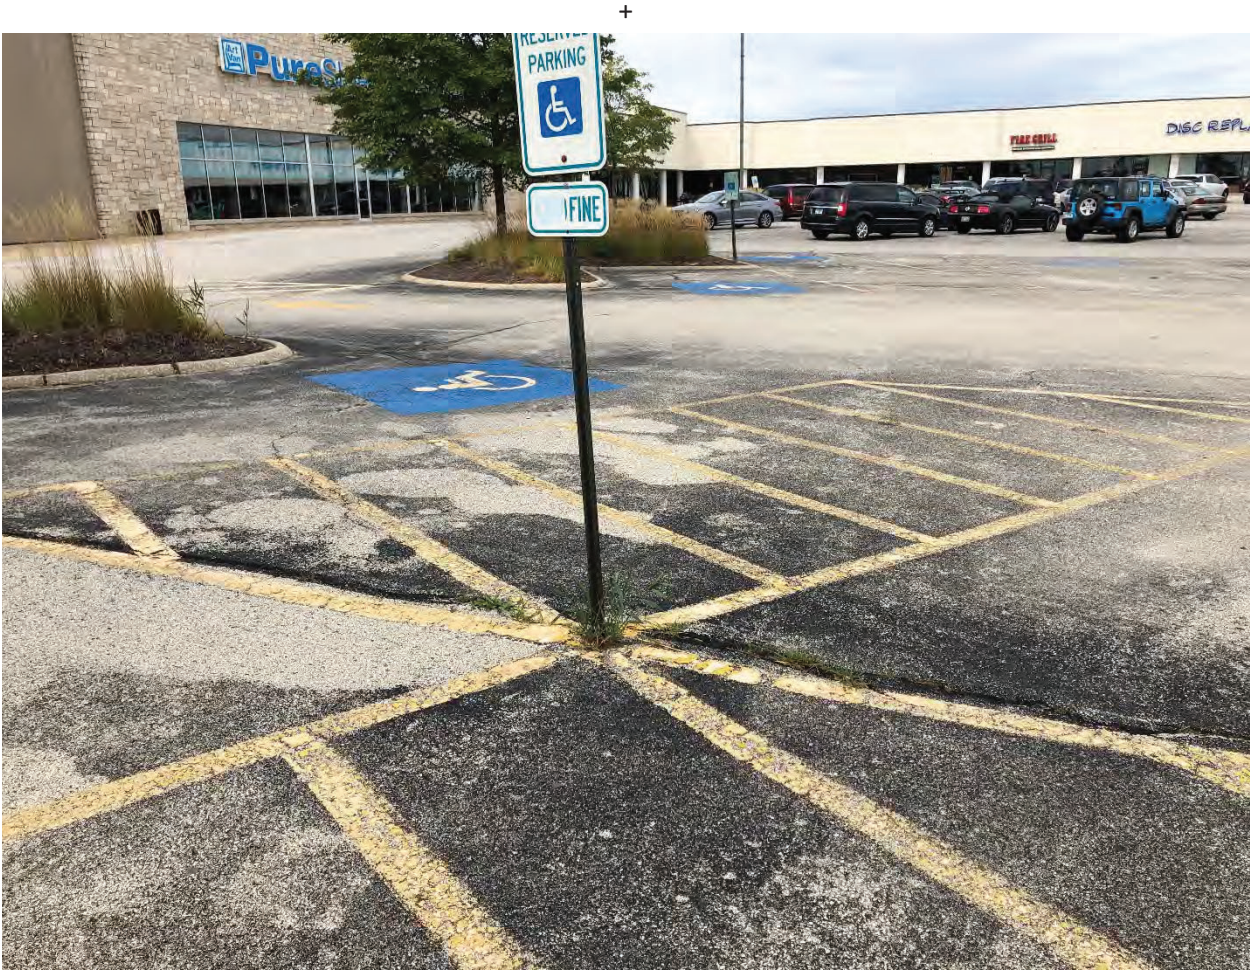
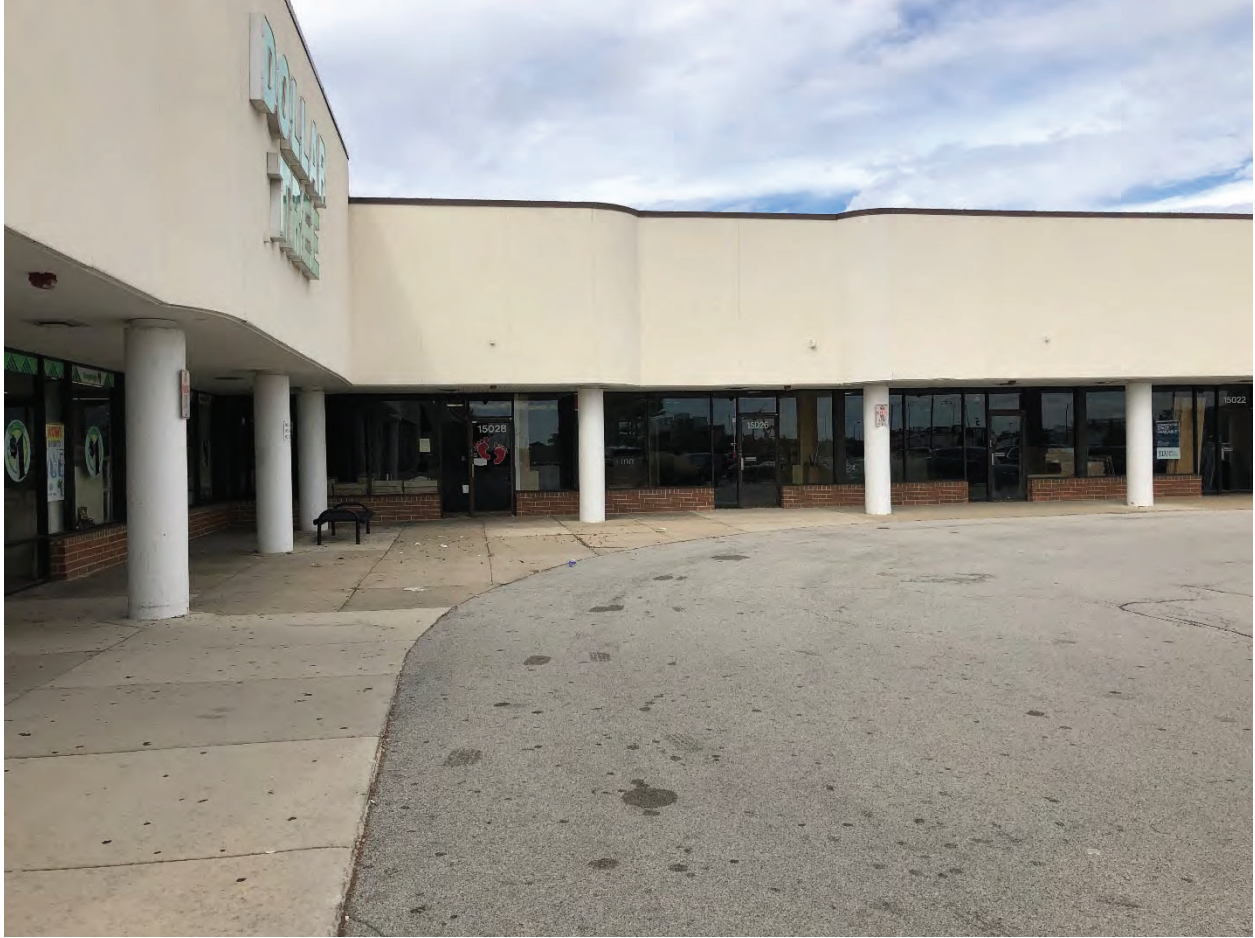
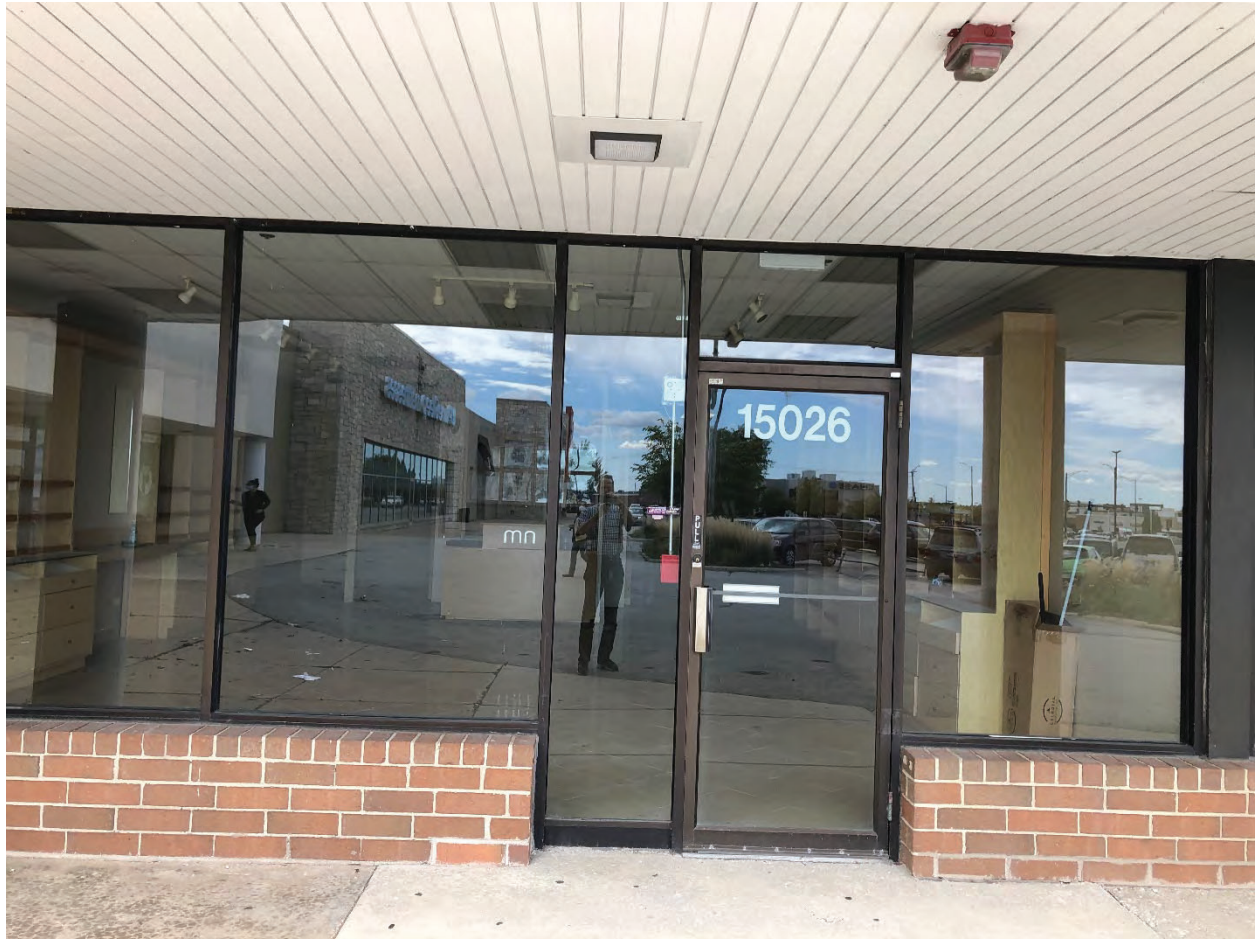
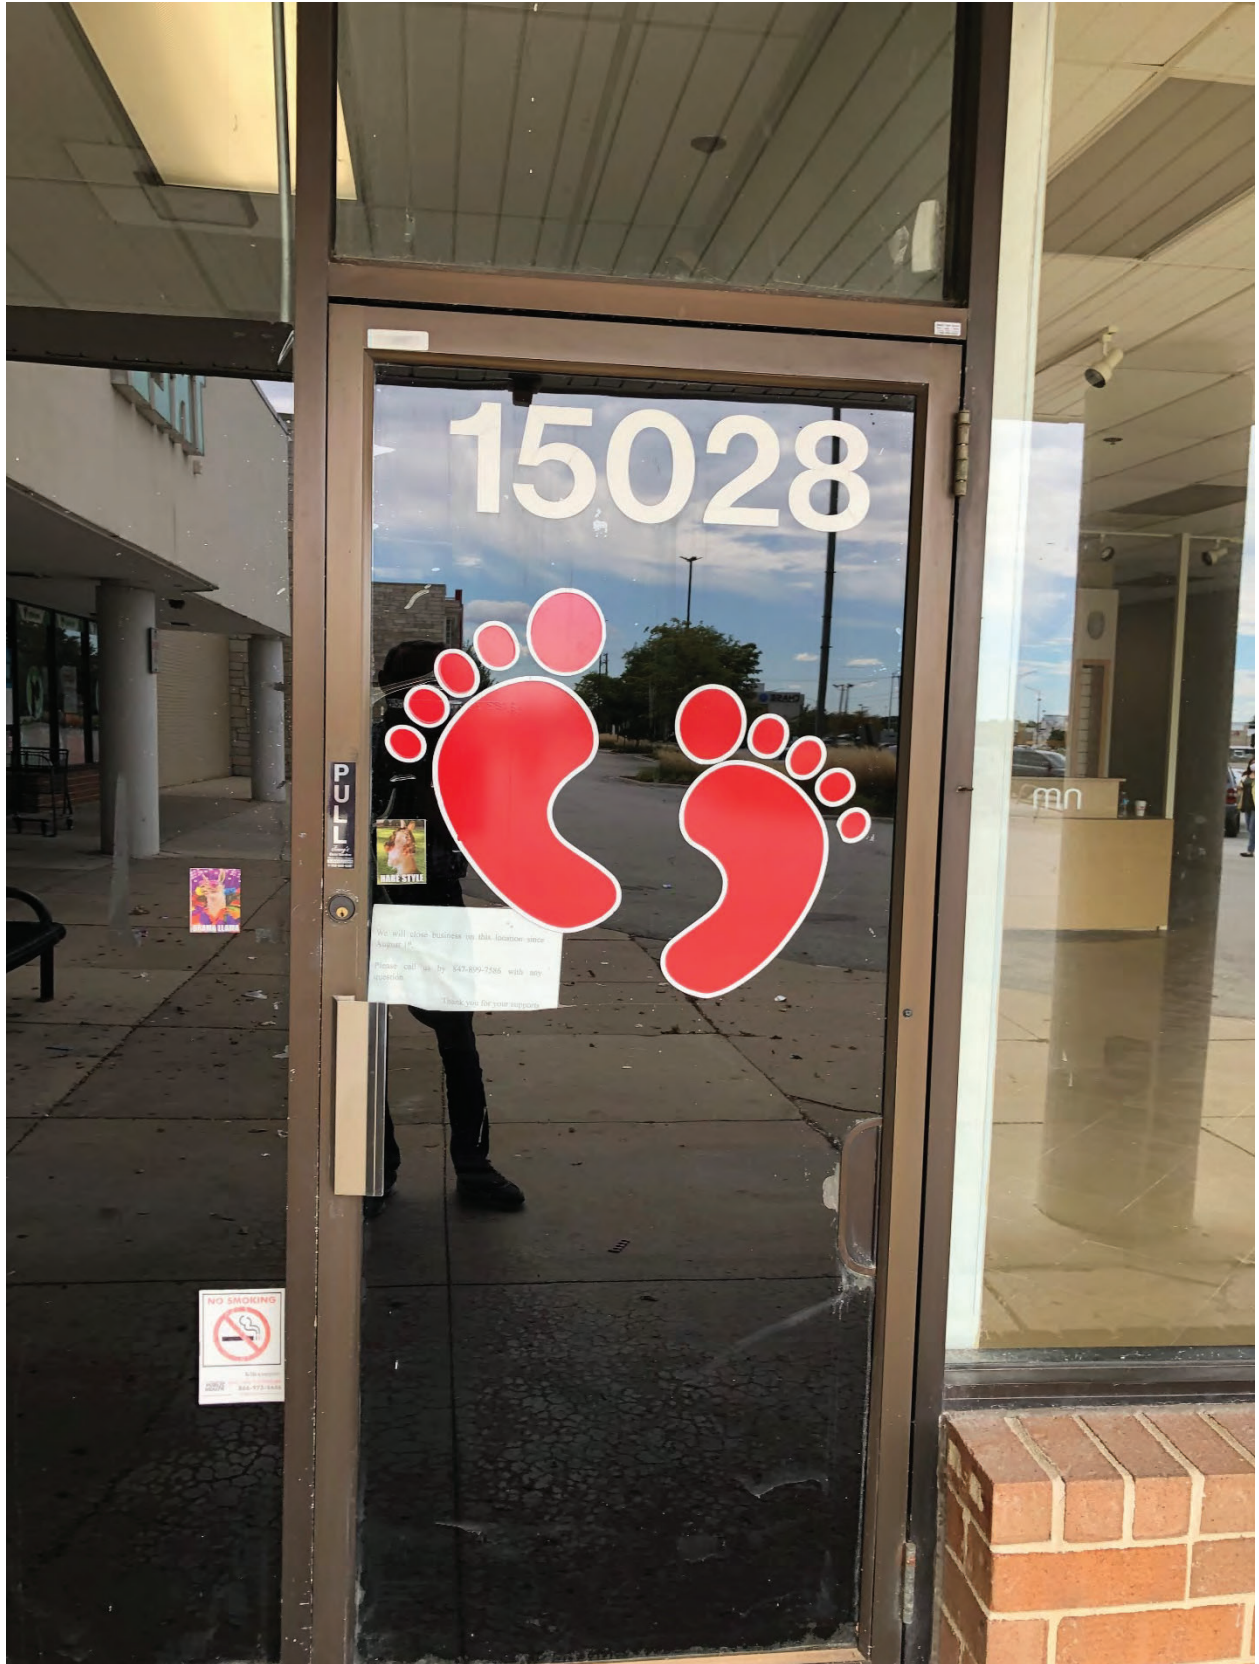
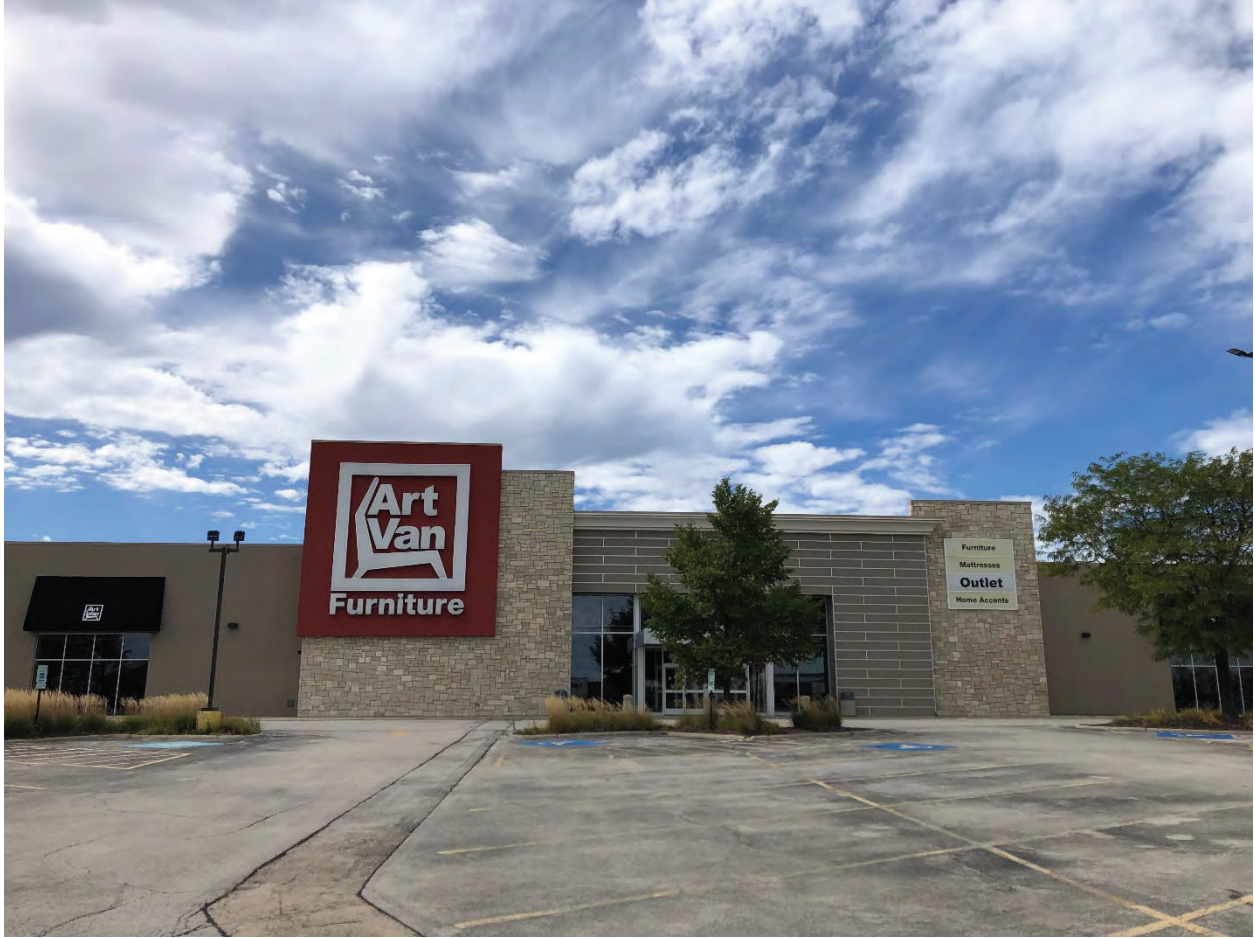
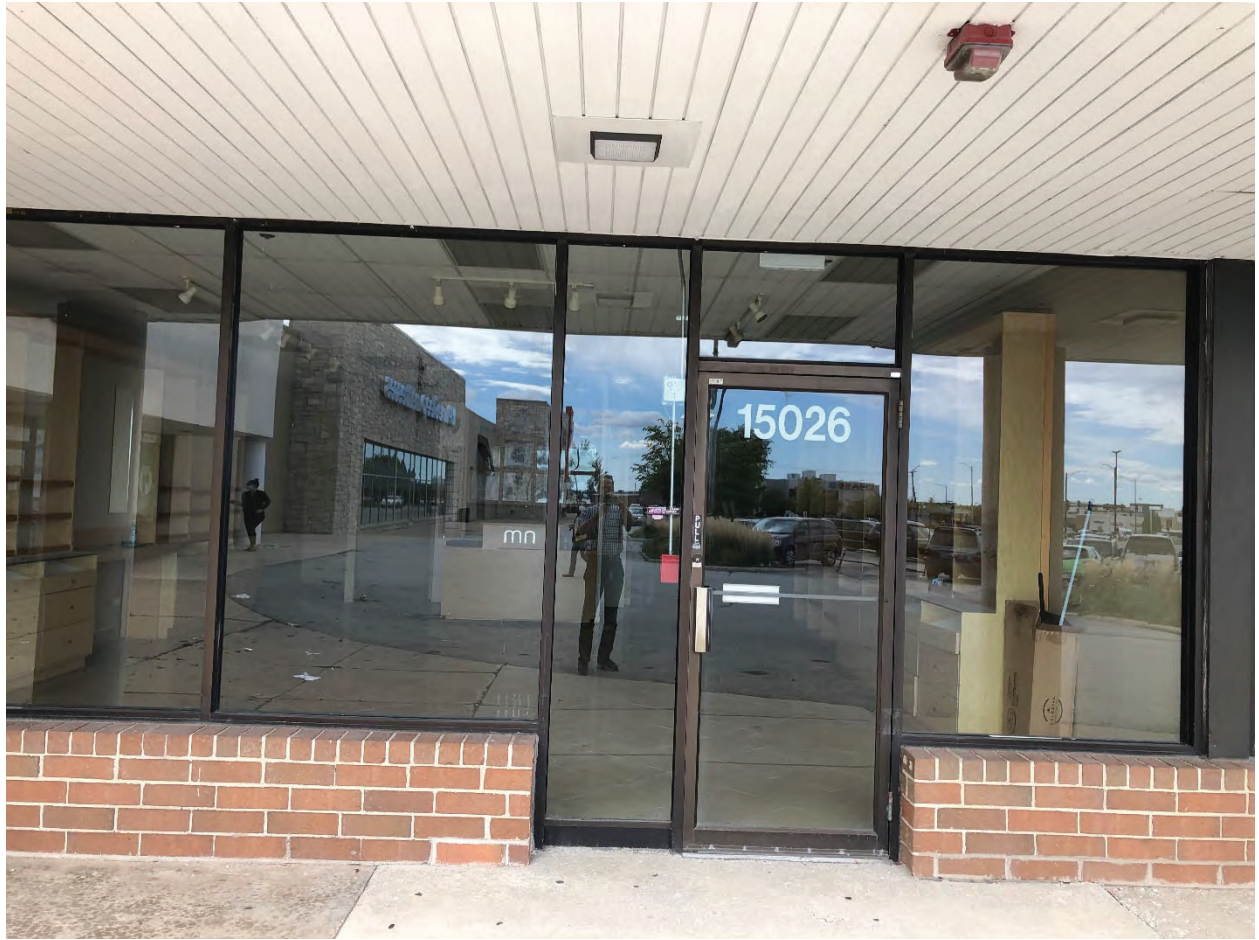
APPENDIX A: SITE INSPECTION PHOTOS

**A third eligibility factor that applies is “Deterioration”.** Structures and site improvements on the property are deteriorated including, for example, defects in the components such as doors which require replacement in the building space formerly occupied by Art Van furniture. The windows in the former Art Van furniture building space also require replacement. The fascia and facade of retail center need to be replaced and upgraded. Surface improvements evidence deterioration, including, but not limited to, surface cracking, crumbling, depressions, loose paving material, and weeds protruding through paved surfaces. Appendix A includes photographs showing examples of deterioration.

**A fifth eligibility factor that applies is “Dilapidation”.** The vacant building space formerly occupied by Art Van furniture is dilapidated. The roof needs replacement. New interior LED lighting needs to be installed in the former Art Van furniture space while exterior lighting updates are required as part of the facade improvements needed for the exterior of the retail center. The parking lot detention facilities need to be rehabilitated to modern standards. Some utilities are reportedly deteriorated, in disrepair, and antiquated and will need to be relocated and improved to modern standards.
