**WHETHER REDEVELOPMENT BLIGHTING CONDITIONS EXIST AND THE  
NEED FOR A CLASS 7(B) INCENTIVE TO BRIDGE A FEASIBILITY  
GAP FOR THE REDEVELOPMENT OF PROPERTY  
LOCATED AT 15080 SOUTH LAGRANGE ROAD, ORLAND PARK**

**GRUEN GRUEN + ASSOCIATES**

October 2021

## APPENDIX A: SITE INSPECTION PHOTOS

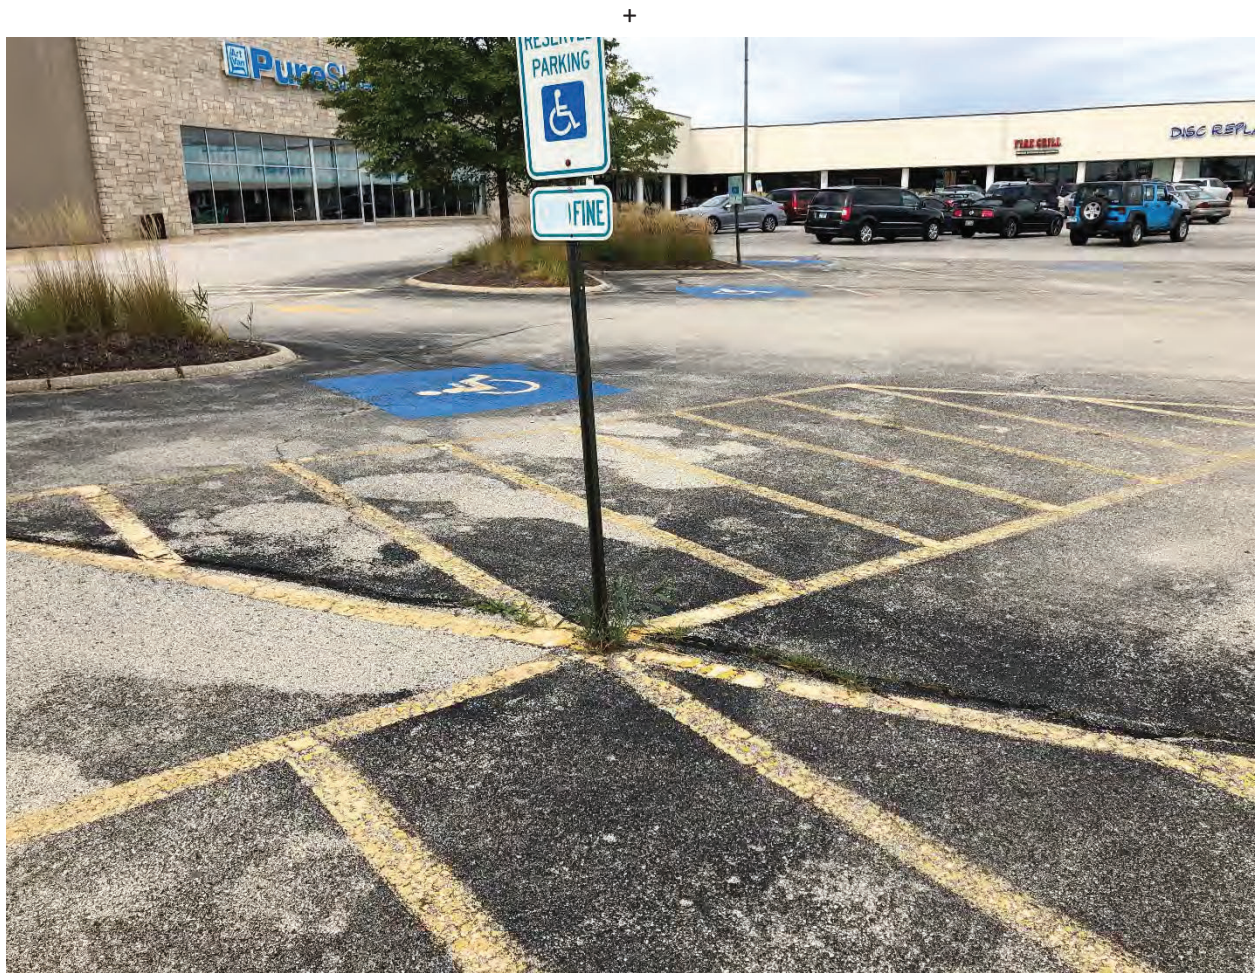
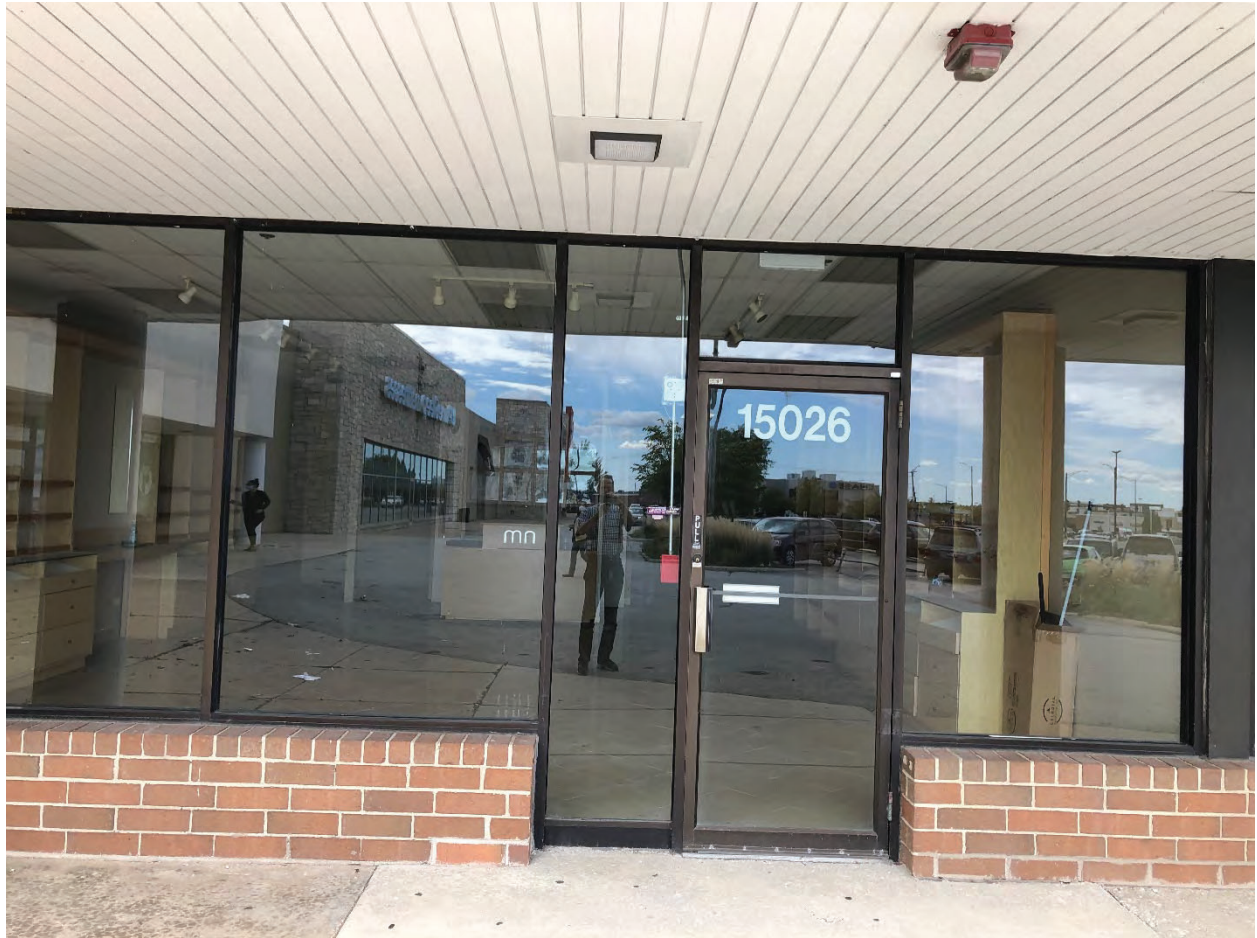
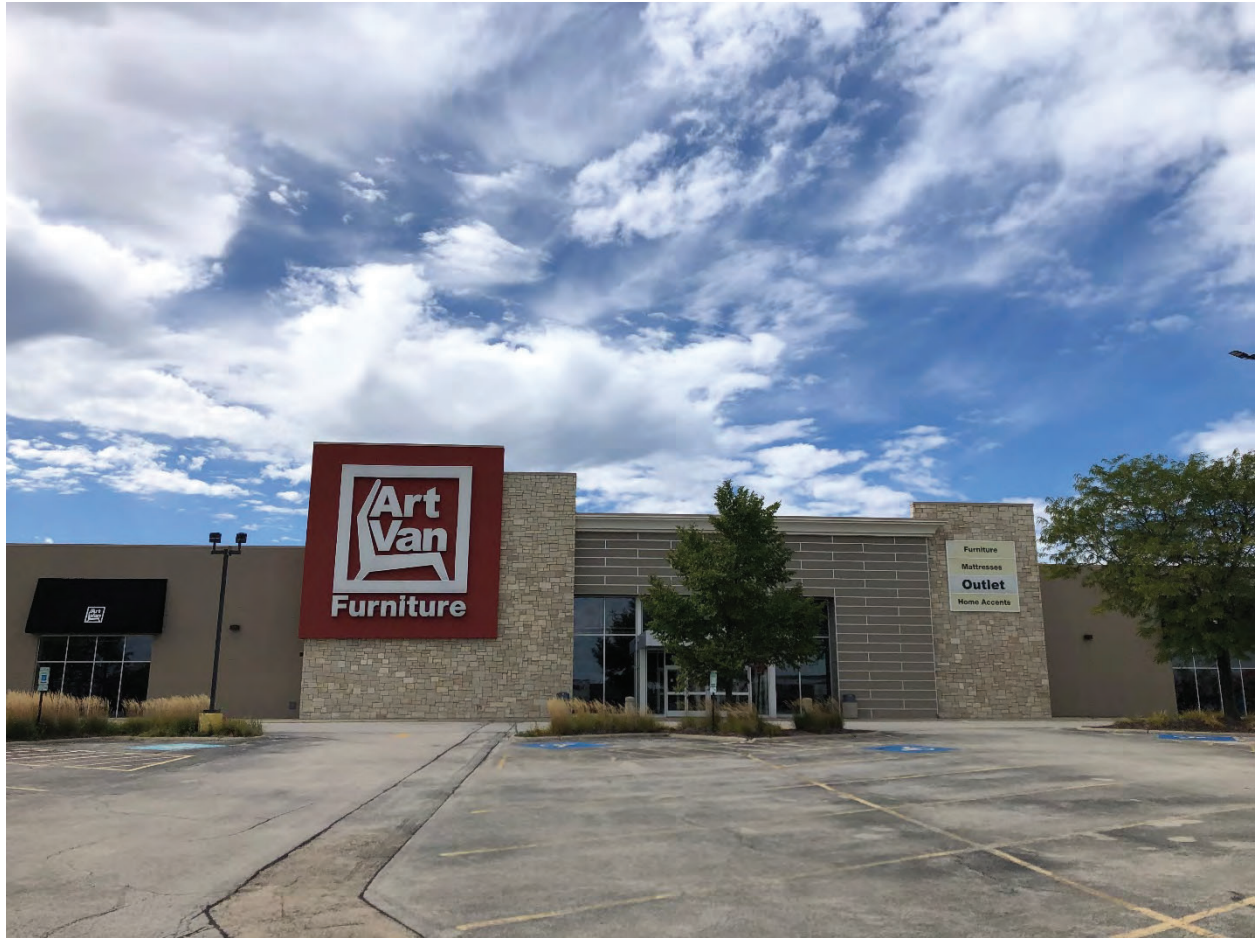
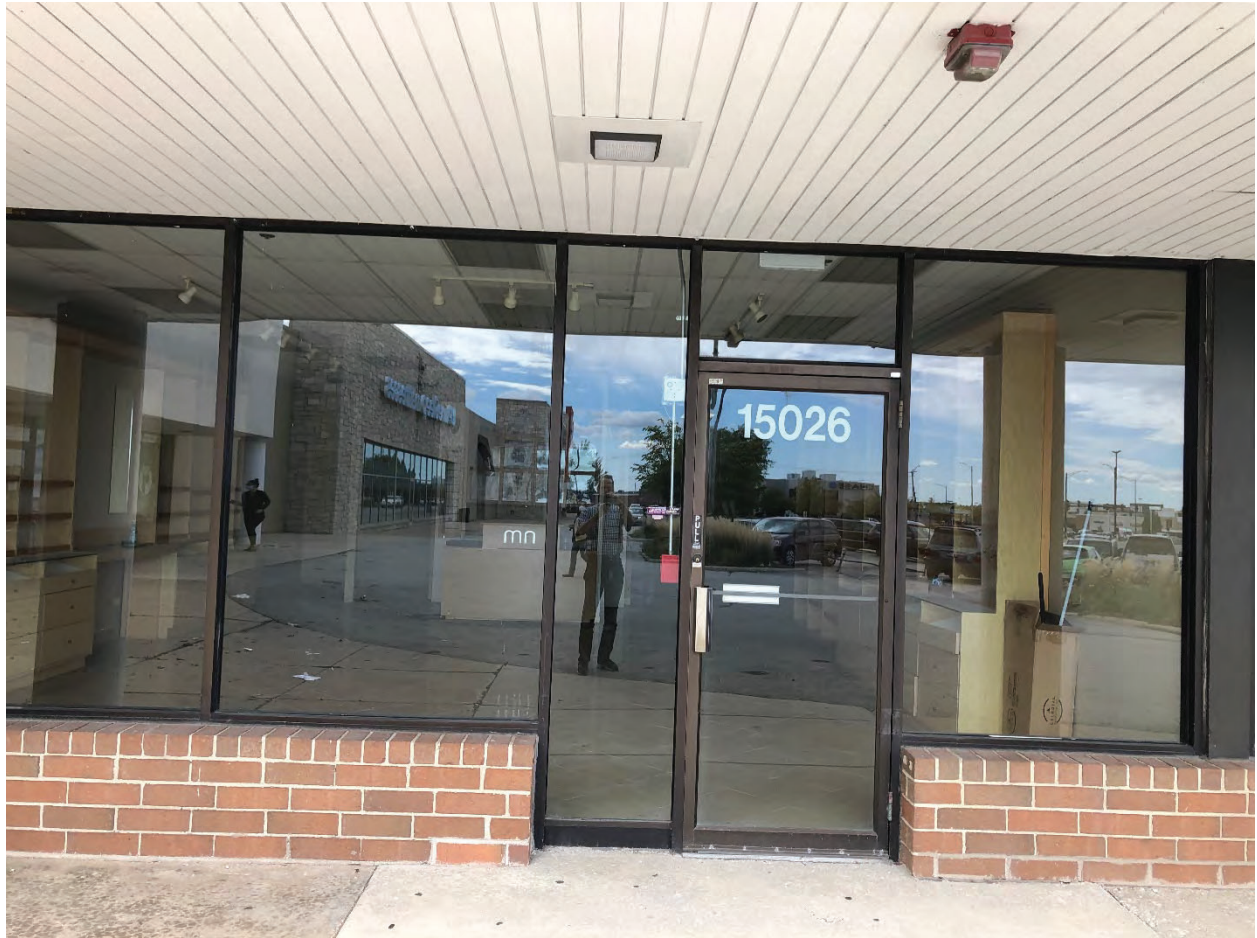
**A third eligibility factor that applies is “Deterioration”.** Structures and site improvements on the property are deteriorated including, for example, defects in the components such as doors which require replacement in the building space formerly occupied by Art Van furniture. The windows in the former Art Van furniture building space also require replacement. The fascia and facade of retail center need to be replaced and upgraded. Surface improvements evidence deterioration, including, but not limited to, surface cracking, crumbling, depressions, loose paving material, and weeds protruding through paved surfaces. Appendix A includes photographs showing examples of deterioration.

**A fifth eligibility factor that applies is “Dilapidation”.** The vacant building space formerly occupied by Art Van furniture is dilapidated. The roof needs replacement. New interior LED lighting needs to be installed in the former Art Van furniture space while exterior lighting updates are required as part of the facade improvements needed for the exterior of the retail center. The parking lot detention facilities need to be rehabilitated to modern standards. Some utilities are reportedly deteriorated, in disrepair, and antiquated and will need to be relocated and improved to modern standards.
