Facilities and Operations Master Plan

Phase 1: Facilities Condition Assessment

PROJECT TITLE: Facilities and Operations Master Plan - Phase I: Facility Condition Assessment

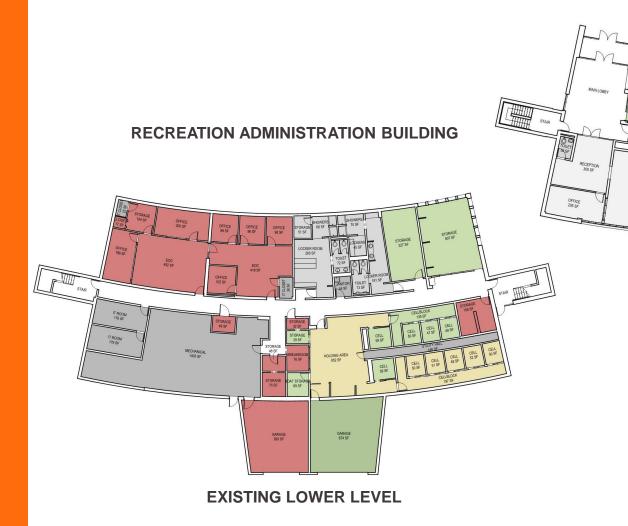
EXISTING UPPER LEVEL

Recreation Administration Building

Spatial analysis of the Recreation Administration Building resulted in the following conclusions:

- Inefficient use of space.
- Building layout was not optimal for staff needs.
- Limited ability to store large project materials within the building.
- Additional buildings were required to store necessary materials.
- · Code violations in exit stairwells.

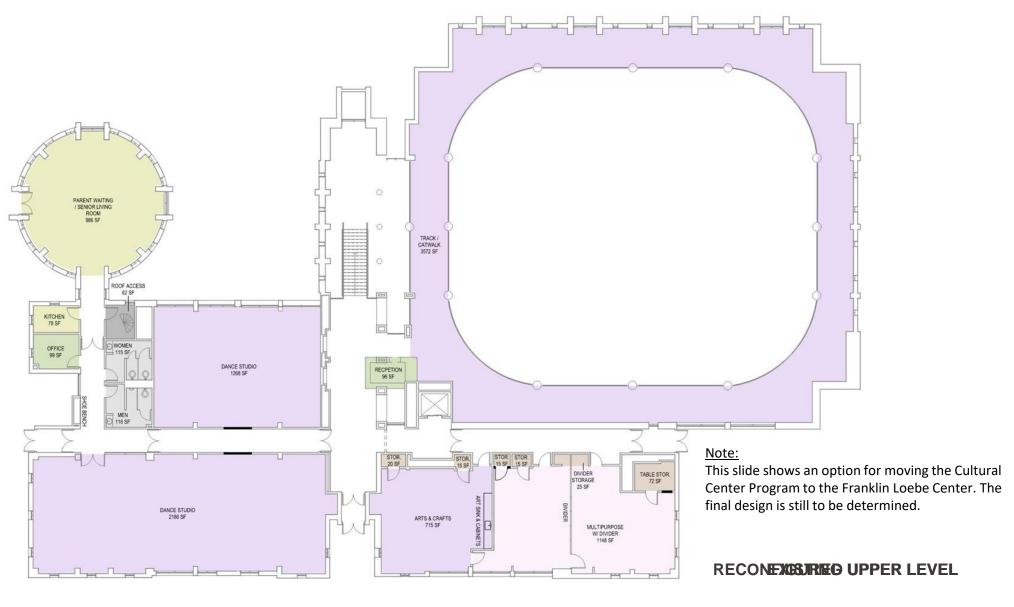
Franklin Loebe Center

Spatial analysis of the Franklin Loebe Center resulted in the following conclusions:

- The existing classrooms and storage rooms are underutilized.
- The building has the capacity to accept programming from the Cultural Arts Center.
- Locker areas can be used as theatre dressing rooms.
- A Green Room could be introduced for the Theatre; it could also serve as a small Meting Room.
- The Multi-Purpose Room can double as a Piano Room. The piano can remain for ensemble rehearsals.
- The Reception Area can be used to greet visitors and serve as a Ticket Booth for performances.

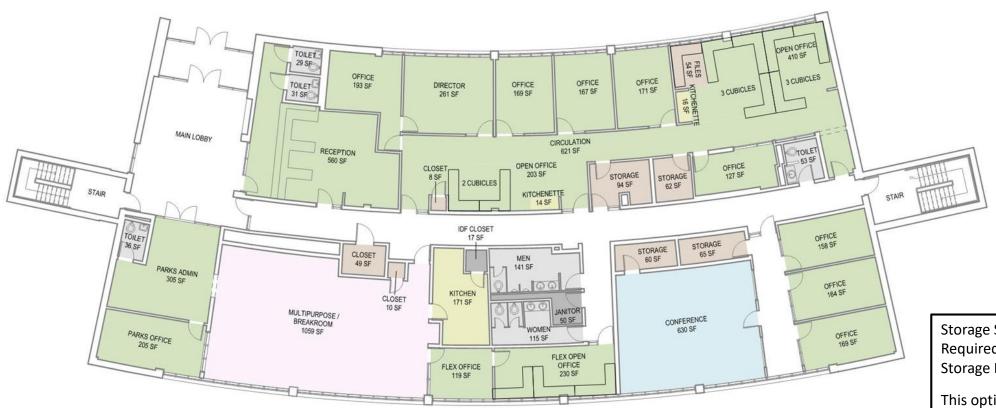
RECONFIGURED UPPER LEVEL

Upper Level Floor Plan

Renovations Include:

- Potential Flex Office space for displaced departments or future staff.
- Stored items removed from exit stairwells.
- Code compliant guardrails provided in exit stairwells.

Storage Space Required Storage Space Storage Deficiency

4,800 SF 5,390 SF

(590) SF

This option requires that Recreation Administration maintain Event Storage in Well House 9.

The 590 SF storage shortfall can be overcome if unnecessary items are discarded, and the storage rooms are organized with shelving.

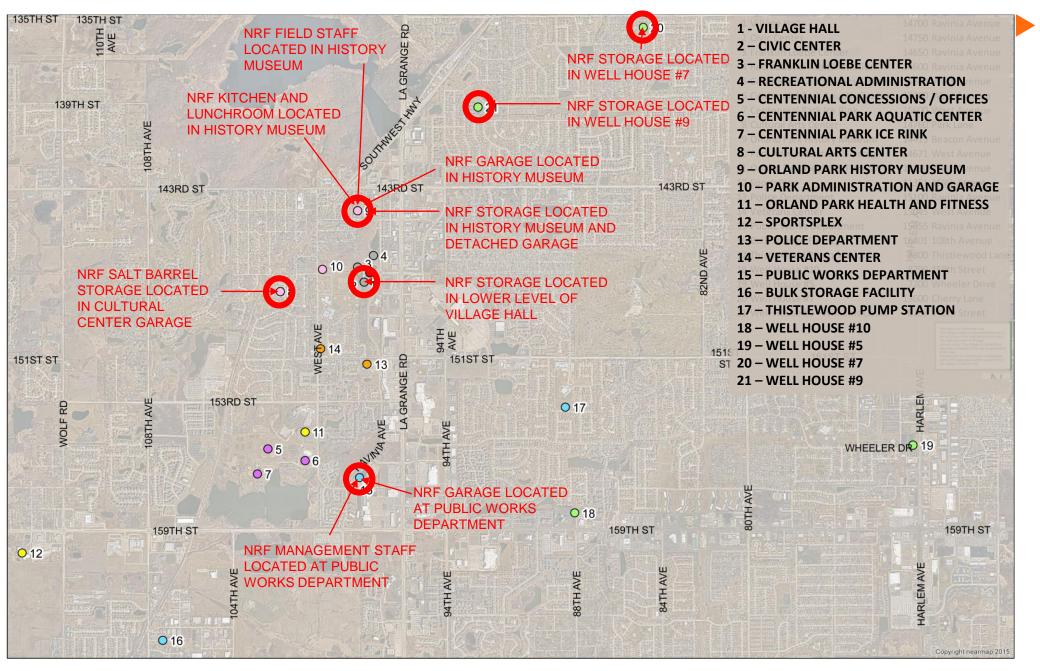
NRF Staff and Equipment dispersed throughout Village.

NRF Staff desire consolidation.

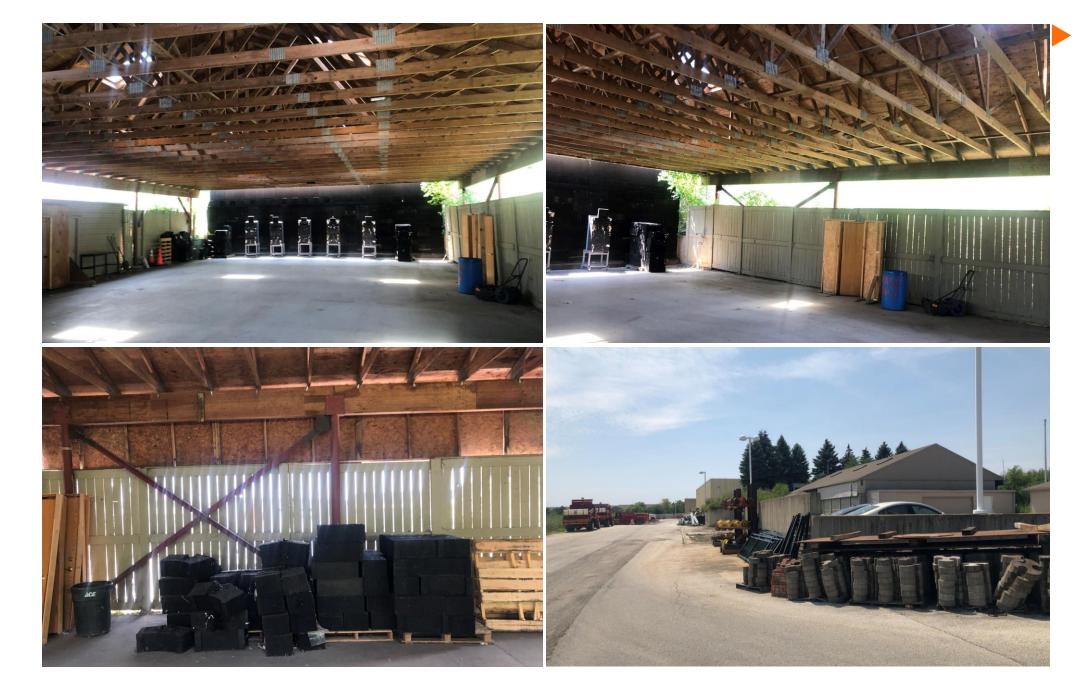
Police Shooting Range Creates an Unsafe Site Condition.

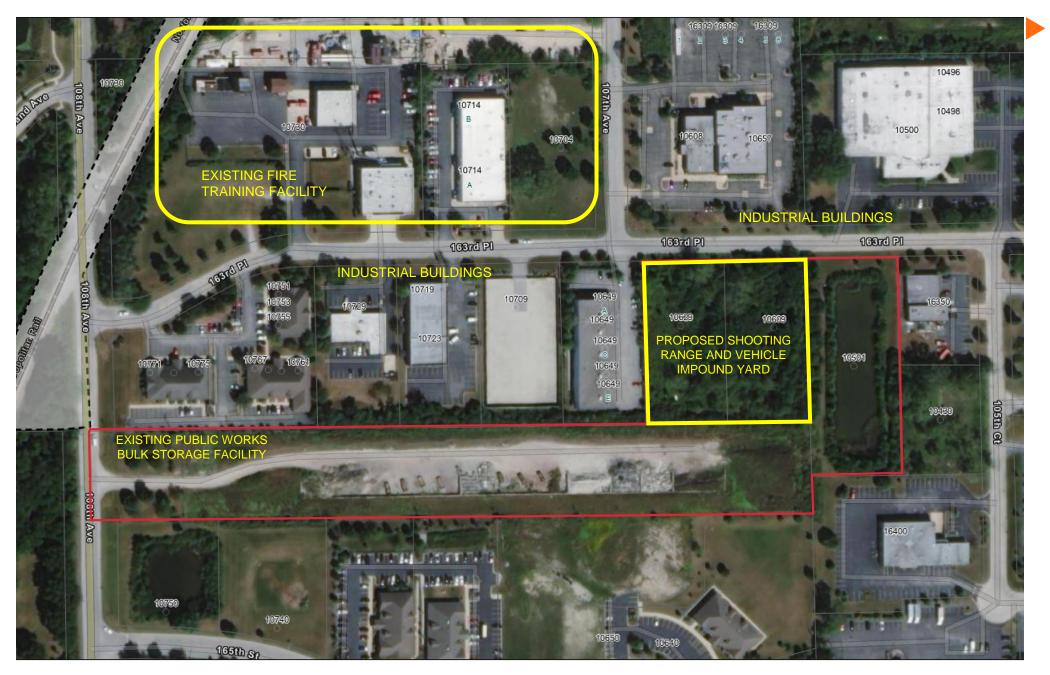
The Police Shooting Range and Vehicle Impound Yard can be moved to an alternate site on land that is owned by the Village.

The Orland Park Fire Training Facility and industrial building are near the proposed site.

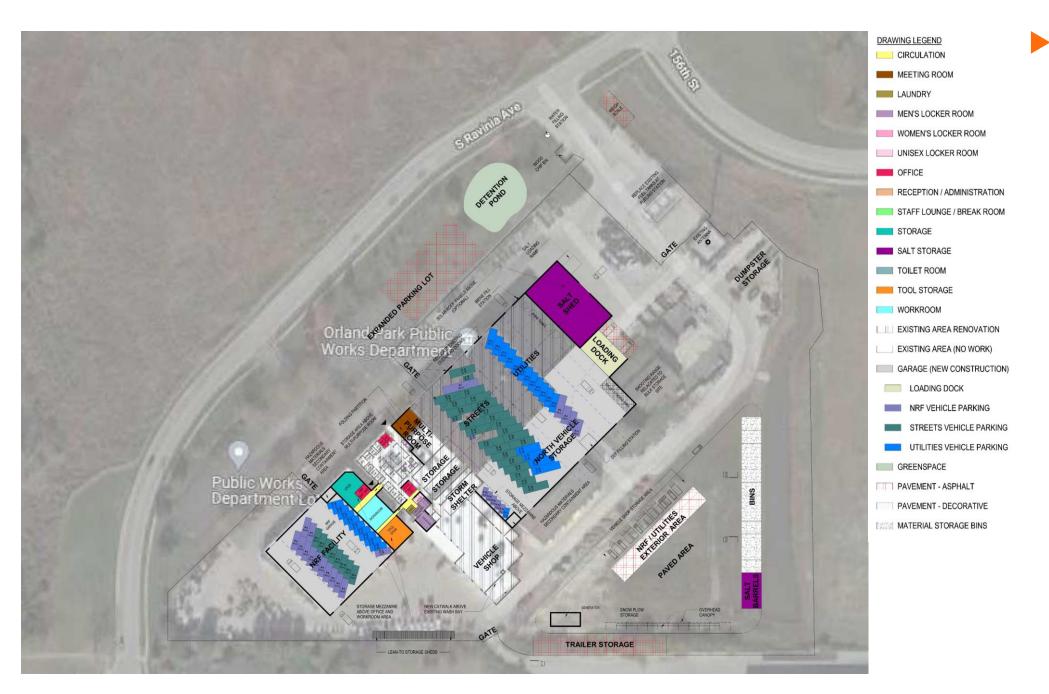
Phase 1 – Site Construction

- Parking Lot Expansion
- Weigh Scale
- Fuel Tank Replacement
- Pavement in Southeast Corner
- Material Storage Bins
- Covered Storage Areas

Phase 2 – New NRF Facility and Admin Building Interior Renovation

- Existing Metal Garage Demolition
- New NRF Facility on Old Metal Garage Site
- Administration Building Interior Renovation, Including Multi-Purpose Room Addition

Phase 3 – Shooting Range Construction

- Demolition of Existing Shooting Range and Sheds
- Construction of new Off-Site Shooting Range

Phase 4 – North Garage Expansion

- Demolition of existing storage building
 - North Garage Expansion
- Salt Shed Construction
- Loading Dock Construction

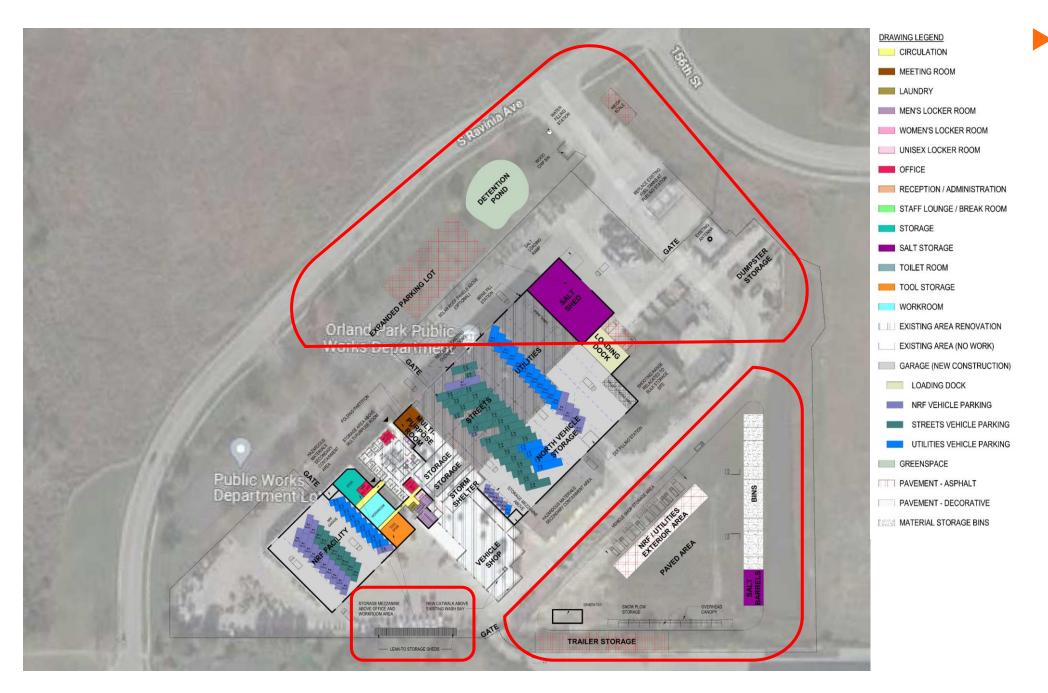
Phase 1

Site Construction

- Parking Lot Expansion
- Weigh Scale
- Fuel Tanks Replacement
- Water Filling Station
- Pavement in Southeast Corner
- Generator
- Material Storage Bins
- Covered Storage Areas

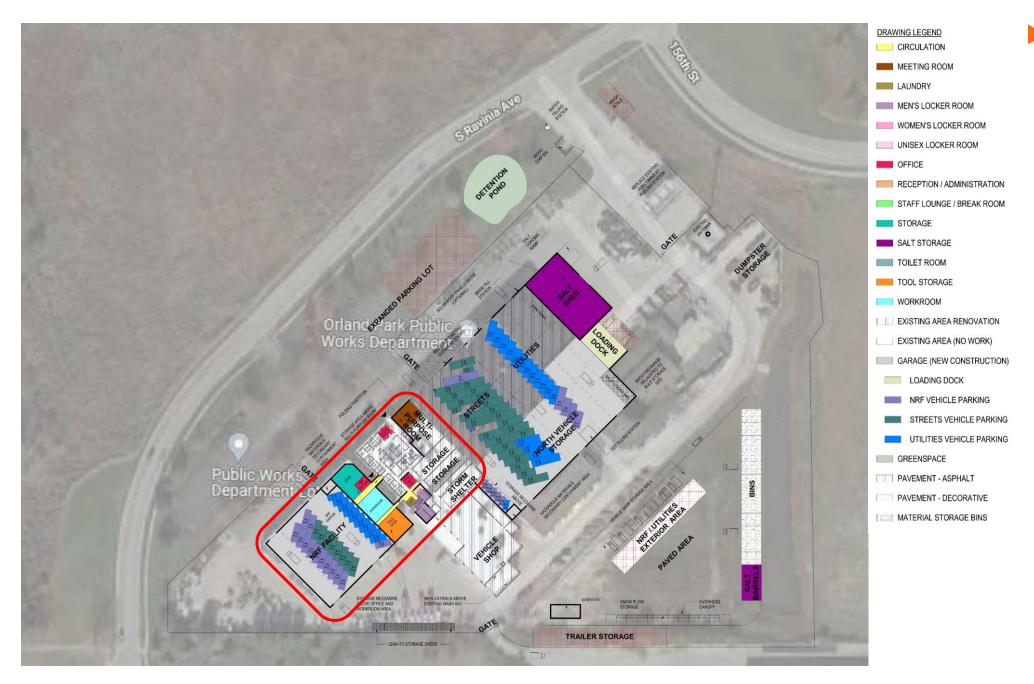
Phase 2

New South Building and Interior Renovation

- New NRF spaces consolidated from other facilities
- · Locker Room Renovation
- Multi-Purpose Room Addition and Renovation

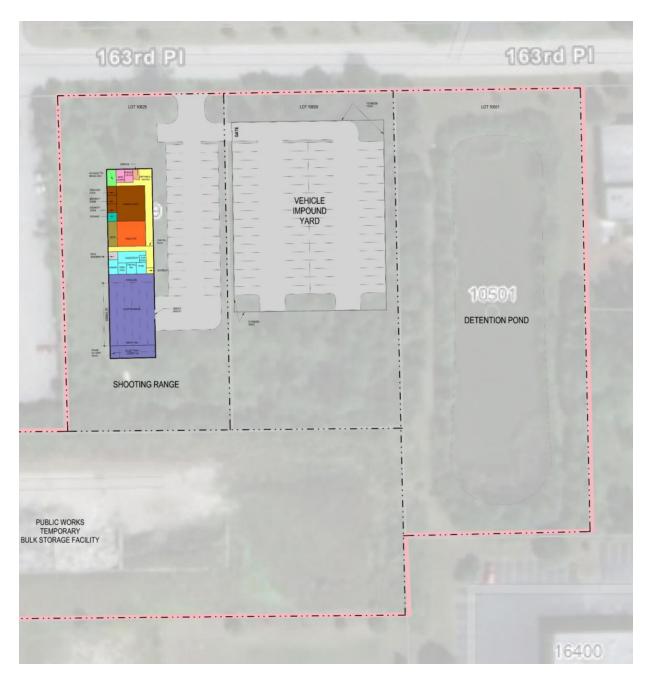
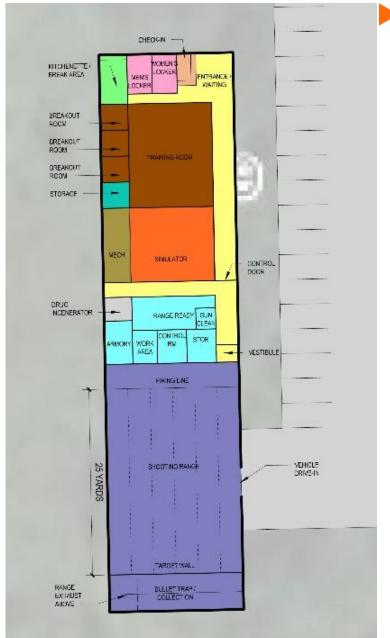
Phase 3
Proposed Plans for
Relocated Shooting Range
and Vehicle Impound Yard

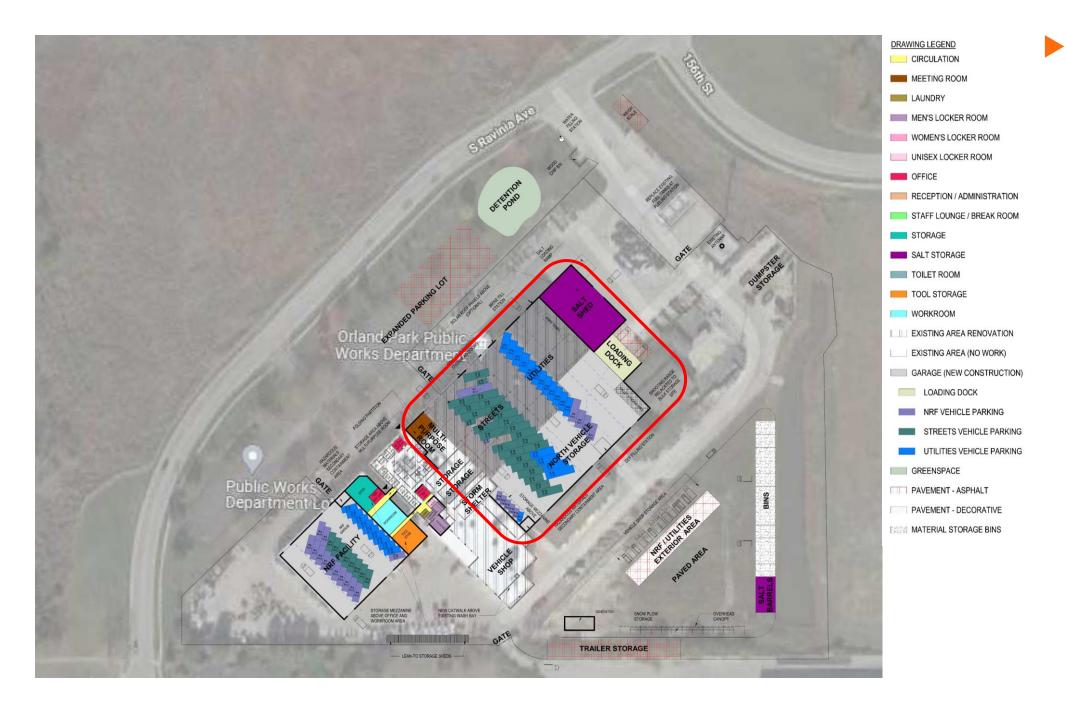
Phase 4

North Garage Expansion

- Existing Storage Building Demolition
- North Garage Expansion
- Salt Shed and Loading Dock Construction
