# THE VILLAGE OF ORLAND PARK BASIN BEST PRACTICES PROGRAM

## BASIN ASSESSMENT AND MANAGEMENT PLAN REPORT

Report Date:  
June 30, 2011

Prepared by:  
V3 COMPANIES

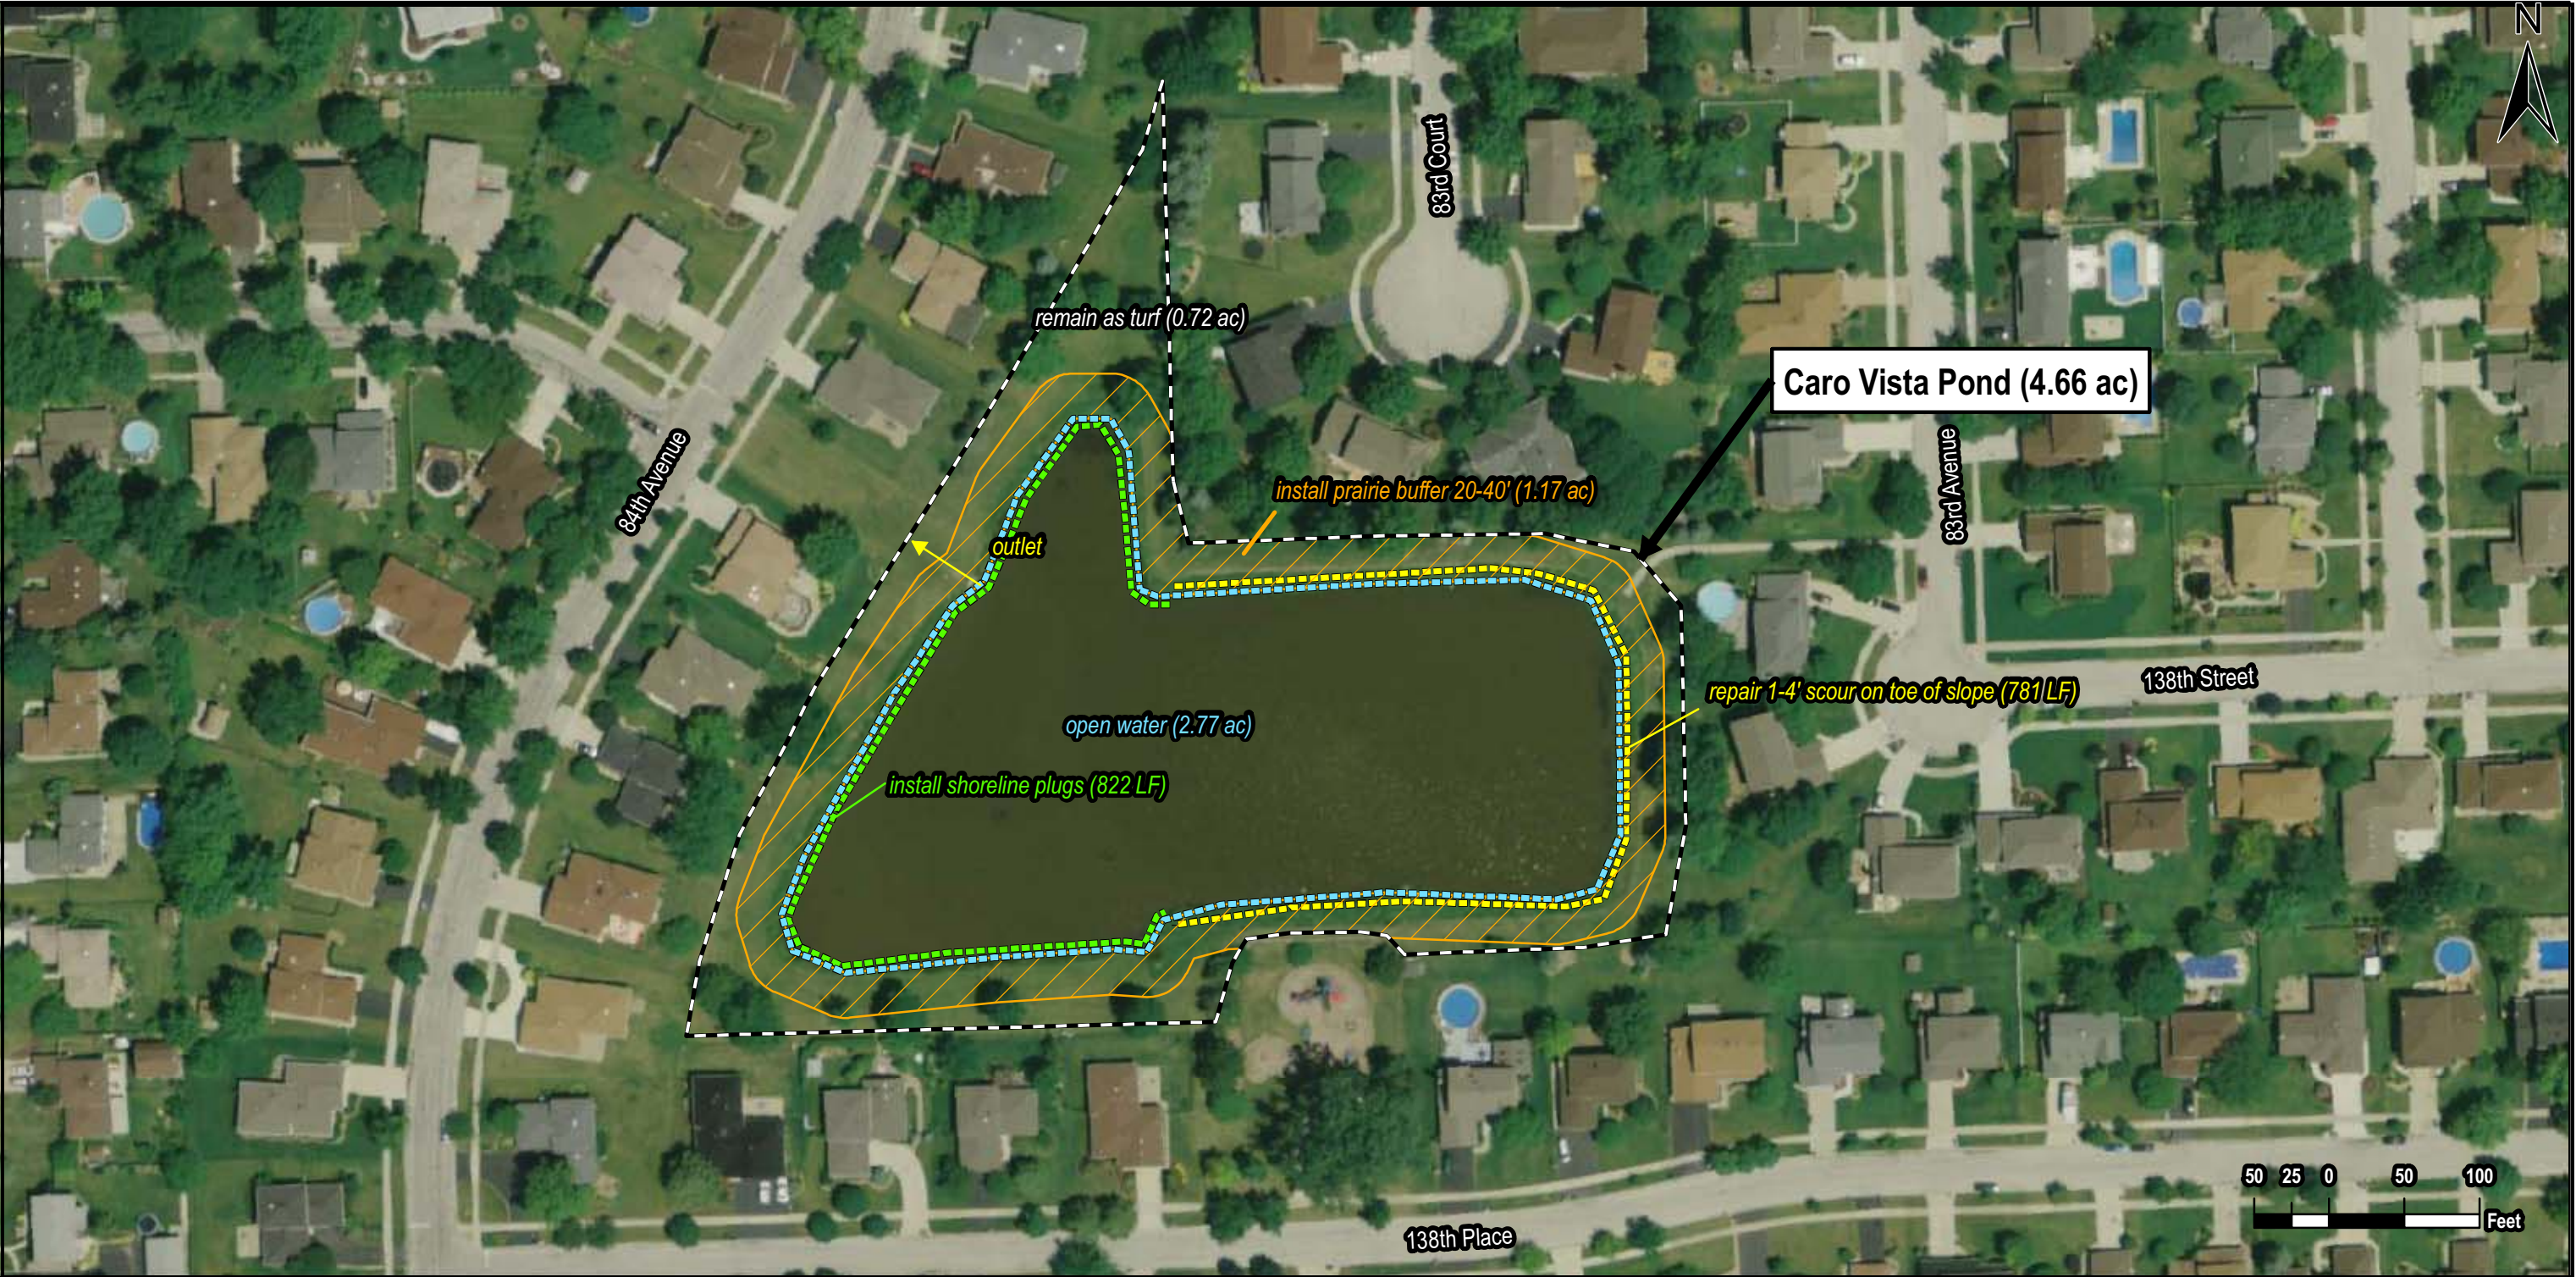
**Narrative:** Caro Vista Pond is a wet basin which has been restored in the past with bank shaping and fiber roll installations. However, the banks continue to experience significant erosion on the eastern half of the basin likely due to muskrat damage and wind action along this steep slope. V3 recommends repairing the banks along the eastern half of the basin with re-grading, native shoreline plugs and native prairie buffer. Also recommended to install shoreline plugs around western half of basin to protect shoreline along with a 20-40' native prairie buffer around the entire basin.

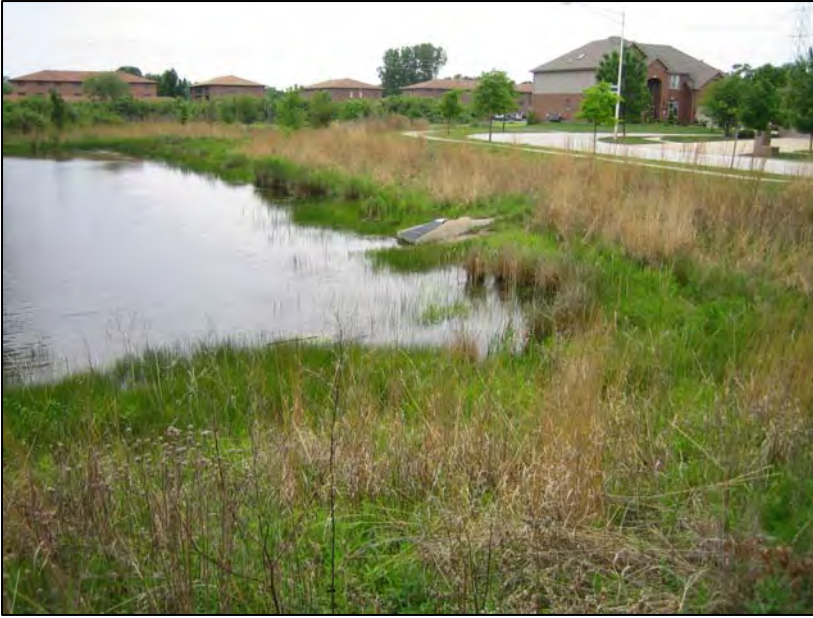
#### **PHOTO 1**

Western slope – Wetland shelf and native slopes in good condition.

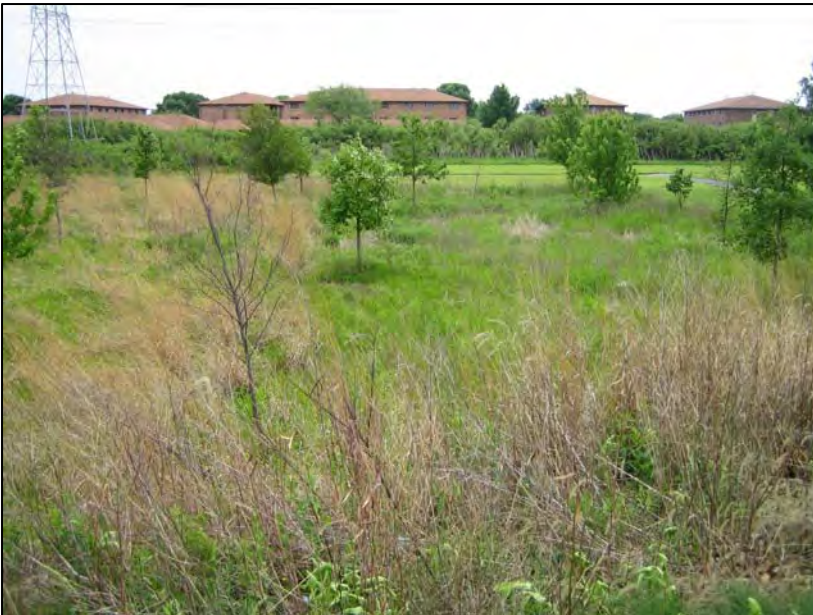
#### **PHOTO 2**

Southwest Corner – Trees installed in wet meadow area. Trees and natives in good condition.

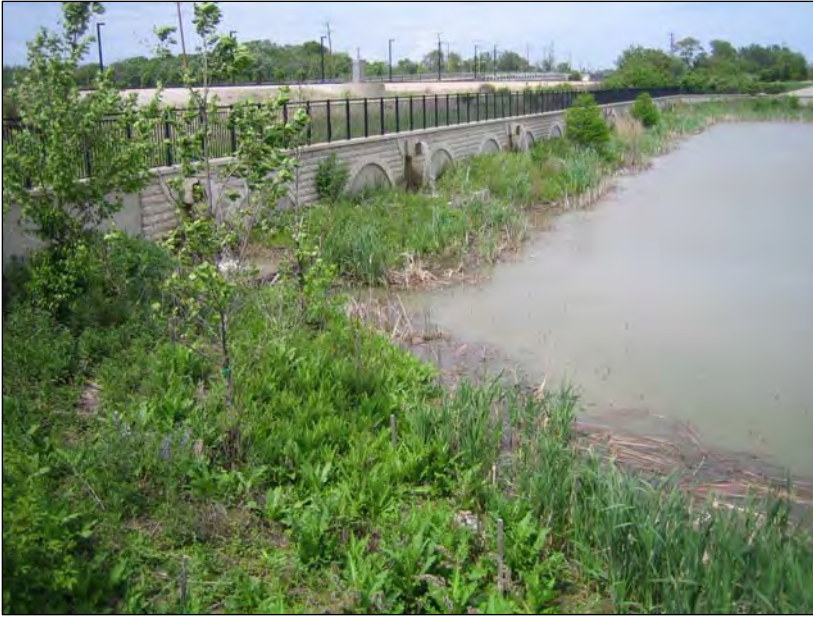
### **PHOTO 1**

North Wall – Fountain features along wall with planter areas and cattail emergent shoreline. Significant weed invasion in planters.

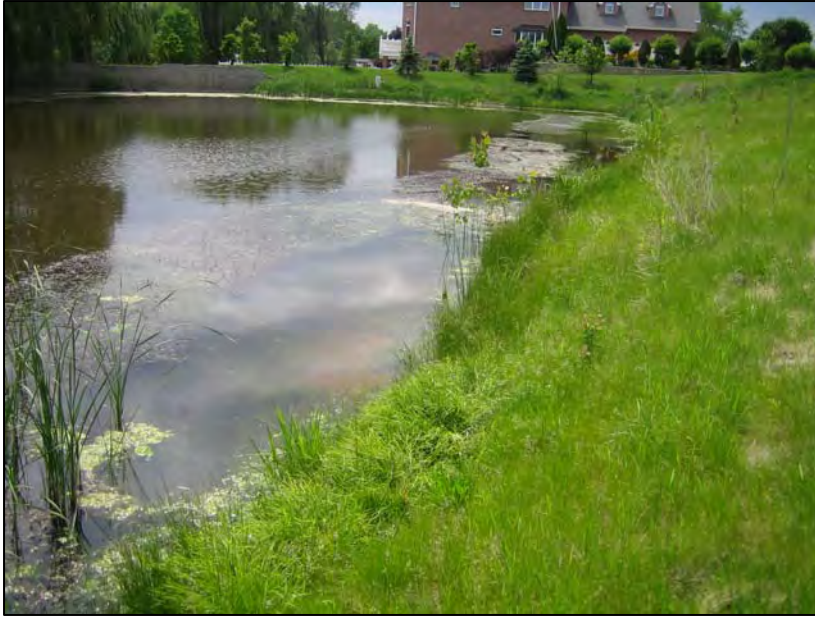
### **PHOTO 1**

North Slope – Unmowed turf grass and emergent shoreline in good condition. Minimal erosion or scour on toe of slope.

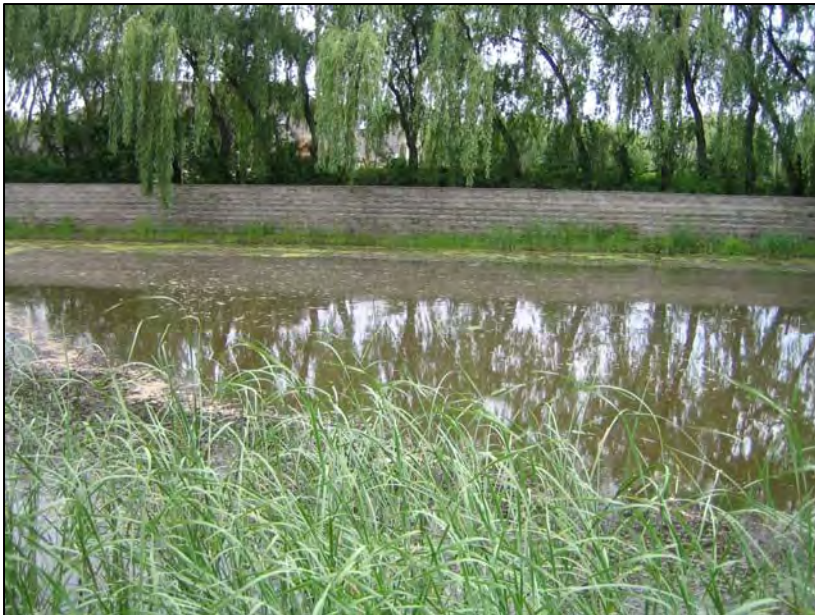
### **PHOTO 2**

South Wall – Block wall completely lines the south shore of this pond. Mature willow trees in the background hang over the wall.

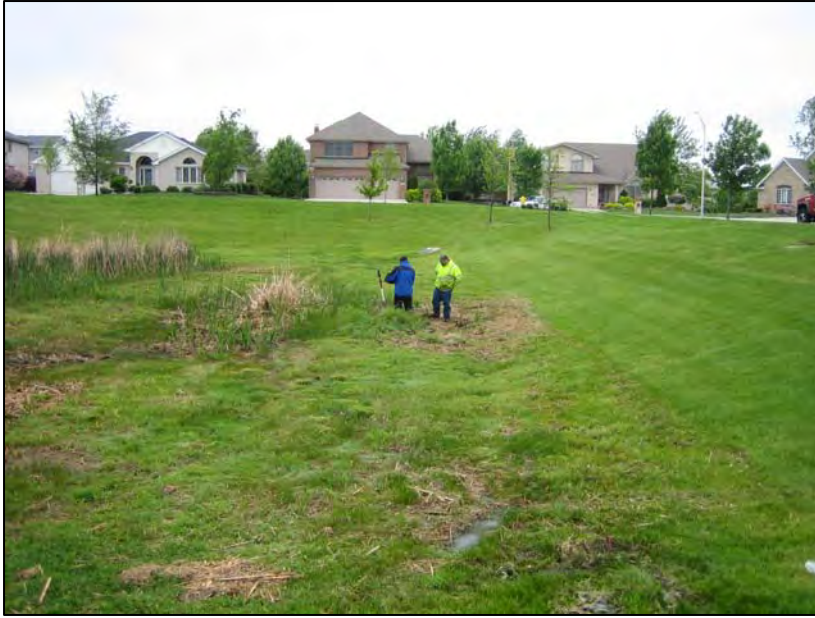
### **PHOTO 1**

Pond overview from west bank. Mowing on pond bottom in wet area and in wetland vegetation.

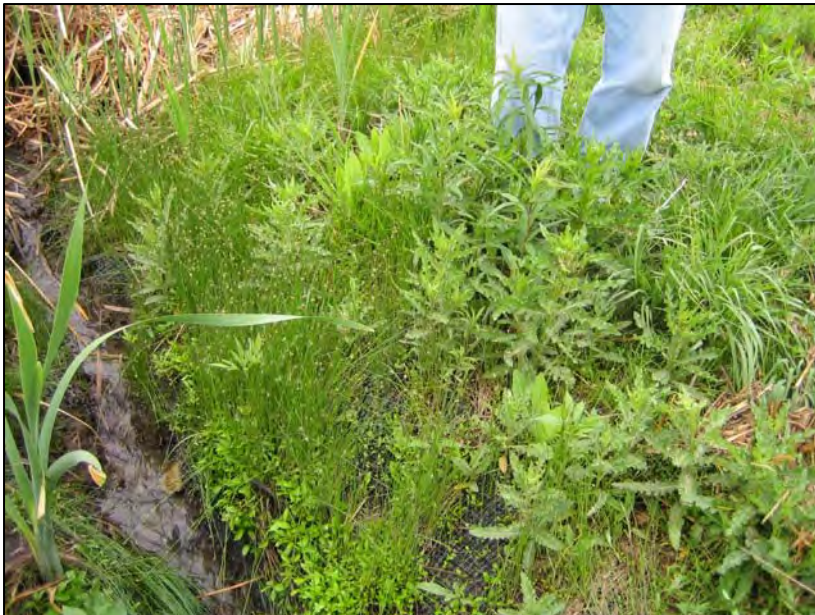
### **PHOTO 2**

Channel cut through bottom of basin by residents to drain a cattail stand. Permanent erosion blanket exposed and cut along channel.

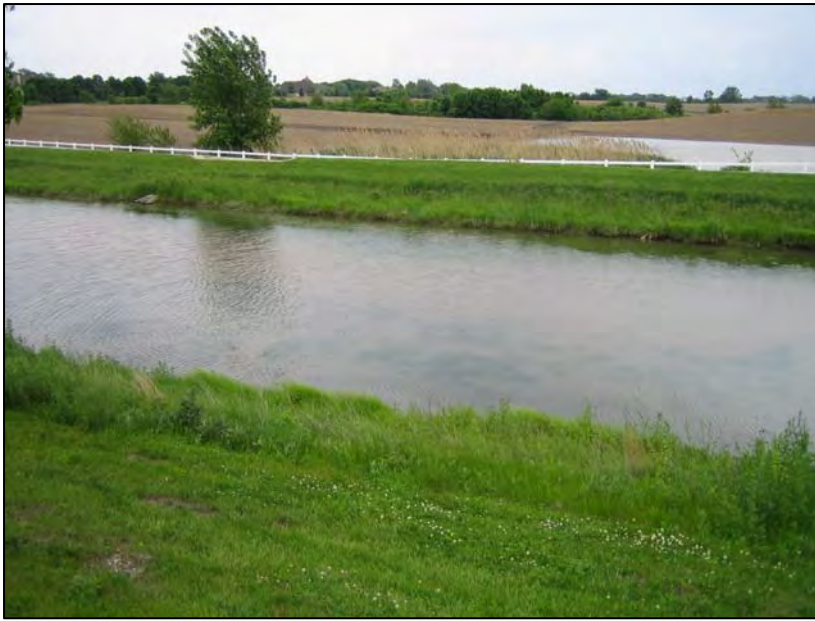
**PHOTO 1**

Pond overview from north bank. Narrow unmowed buffer along pond shoreline. Agricultural field in background is where pond outlets to.

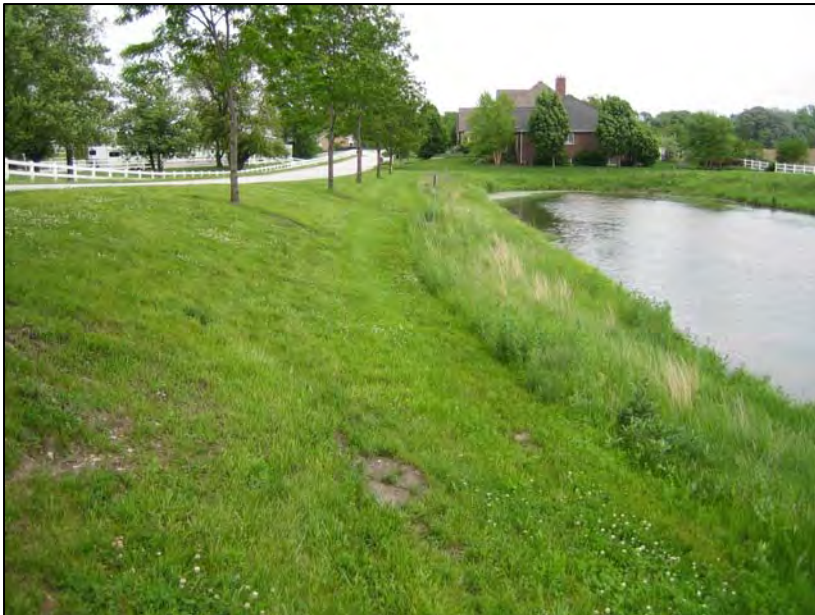
**PHOTO 2**

North slope – mowed area has some bare areas from mower tracks around trees.

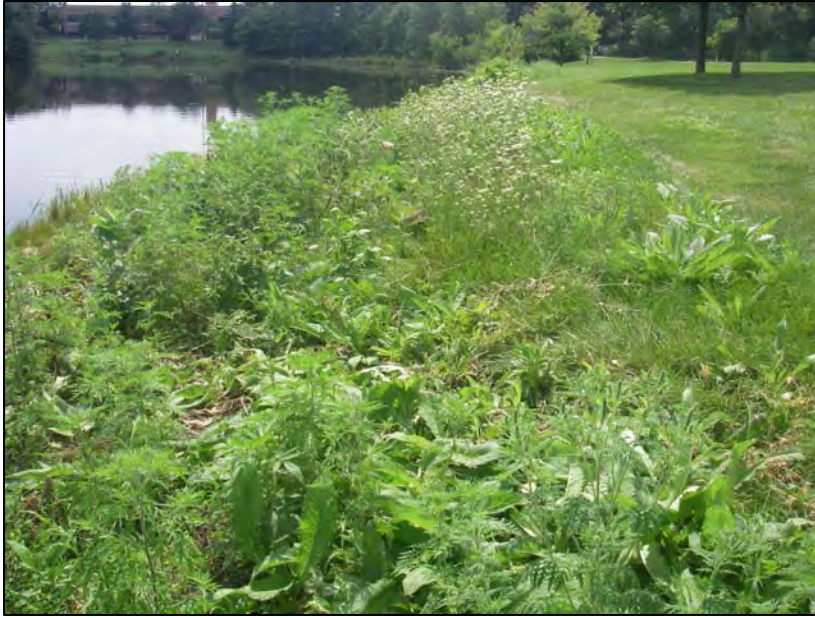
**PHOTO 1**

Teasel & thistle dominated west bank of Police Pond.

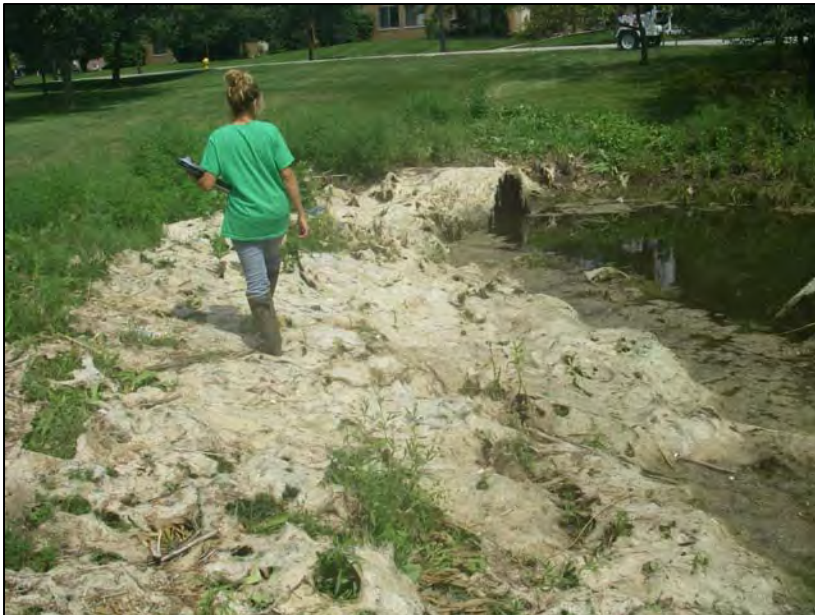
**PHOTO 2**

Severe algae deposit at northern outlet pipe from prior storm event and northern wind fetch. Significant algae problem in this basin.

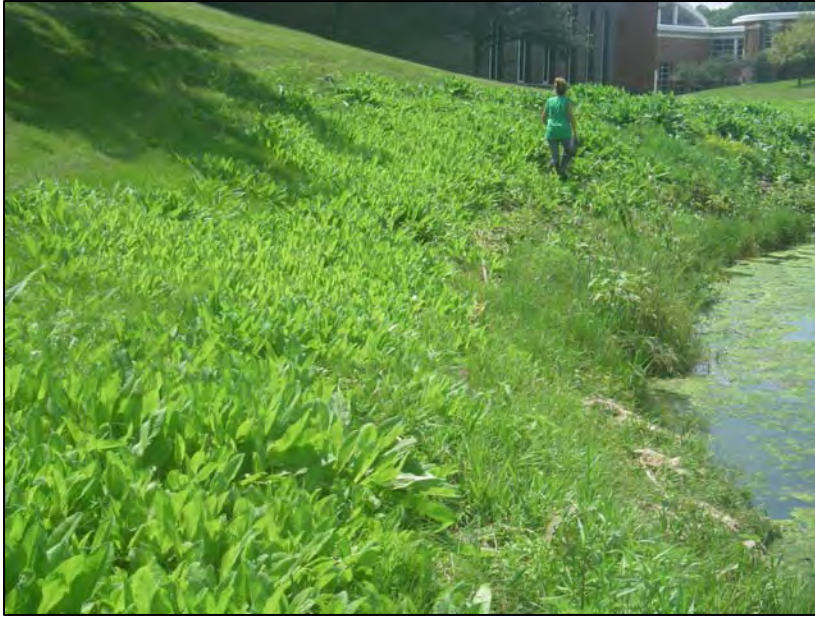
**PHOTO 1**

Banks of Village Center Pond dominated by teasel, thistle and turf grass.

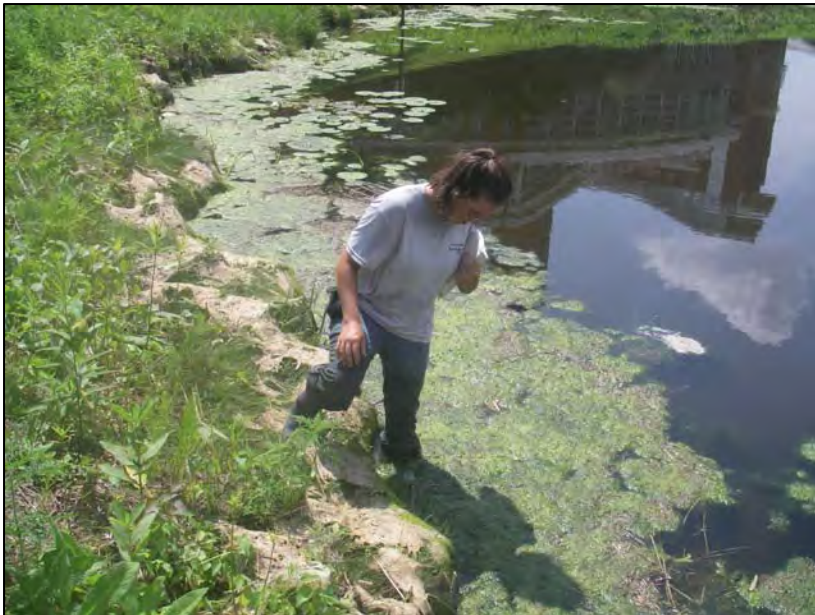
**PHOTO 2**

Approximate one (1') foot drop at toe of slope around much of the basin. Limited scour line appears to be forming above the water line. Obvious algae problem in the basin.

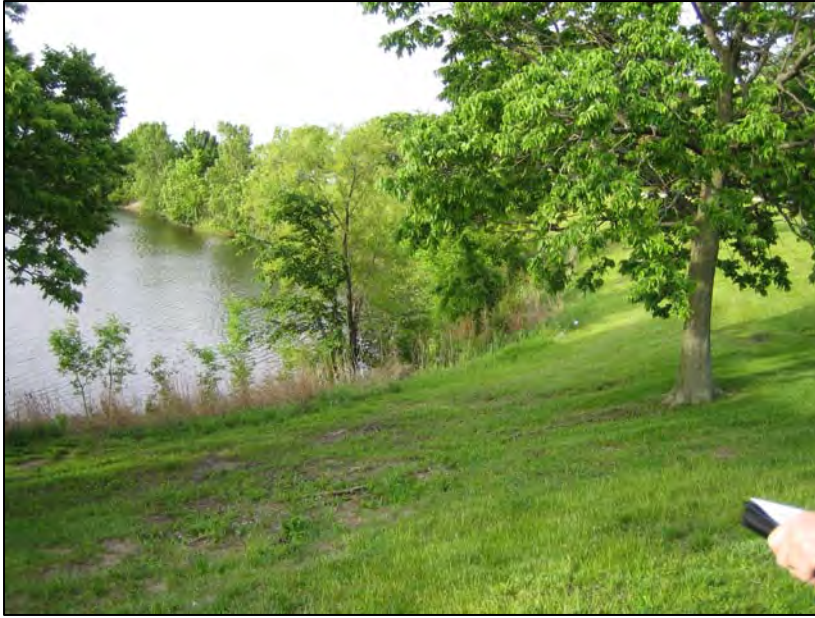
### PHOTO 1

Northwest Corner. Bare spots in turf grass up slopes. Unmowed buffer of turf grass and mature trees lines entire basin.

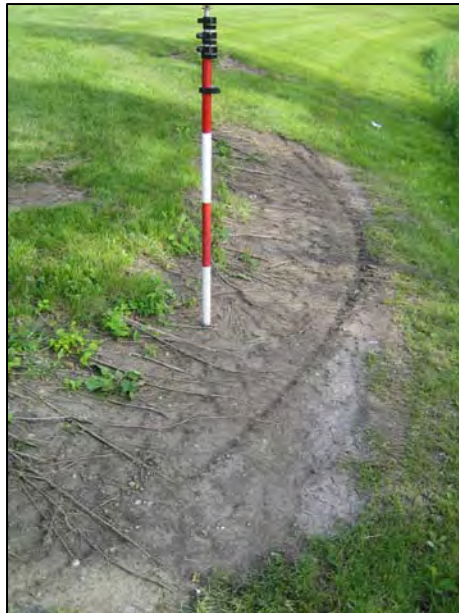
### PHOTO 2

Area of bare slope due to mower tracks.

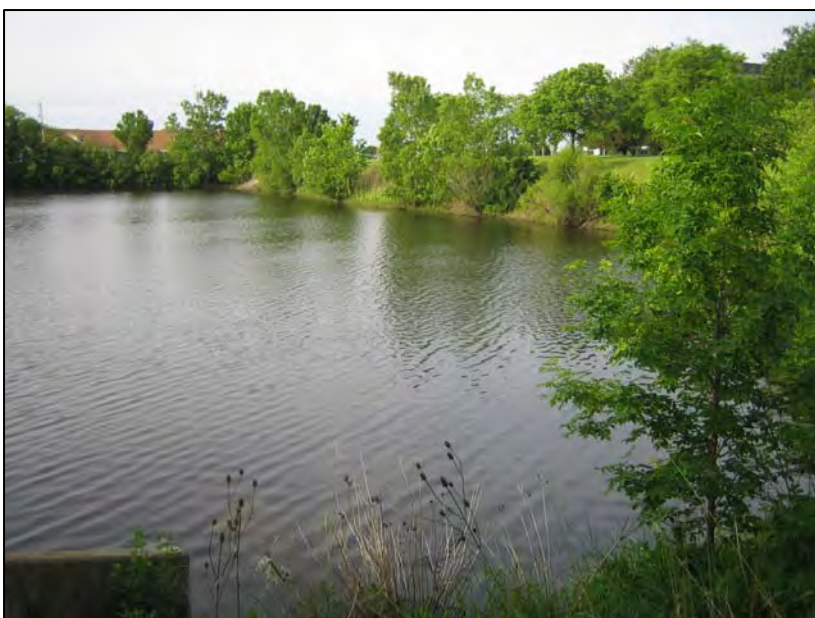
### PHOTO 3

Overview from west slope showing condition of mature trees along shoreline.

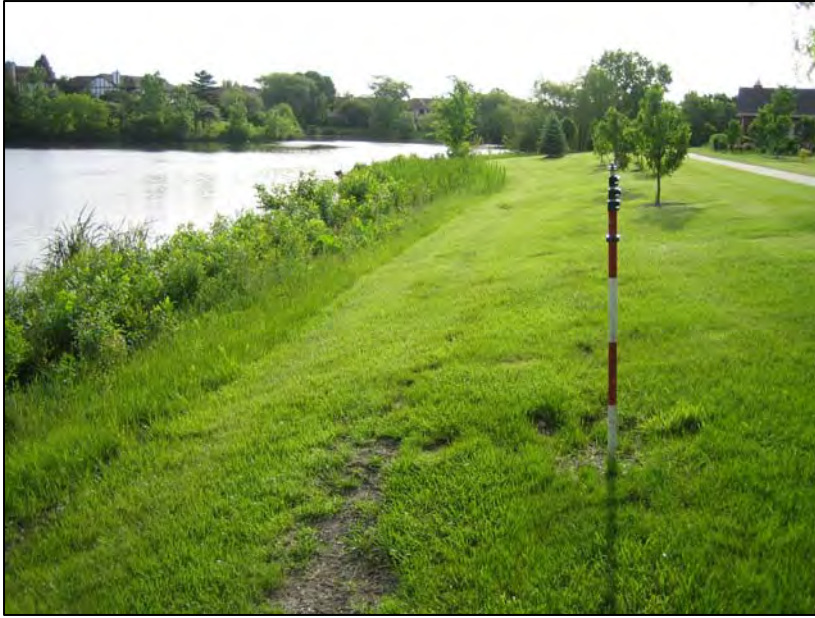
### PHOTO 4

Slope slope – mowed turf area between sidewalk and un-mowed buffer along shoreline.

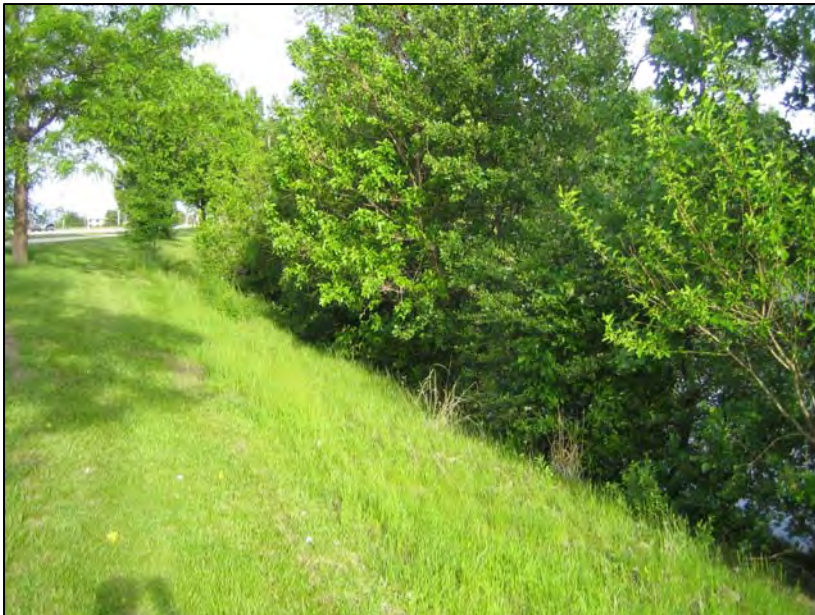
### PHOTO 5

Steep banks at southwest corner of the pond.

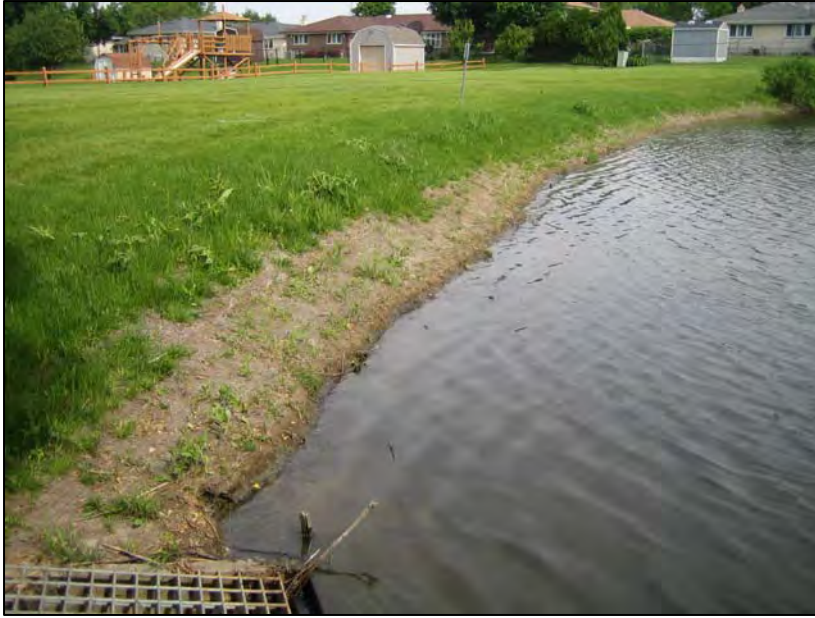
### **PHOTO 1**

West Slope. Bare zone along shoreline due to chemical spill damage.

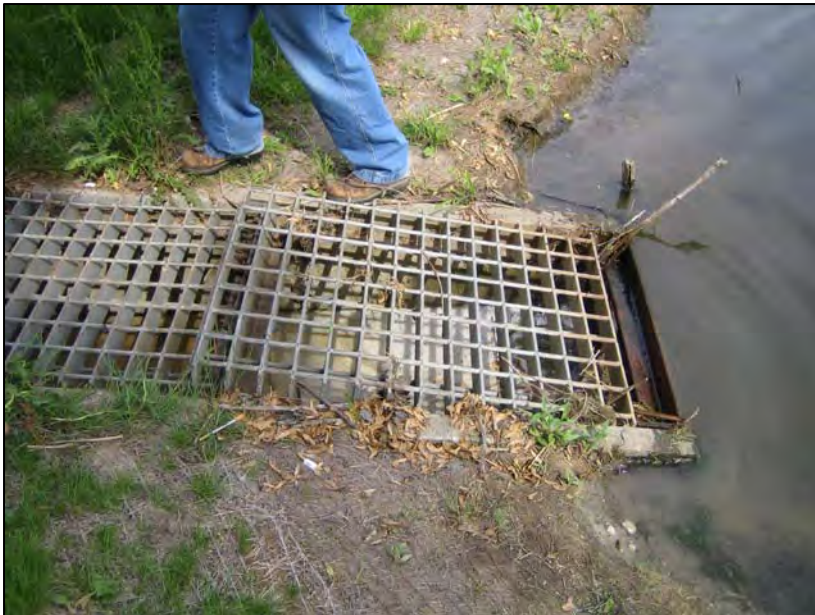
### **PHOTO 2**

OUTLET PROBLEMS: Residents move grate to improve flow – bad outlet design – consider replacement

Outflow grate is moved by residents on a regular basis to lower water elevation.

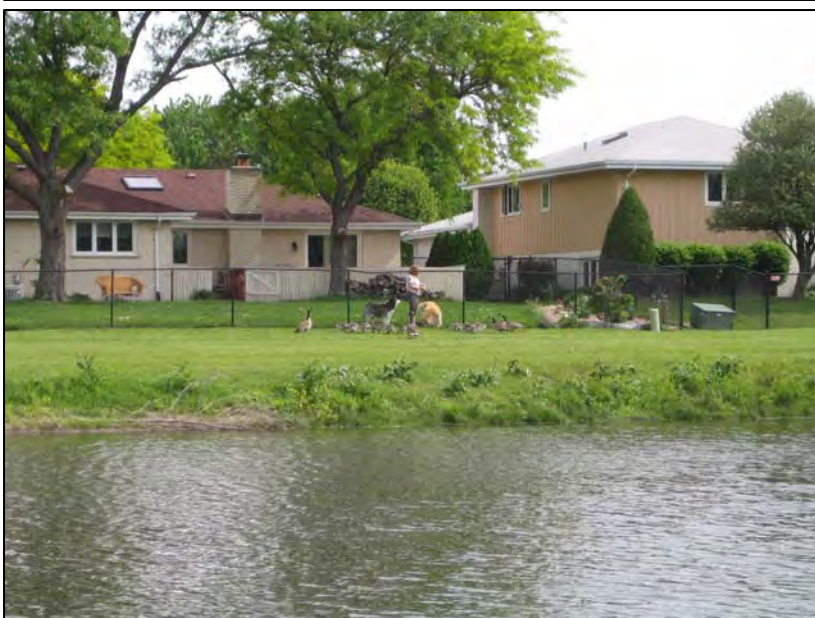
### **PHOTO 3**

Flock of geese being fed by adjacent resident.

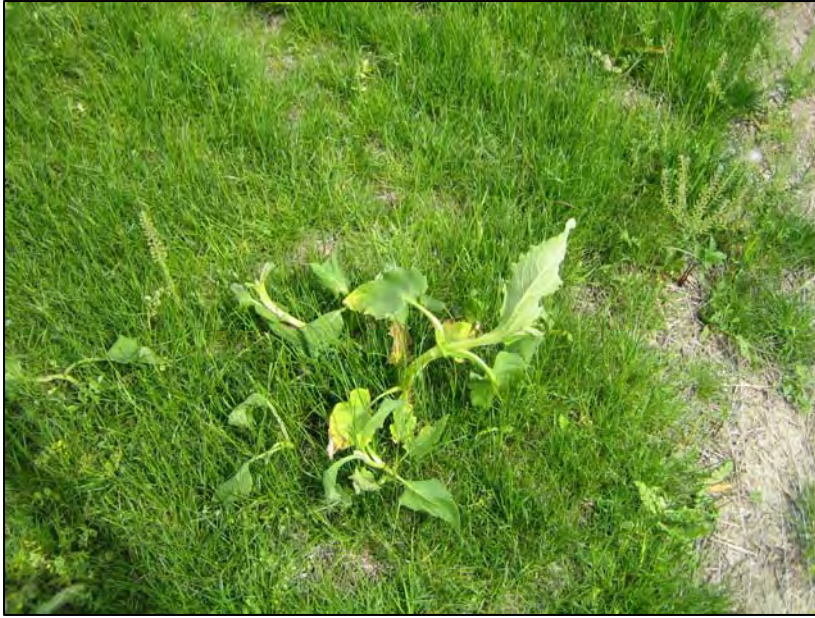
### **PHOTO 4**

Signs of native plant damage due to Weed & Feed application on turf grass.

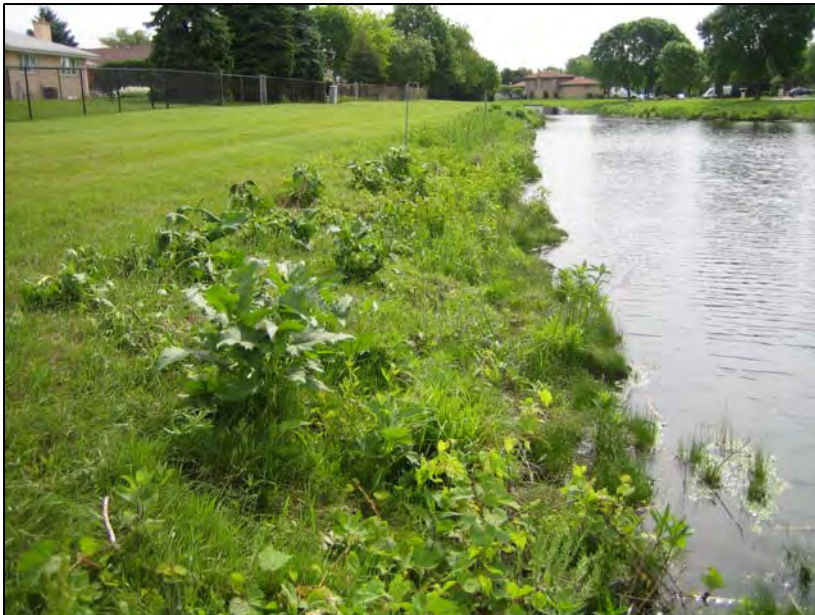
### **PHOTO 5**

South bank – mowed turf along fences and turf/native buffer along shoreline. Signs of historic muskrat damage. Minimal shore erosion on toe of slope.

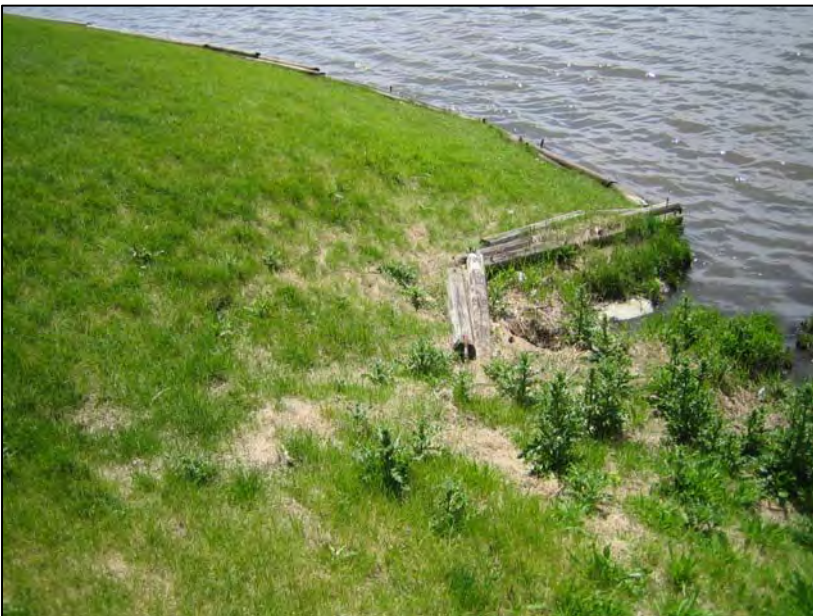
### **PHOTO 5**

South shore – very flat slopes going up to baseball field – minimal buffer. Shallow emergent planting area potential within water line.

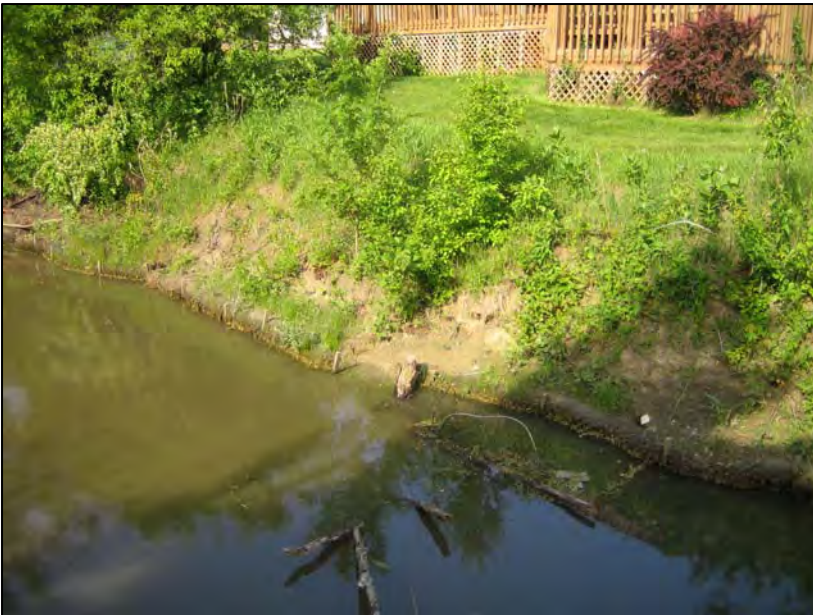
**PHOTO 4**

North slope – area of  
significant bank  
undercutting  
(approximately 2' scour).

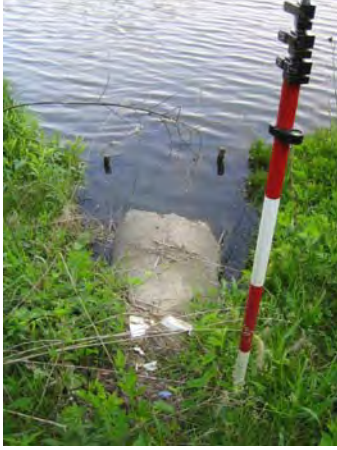
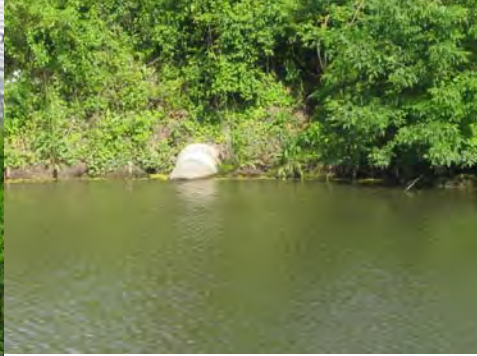
### PHOTO 5 & 6

INLET PROBLEMS: Yes – Multiple Failed FES: on W. side of outlet channel, on SE corner

Locations of FES Failure. Left – Exposed FES on south shoreline. Right – FES dropped into water on north shoreline.

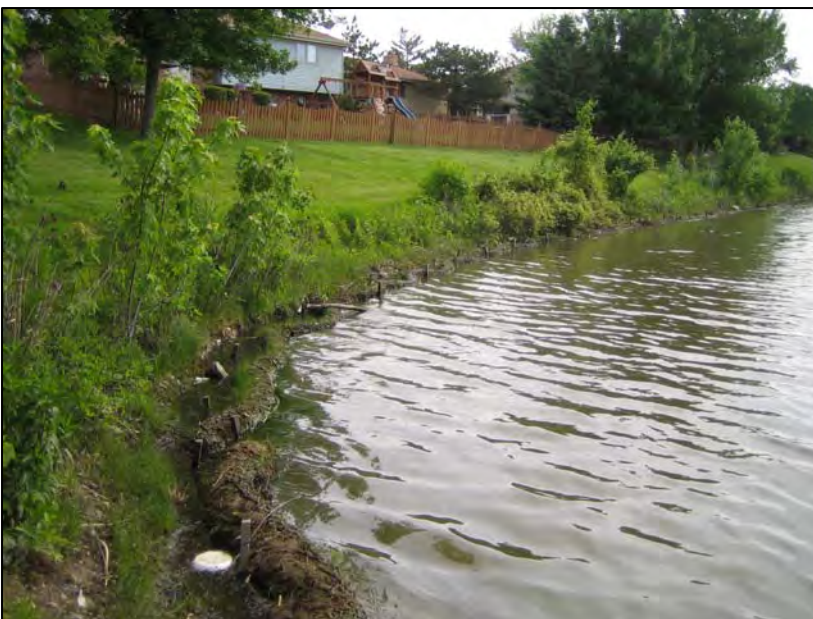
### PHOTO 7

South shoreline – entire shore was repaired in past two years but signs of significant muskrat damage is prevalent along entire shore similar to shown in photo.

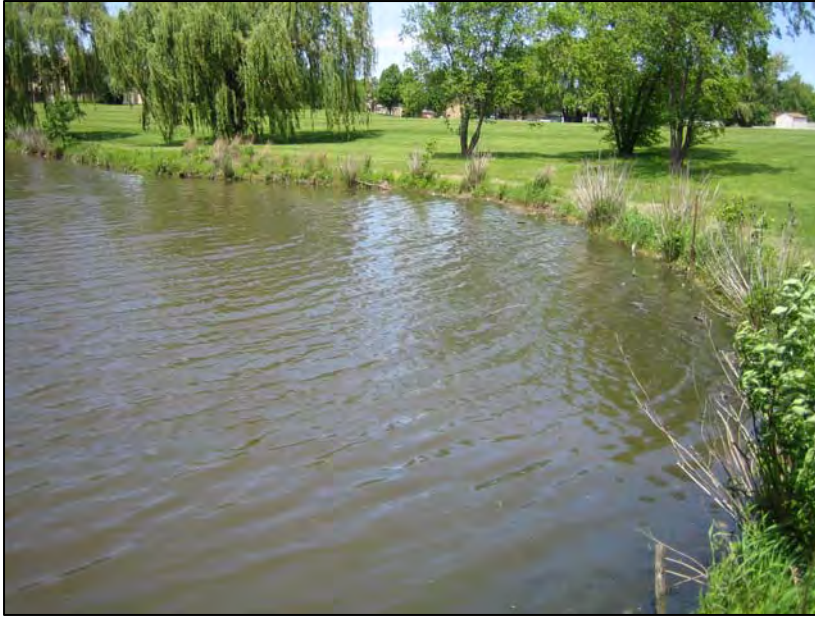
**PHOTO 1**

Northeast Corner – Small un-mowed buffer adjacent to large turf recreational area. Minimal erosion apparent in this location.

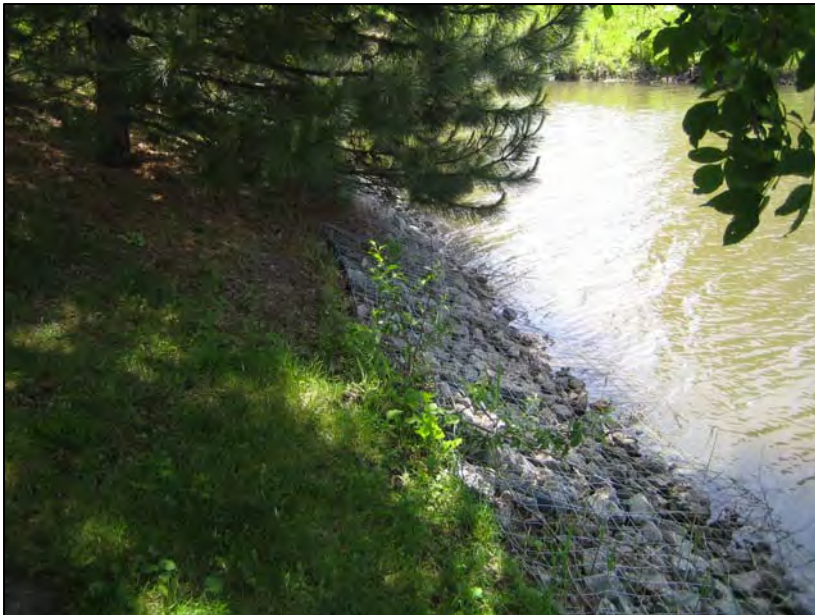
**PHOTO 2**

Gabion mattress installed along resident on north shore along entrance from pond to outlet channel.

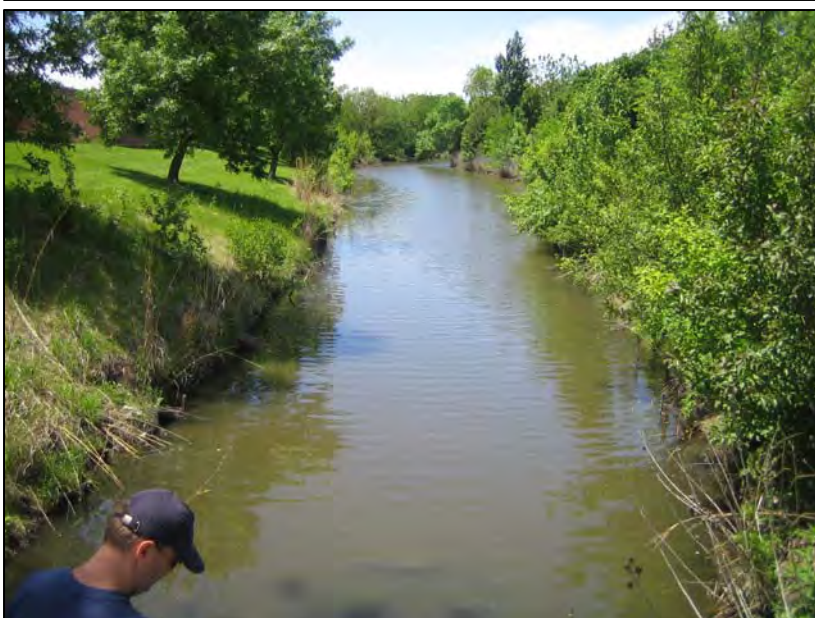
**PHOTO 3**

Steep banks outlet channel to east of pond. Mature tree and shrub growth exists along north slope of this outlet channel. Scour of approximately 1-2' along banks of this channel.

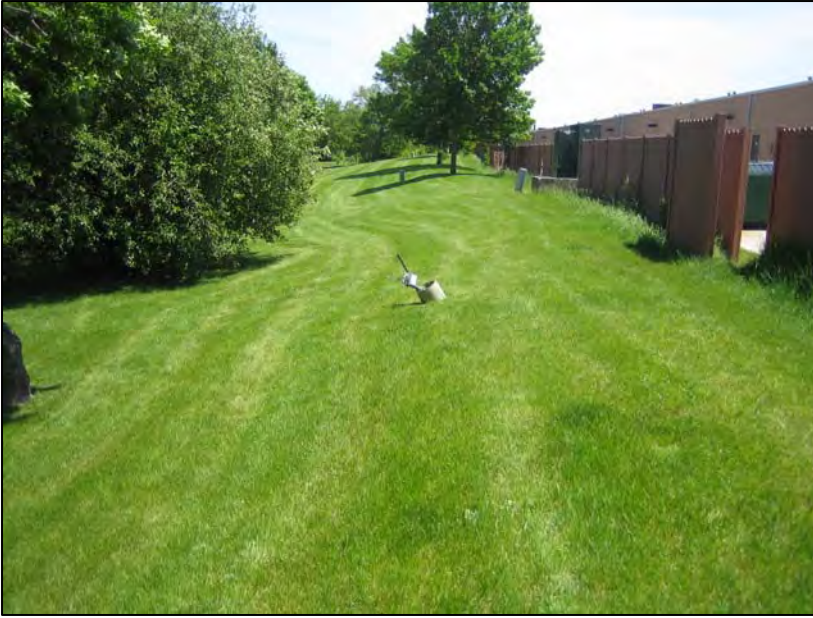
**PHOTO 4**

South of Pond – Large under-utilized turf grass area along commercial property. Mature trees line shoreline on south shoreline.

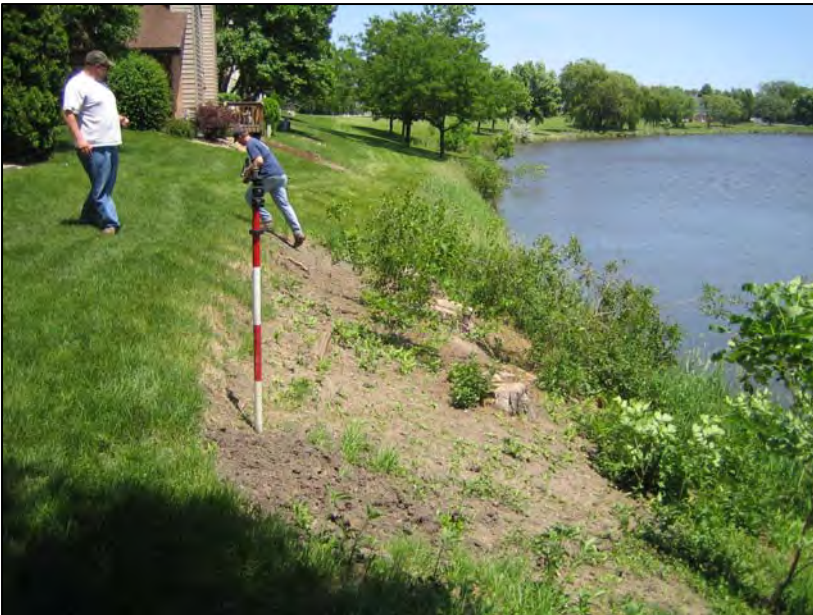
**PHOTO 5**

West slope – Location of 3 large trees (pine) removed on steep slope. Bare slopes above significant scour zone along shoreline.

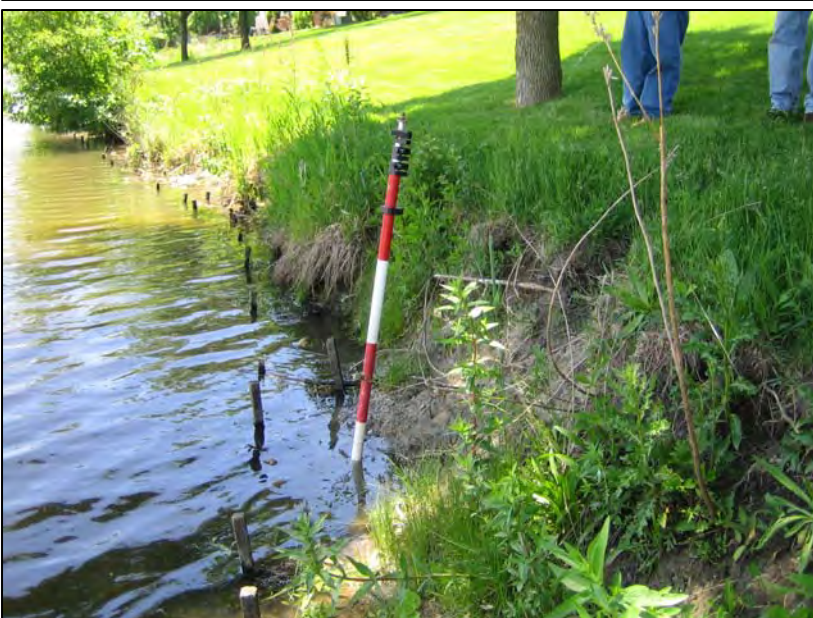
**PHOTO 6**

North slope – Severe bank erosion and sloughing along much of the north shoreline. Signs of historic fiber roll installation that has degraded.

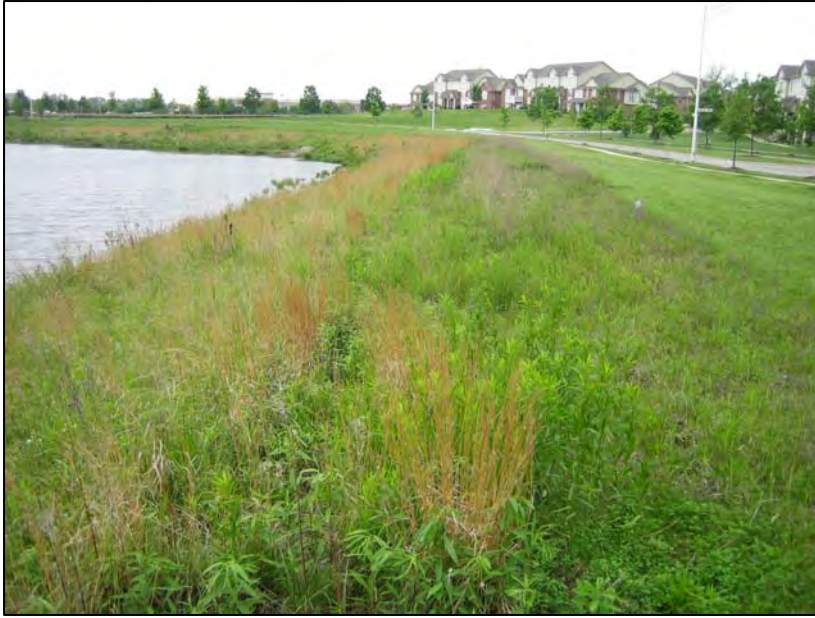
### PHOTO 1

West slope – Transition from sidewalk to mowed turf to native prairie slope to emergent shoreline. Slopes in good condition and excellent mix of natives.

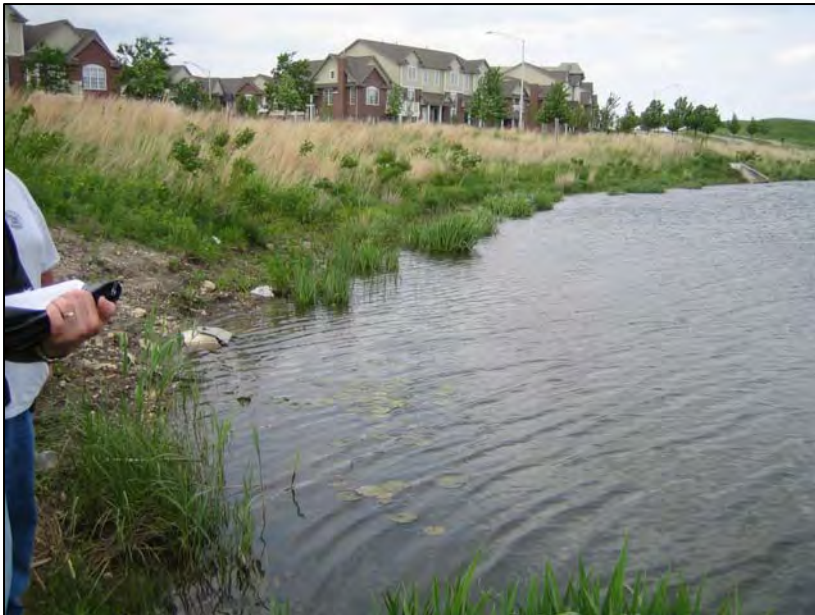
### PHOTO 2

Signs of long drain down period on toe of slopes where prairie vegetation was stressed out but emergent shoreline was tolerating the water. Also signs of fishermen path beaten along shore.

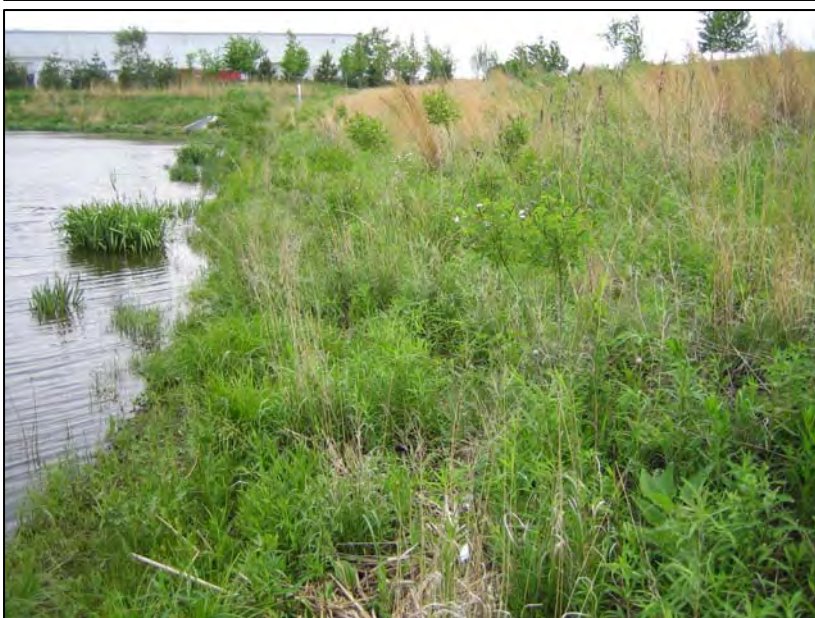
### PHOTO 3

Healthy emergent shore and native prairie buffer surrounds the entire pond.

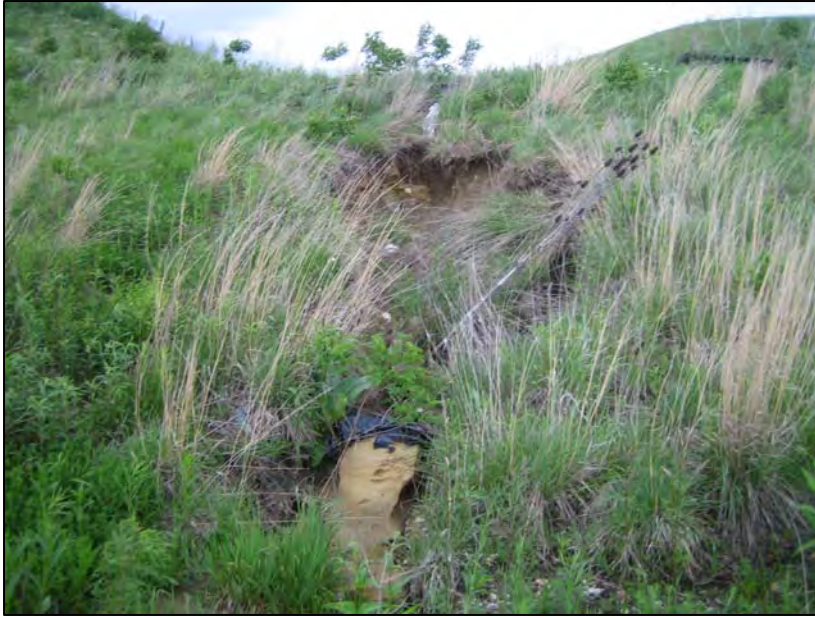
### **PHOTO 4**

Severe rill (5' deep) coming from pavilion and venue area to the north of pond. Need to contain water in a dedicated rip-rap channel down slope.

| YEAR 1 | | | | | | |
|---|---|---|---|---|---|---|
| Repair Erosion Rill | Install Rip-Rap, Fabric, Seed & Blanket in Erosion Area | 1.0 | EA | \$7,500 | 1 | \$7,500 |
