# THE VILLAGE OF ORLAND PARK BASIN BEST PRACTICES PROGRAM

## BASIN ASSESSMENT AND MANAGEMENT PLAN REPORT

Report Date:  
June 30, 2011

Prepared by:  
V3 COMPANIES

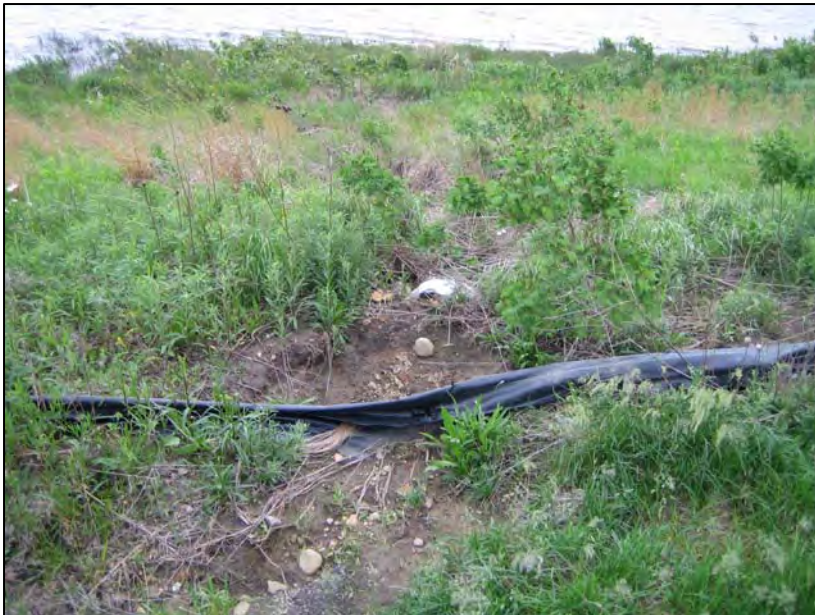
### **PHOTO 5**

North slope – Location of historic silt fence within slopes which is now creating erosion points and rills. Should remove or cut off silt fence along entire length of north slope.

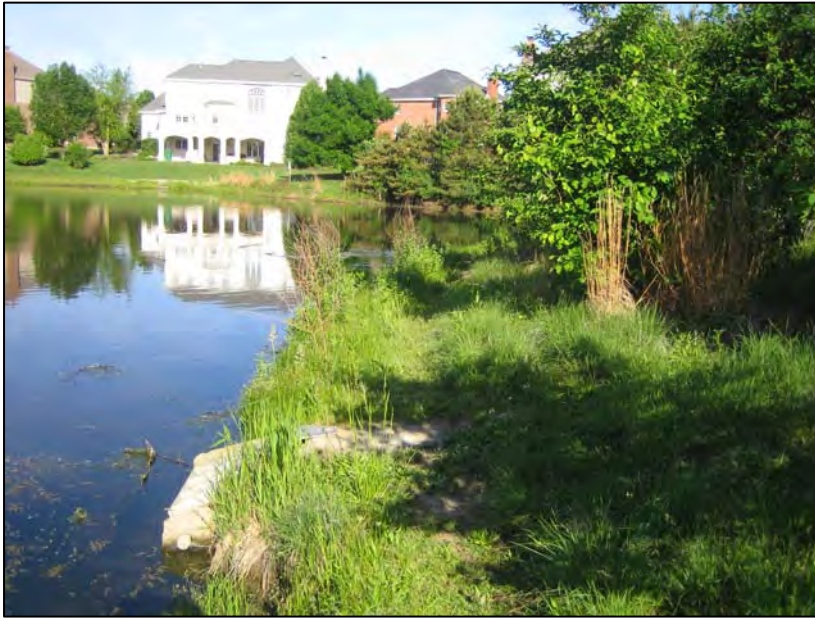
**PHOTO 1**

North slope – Mature trees & shrubs in unmowed turf buffer. Signs of fishermen trail around entire pond.

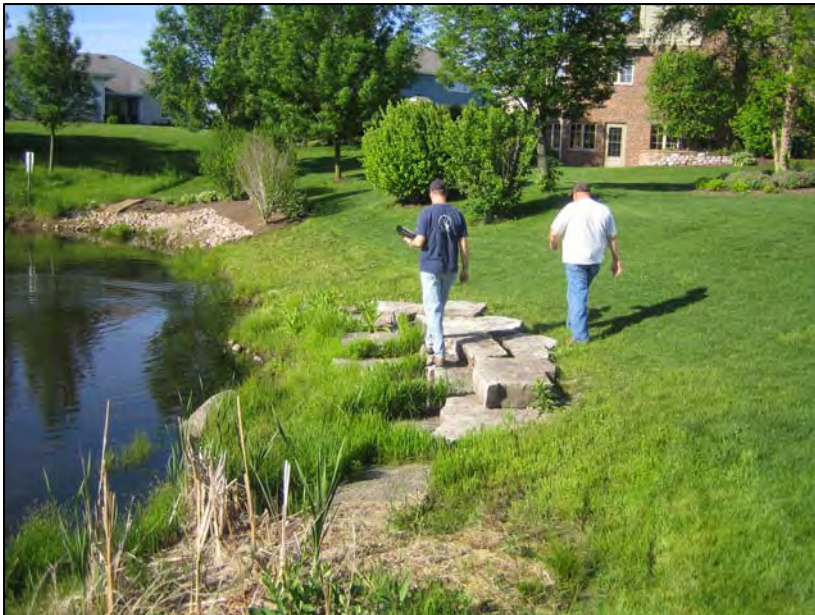
**PHOTO 2**

West slope – landscape installations and mowed turf grass to shoreline.

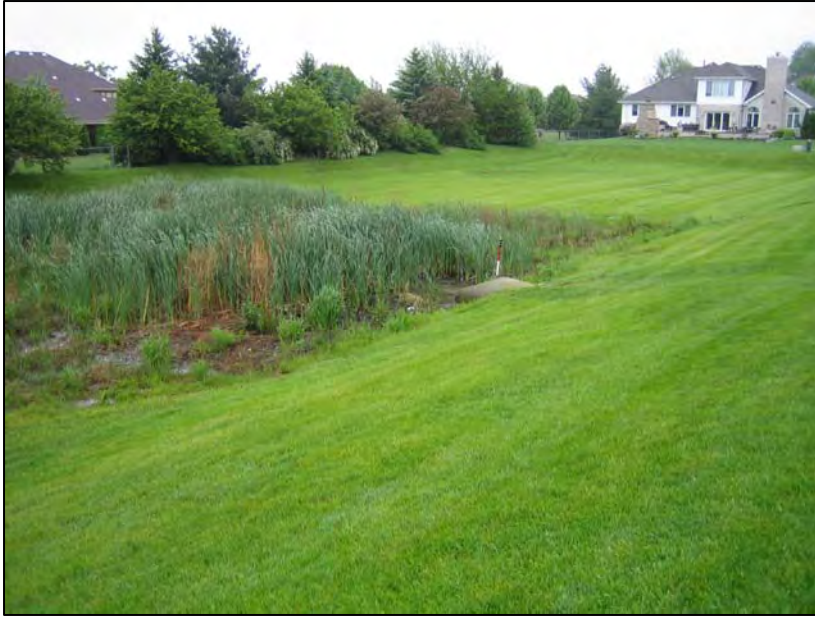
### PHOTO 1

Overview from north slope – turf surrounding low area of cattails.

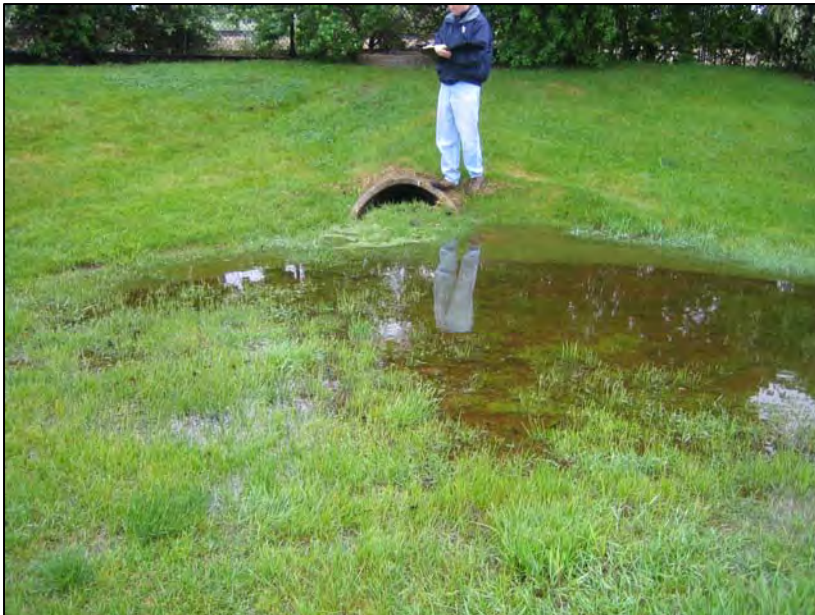
### PHOTO 2

Southeast corner – One of the outlets blocked by sediment.

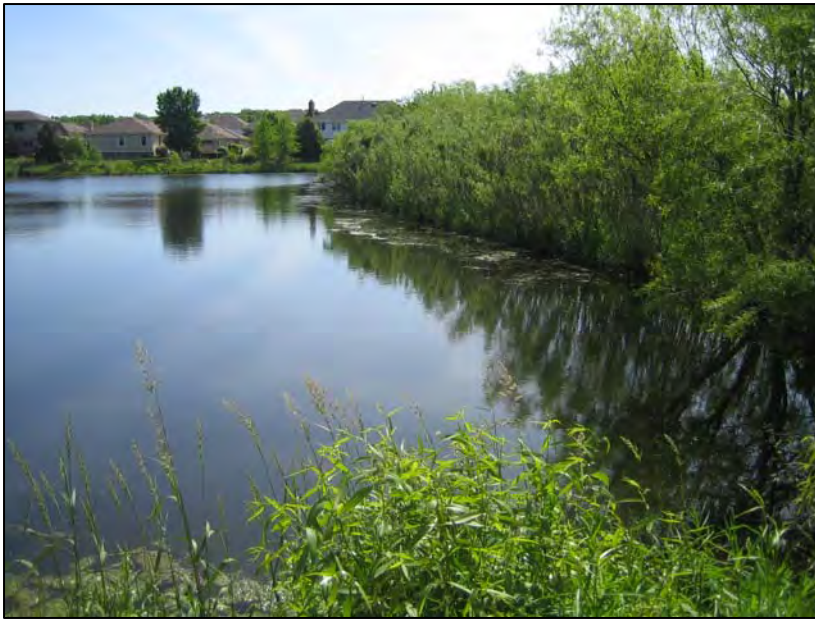
**PHOTO 1**

South shore of pond is mature willow growth and large wetland complex. Pond outlets to this wetland area.

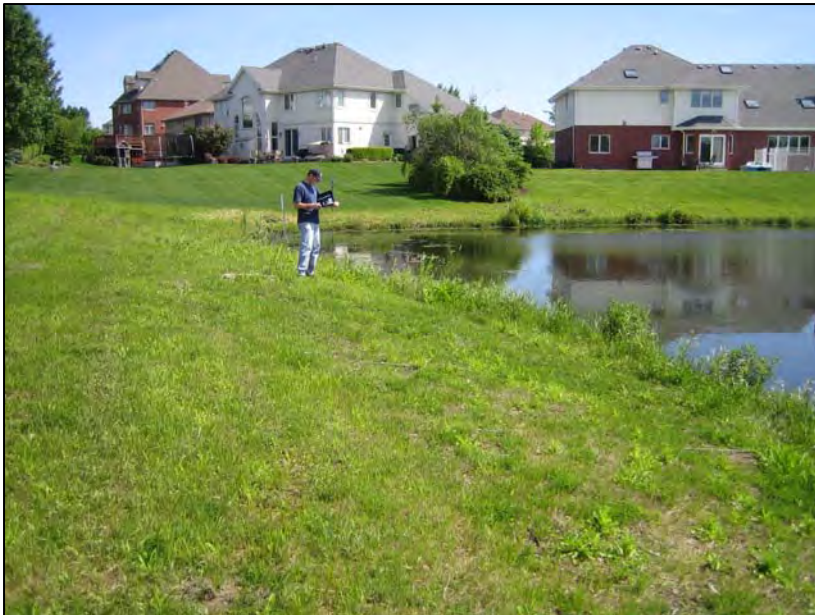
**PHOTO 2**

West slope – Stumps remaining from recent willow cutting performed by Village. Signs of toe erosion and weed invasion increasing throughout area of prior willow stands.

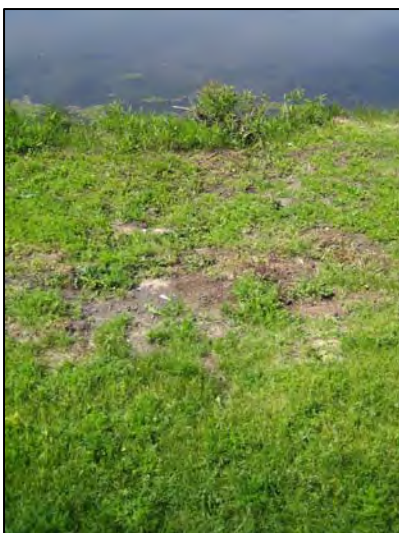
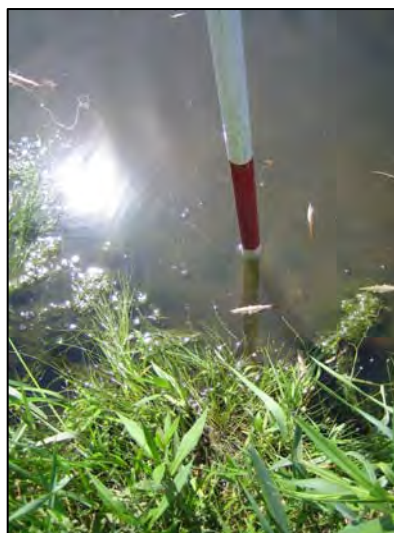
**PHOTO 3 & 4**

Bare spots on slope and 18-24" eroded shoreline typical around west and north slopes.

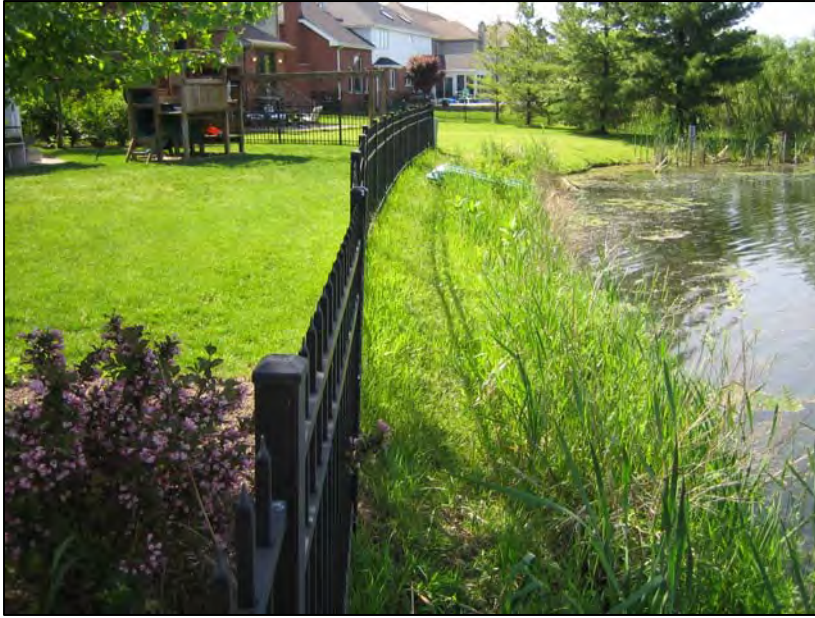
### PHOTO 5

Severe erosion (2' scour) along eastern slope immediately adjacent to fence line.

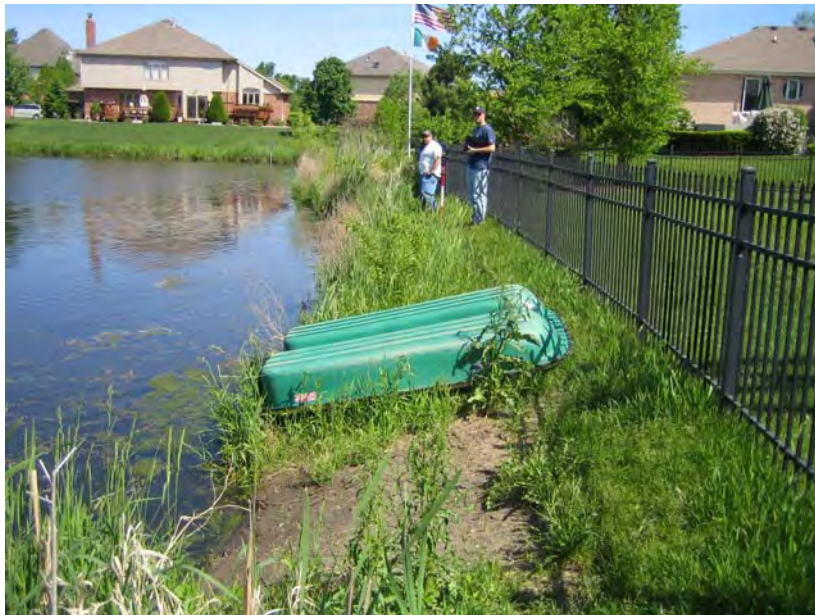
### PHOTO 6

Resident use of slope for boat storage – signs of killed vegetation under boat.

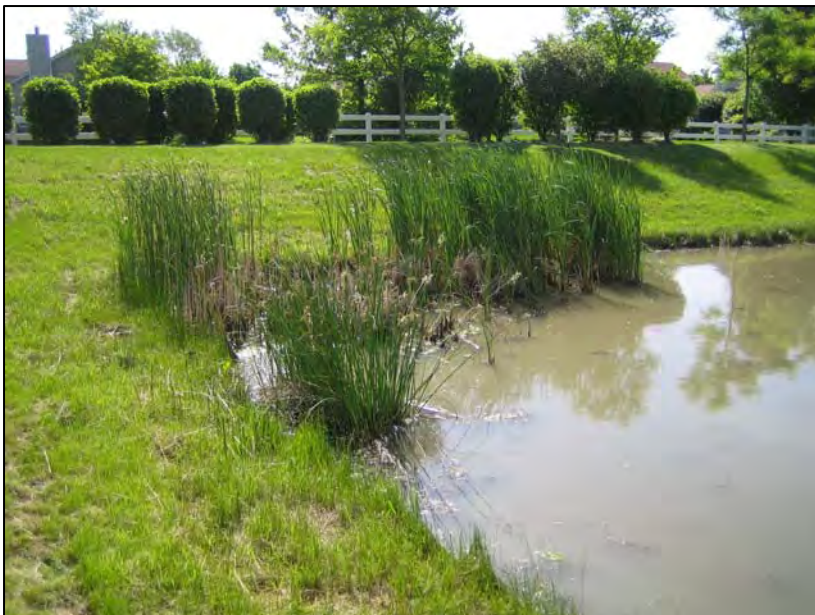
**PHOTO 2**

Cattail growth at outlet from basin. Also observed high turbidity of water likely due to carp or goldfish in shallow pond.

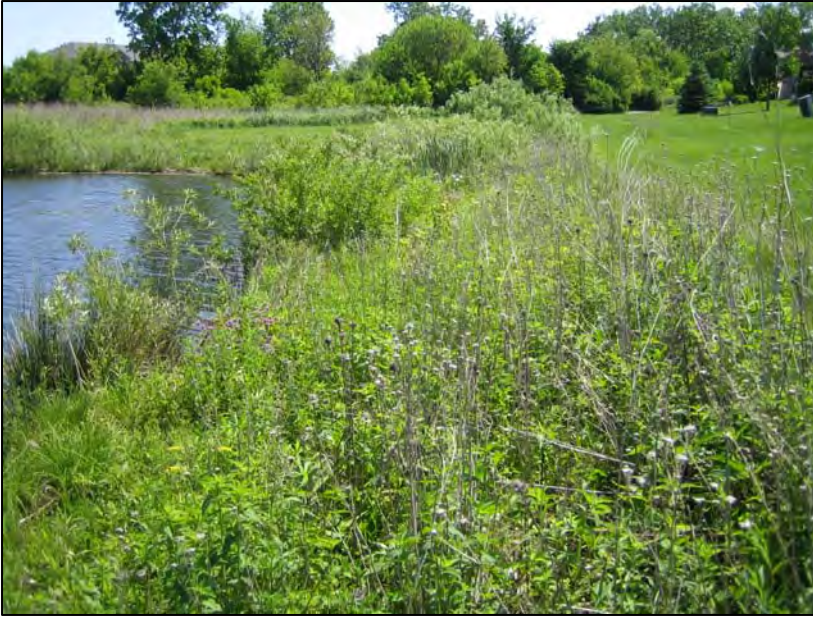
**PHOTO 1**

South slope – Native prairie slopes and emergent shoreline in good condition.

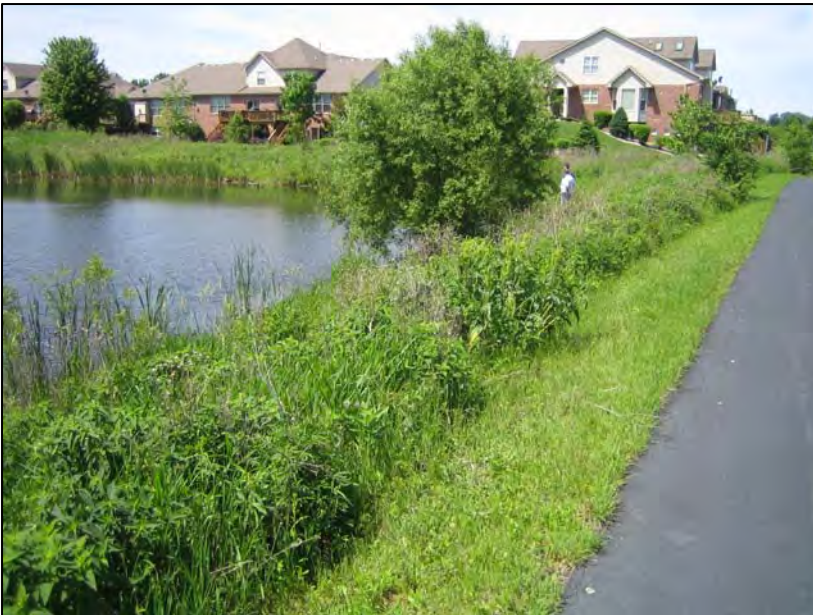
**PHOTO 2**

Regional trail along north top of slope.

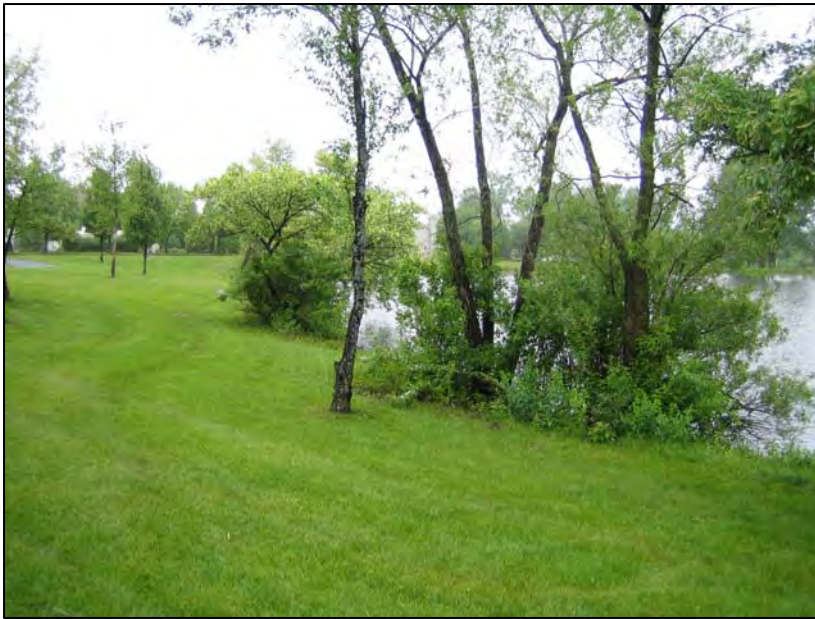
**PHOTO 1**

Minimal un-mowed buffer around pond. No residents on this pond – completely within park. Turf grass with a few mature trees.

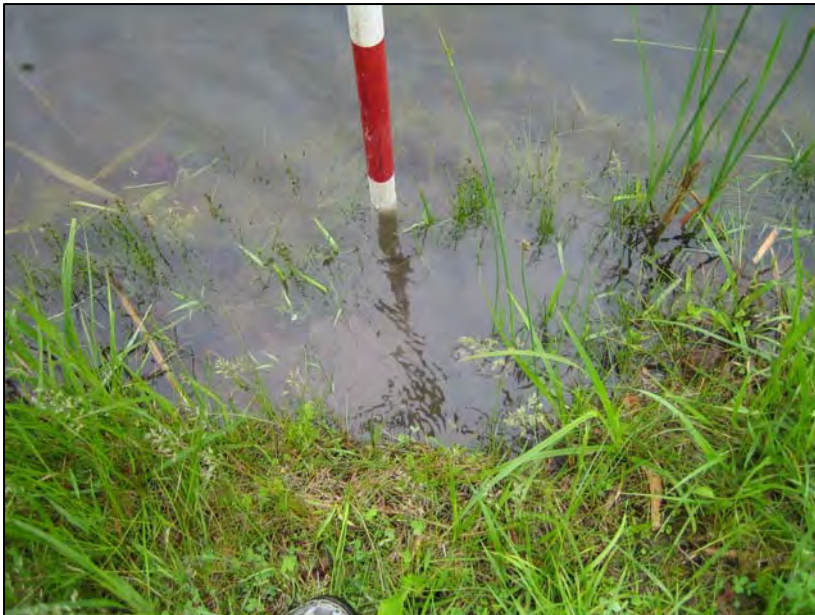
**PHOTO 2**

Good growth of emergent vegetation along shoreline and into water.

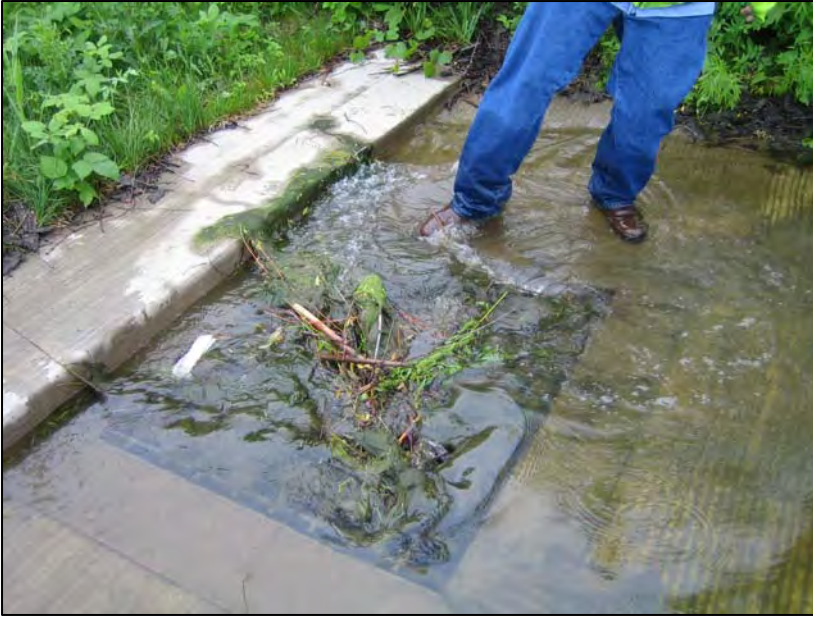
**PHOTO 1**

Blocked outlet grate due to grate design. Regular occurrence and maintenance issue.

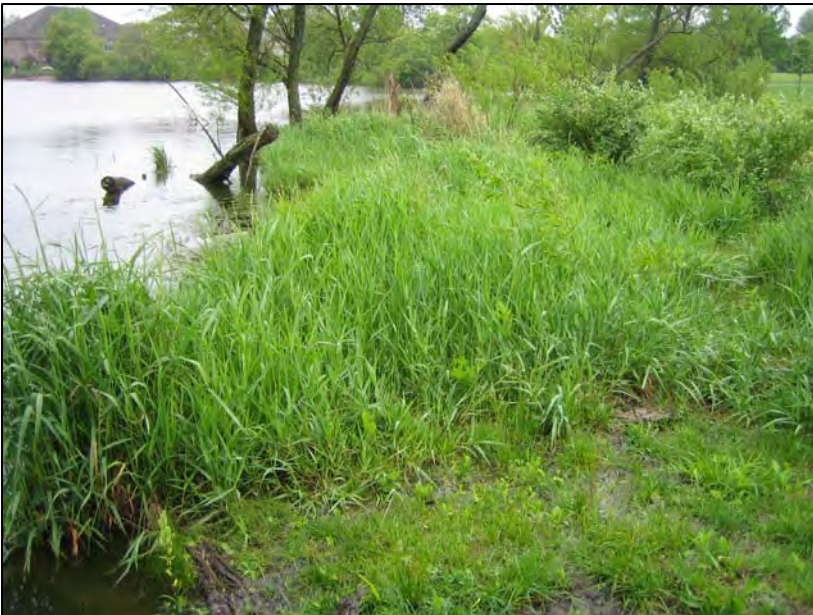
**PHOTO 2**

Un-mowed turf buffer and mature trees and shrubs along west slope.

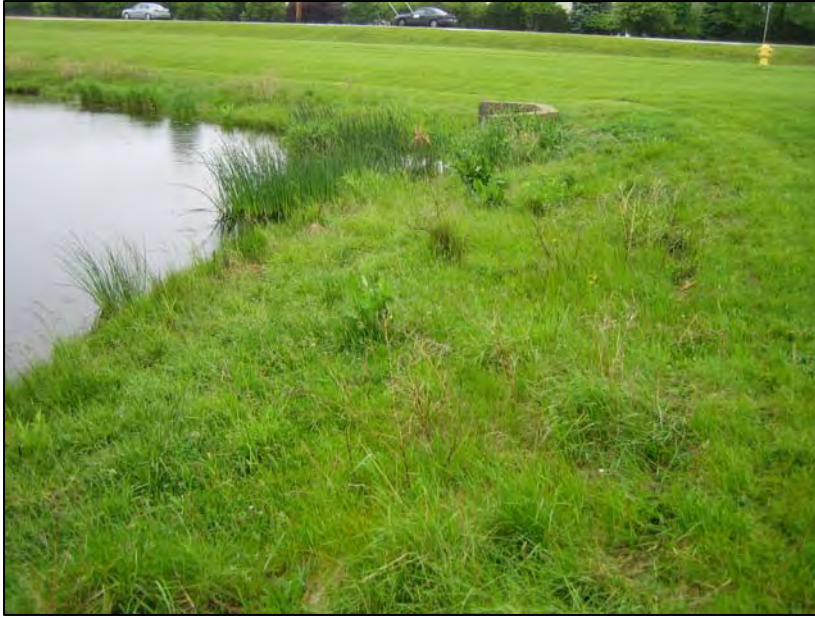
**PHOTO 1**

Flat slopes around entire pond – narrow unmowed buffer with surrounding turf grass.

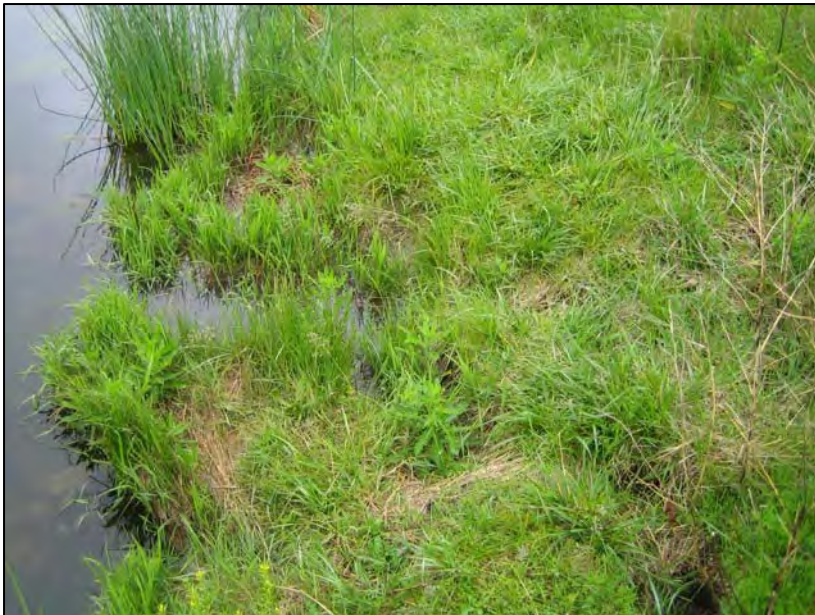
**PHOTO 2**

Good growth of emergent vegetation along shoreline. Signs of historic muskrat activity – not active.

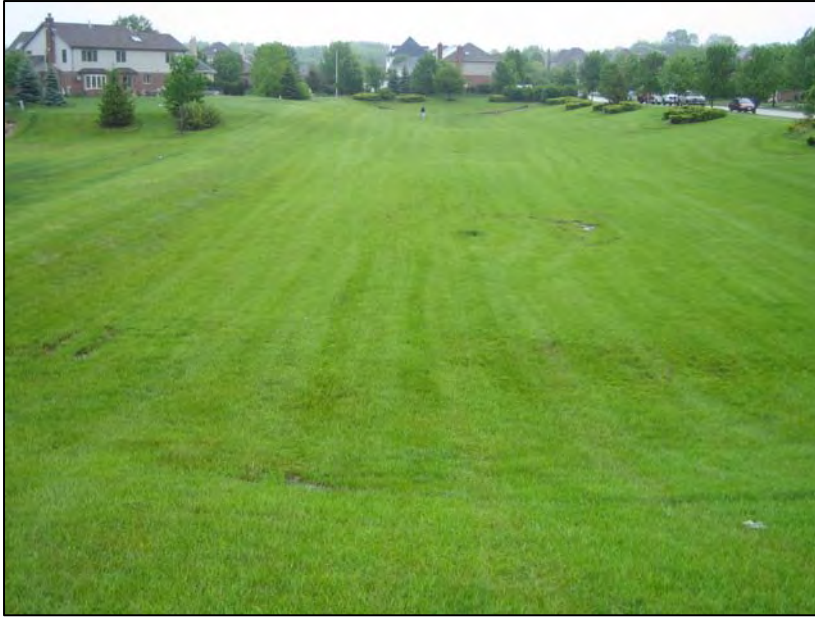
### **PHOTO 1**

Overview of Amber Pond:  
View east.

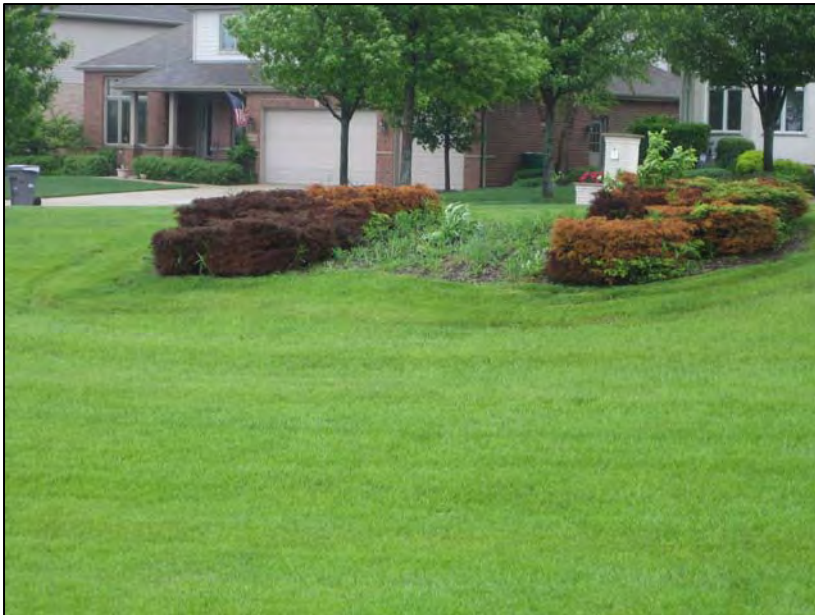
### **PHOTO 2**

View of landscape area  
with dead bushes and  
significant weed growth.  
Also observe mower  
wheel scrapes around  
landscape areas.
