ORLAND  
PARK

# Emergency repairs to Wedgewood Forcemain Discharge manhole and piping

# Executive Summary of Emergency Repairs to Sewer main

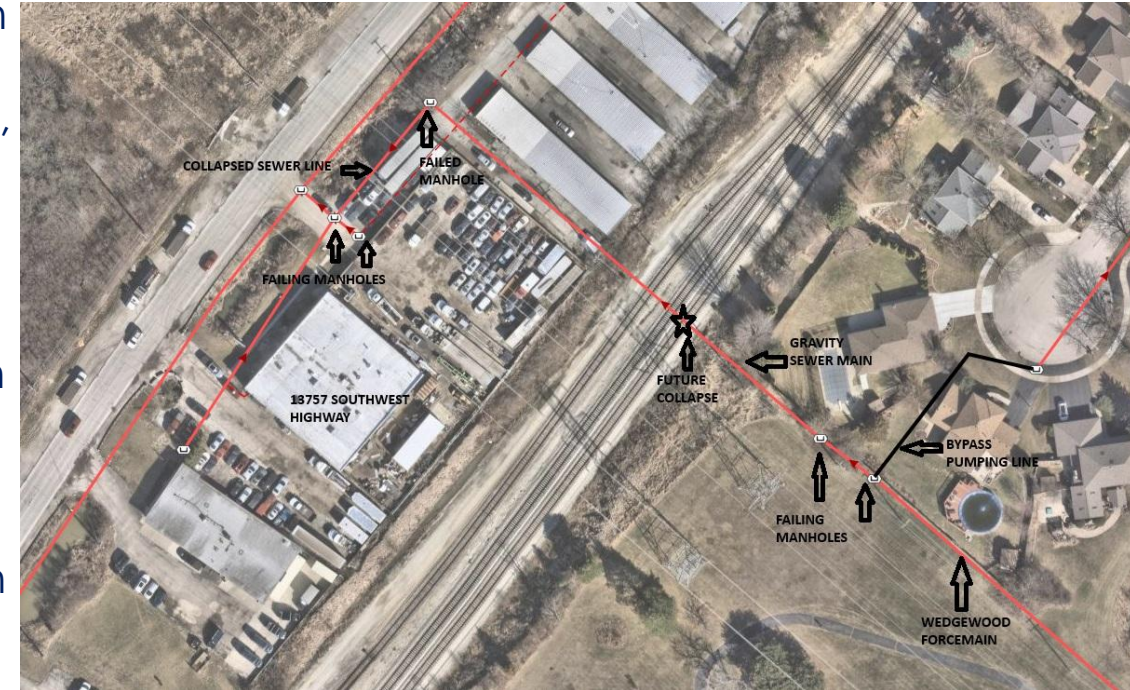
Wedgewood Force Main Emergency Repairs  
Near Southwest Hwy

- Hydrogen Sulfide gases, byproduct of raw sewage, mixes with oxygen and creates a very acidic condensation on concrete and ductile iron piping which eats away the concrete, piping, and existing liner installed in 2004.

- Setup bypass pump.
- Shutdown 20" pipe and activated 10" emergency force main pipe from Wedgewood. (1/2 capacity though)
- With help of Airy's, dug up 20" pipe location to install new section and vactored all old debris out of remaining pipe.
- Inspected five (5) manholes and videoed 620 feet of piping in the area to assess condition to include pipe under railroad track.
- Reestablished flow to 20" pipe temporarily until materials could arrive to do permeant repairs to (5) manholes and the remaining pipe.
- Materials ordered and work has begun on manholes and lining of piping to follow once manholes are complete.

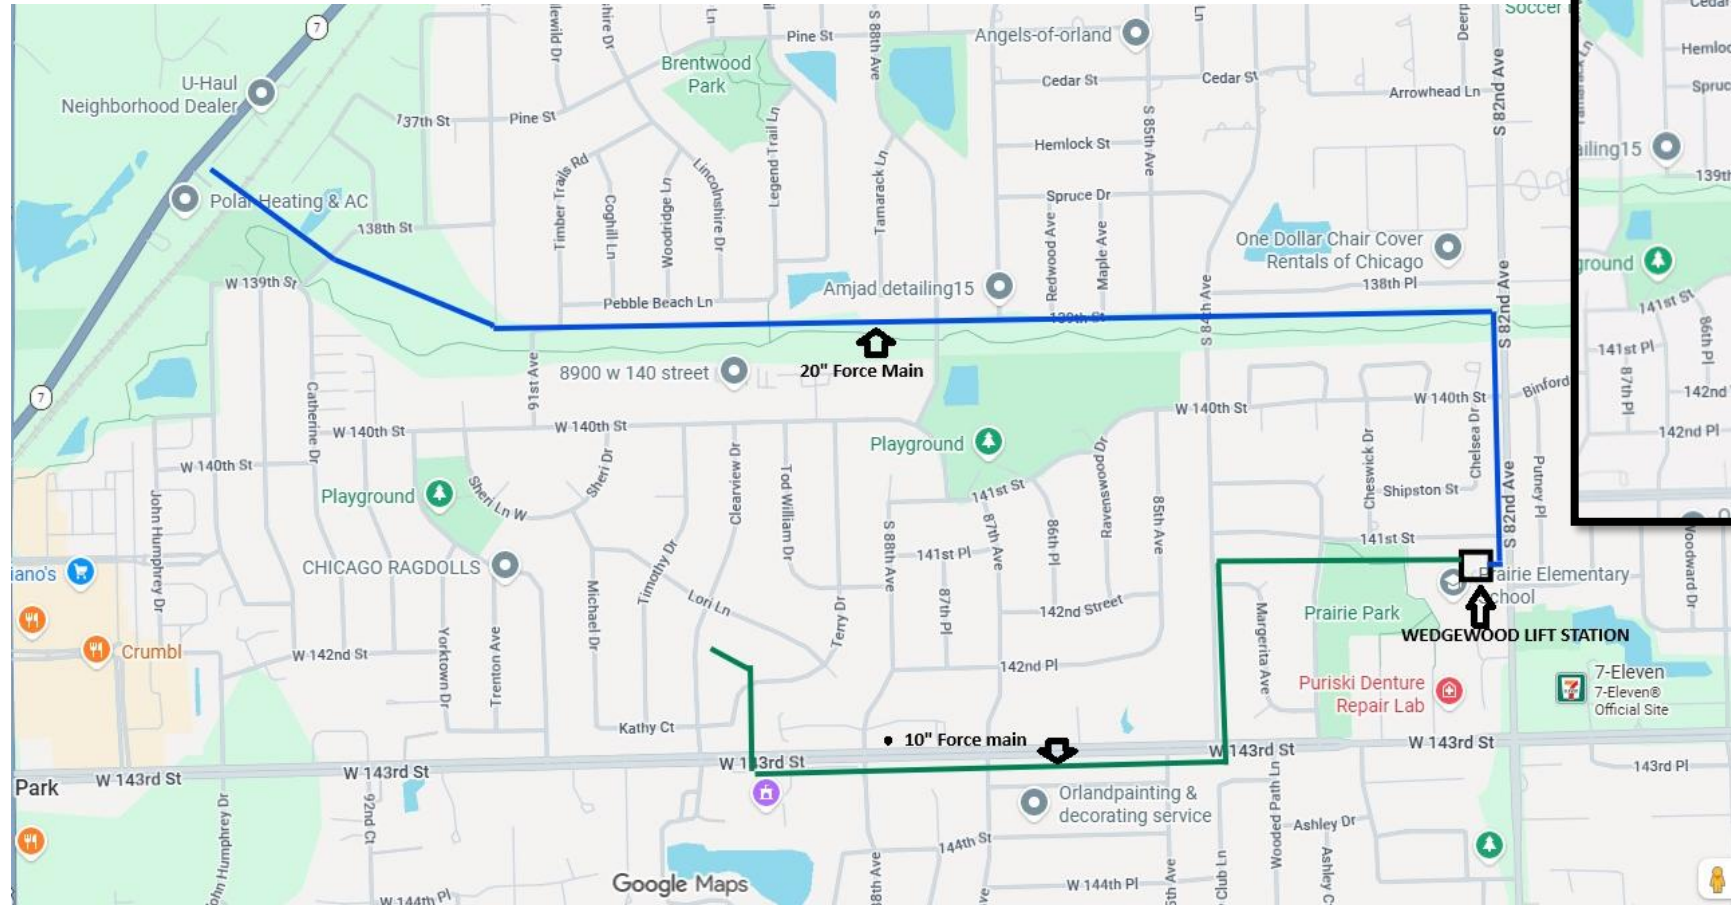
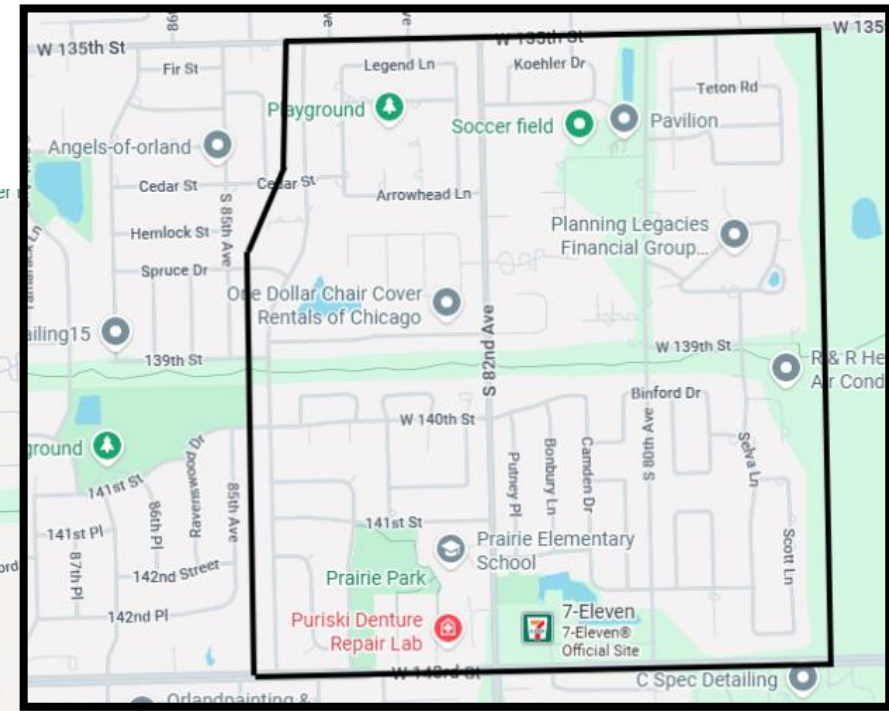
## WedgeWood Forcemain

**Wedgeood Lift Station: 20" is primary feed, 10" is emergency feed  
Both forcemains ultimate connect to MWRD Interceptor on Southwest highway**

Due to drop of elevation from ComEd easement to MWRD interceptor and to go under Railroad tracks, the force main transitions to a gravity main. This portion of the line (red box) is the area we are addressing in the repairs.
