## TYPICAL SIDEWALK

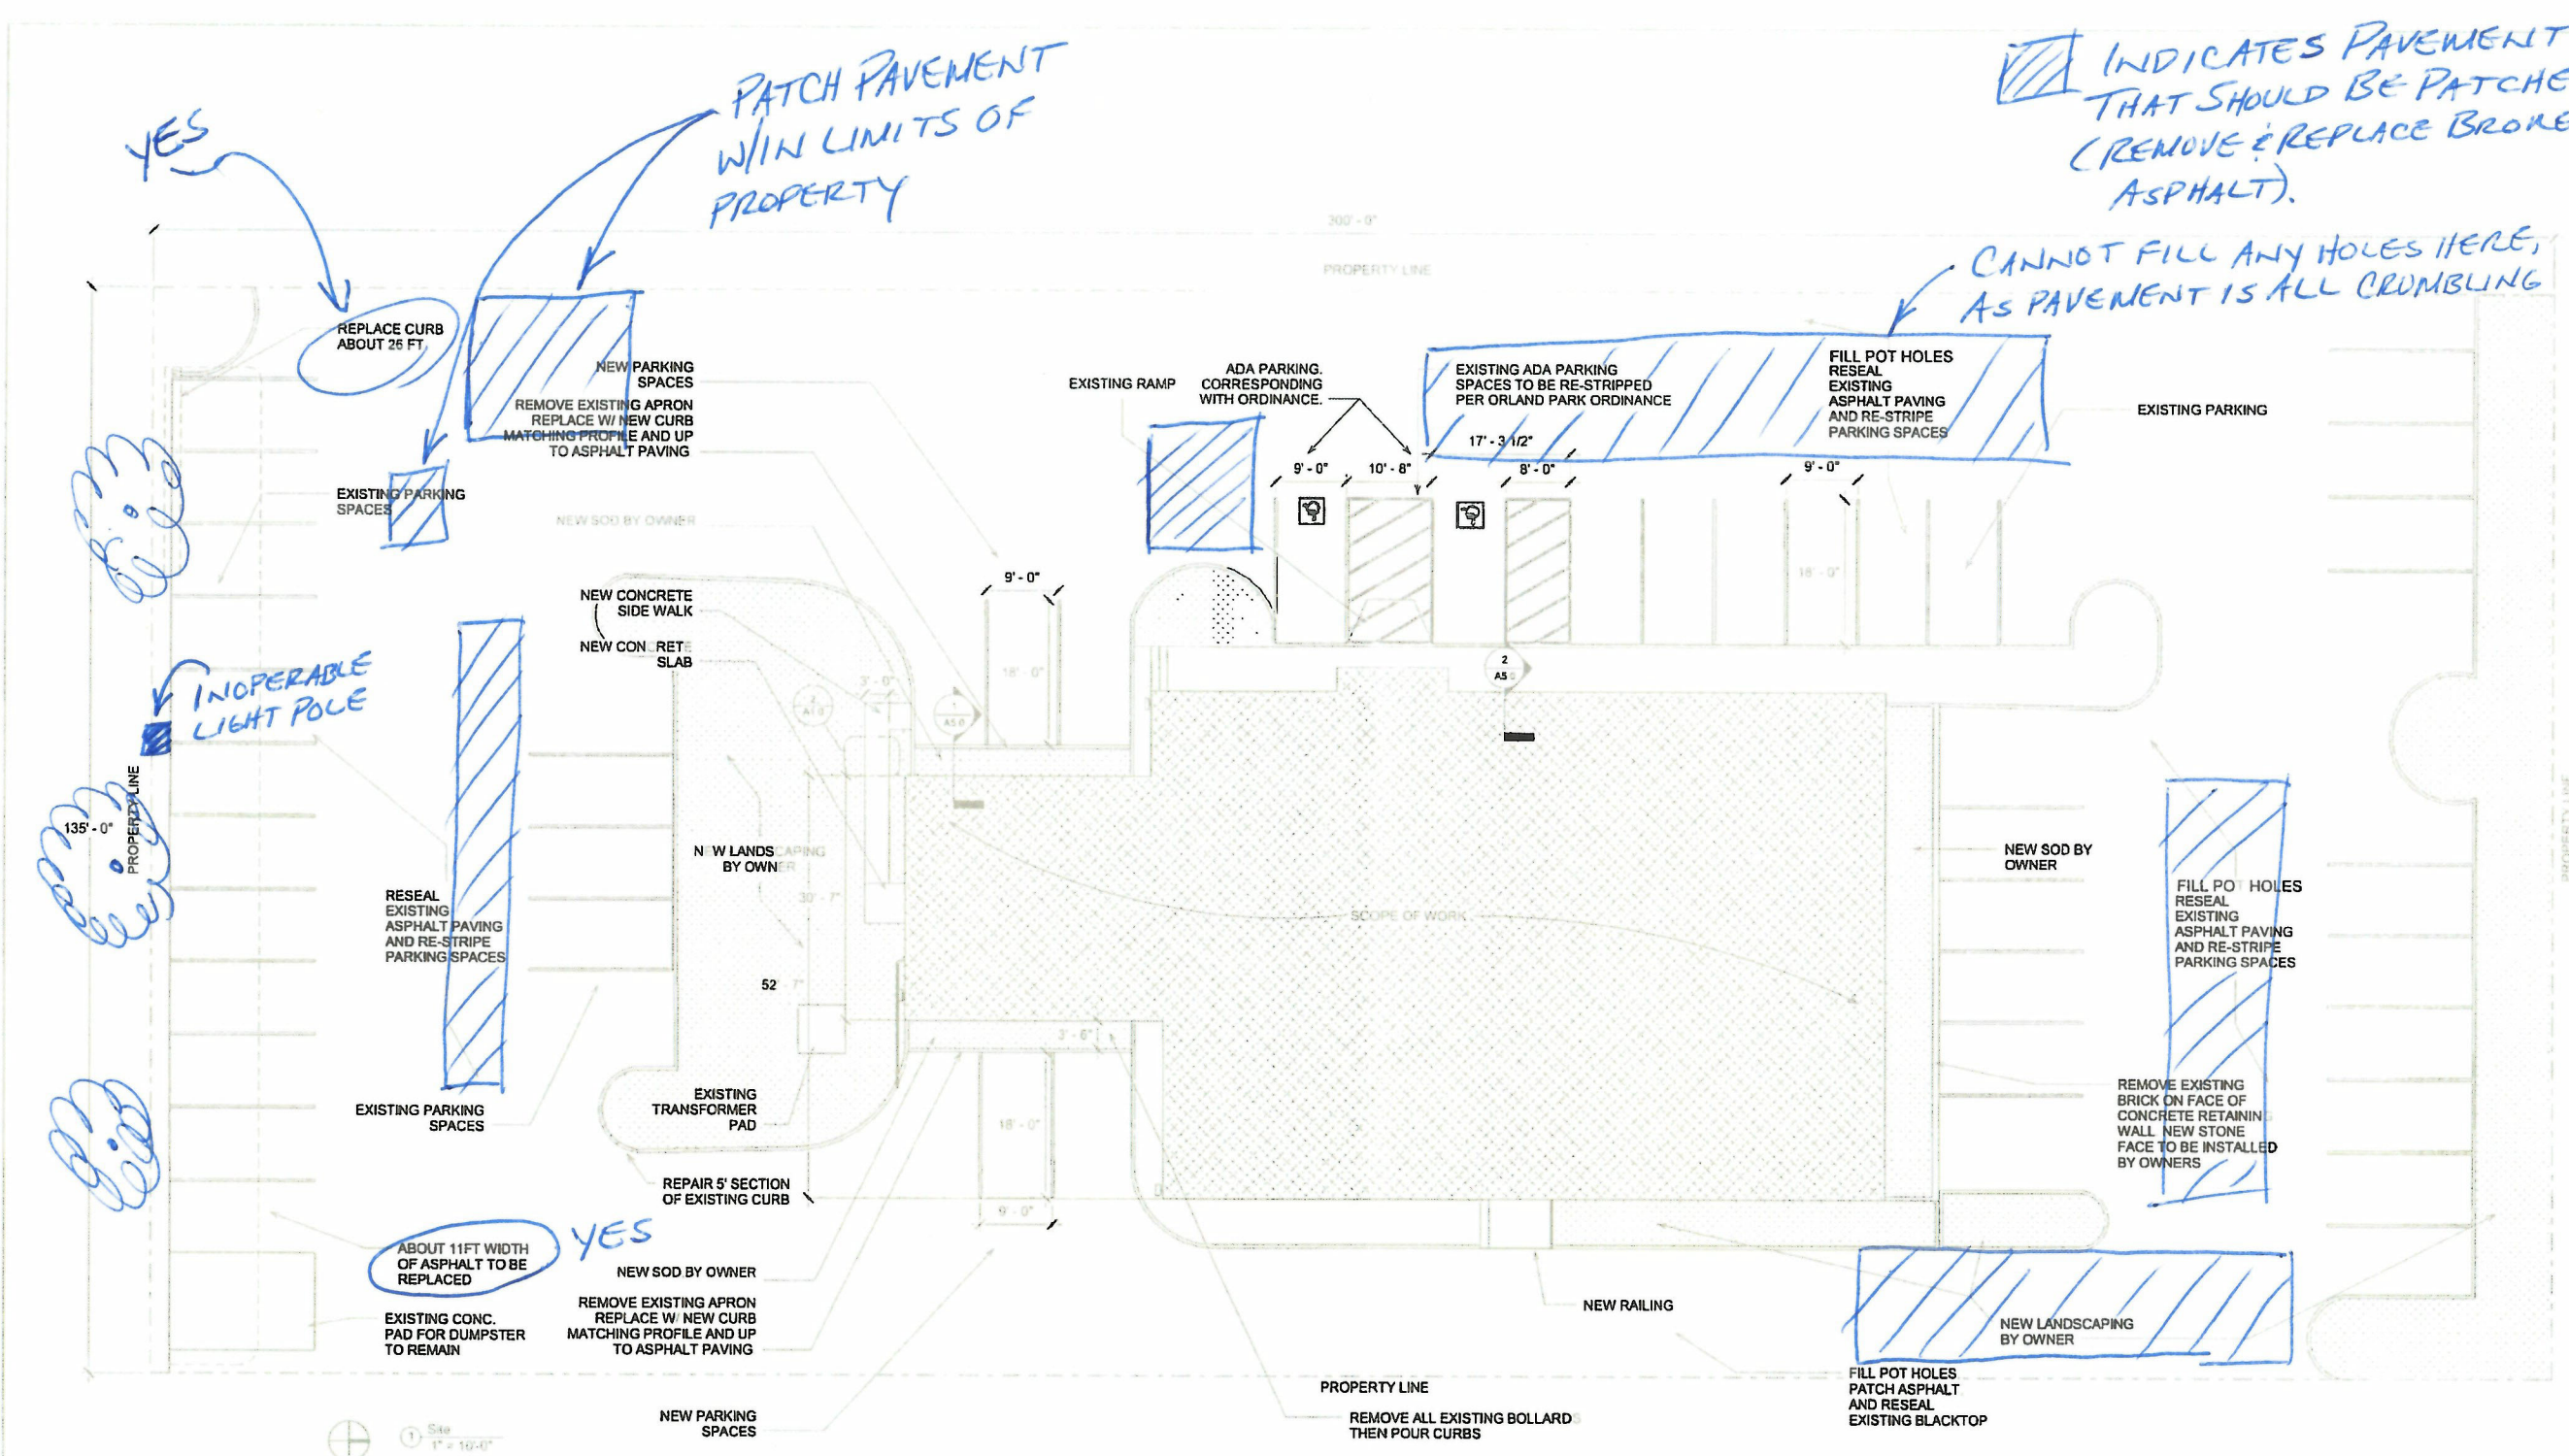
- NOTICED SEVERAL PARKING BLOCKS/WHEEL STOPS AROUND PARKING LOT. SINCE THE LOT IS CURBED, IT WOULD SEEM THESE BLOCKS SHOULD BE REMOVED.
- 3 SICK TREES @ SOUTH PROPERTY SHOULD BE REMOVED.
- REMOVE INOPERABLE LIGHT POLE & BASE FOUNDATION.

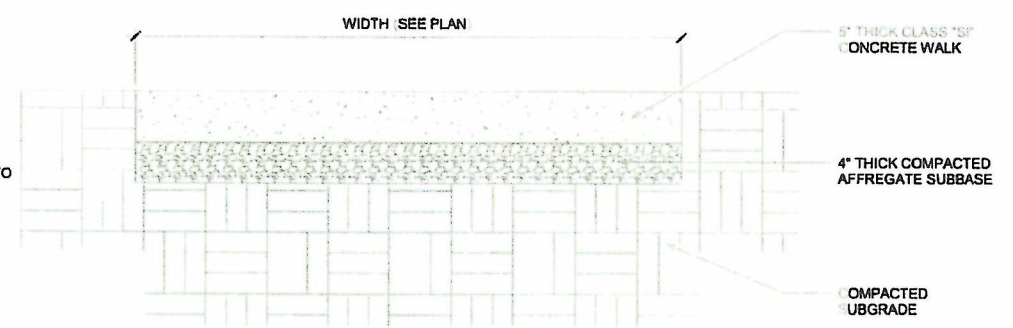
2 Site - Callout 1  
1 1/2" = 1'-0"

- NOTES**
1. SURFACE TO BE A LIGHT BROOM FINISH AT RIGHT ANGLES TO THE EDGE OF THE SIDEWALK
  2. ASPHALTIC FELT EXPANSION JOINTS SHALL BE PROVIDED 30FT O.C. WITH 1/2" DEEP CONTROL (FALSE) JOINTS 5FT O.C.
  3. SIDEWALK THROUGH ENTRANCE SHALL BE 6" THICK WITH 6x6xW1 4xW1 4 WWF
