# THORNTON EQUIPMENT SERVICES, INC.

Village of Orland Park  
Mill Creek Pond Slope Stabilization

Oct. 19, 2015

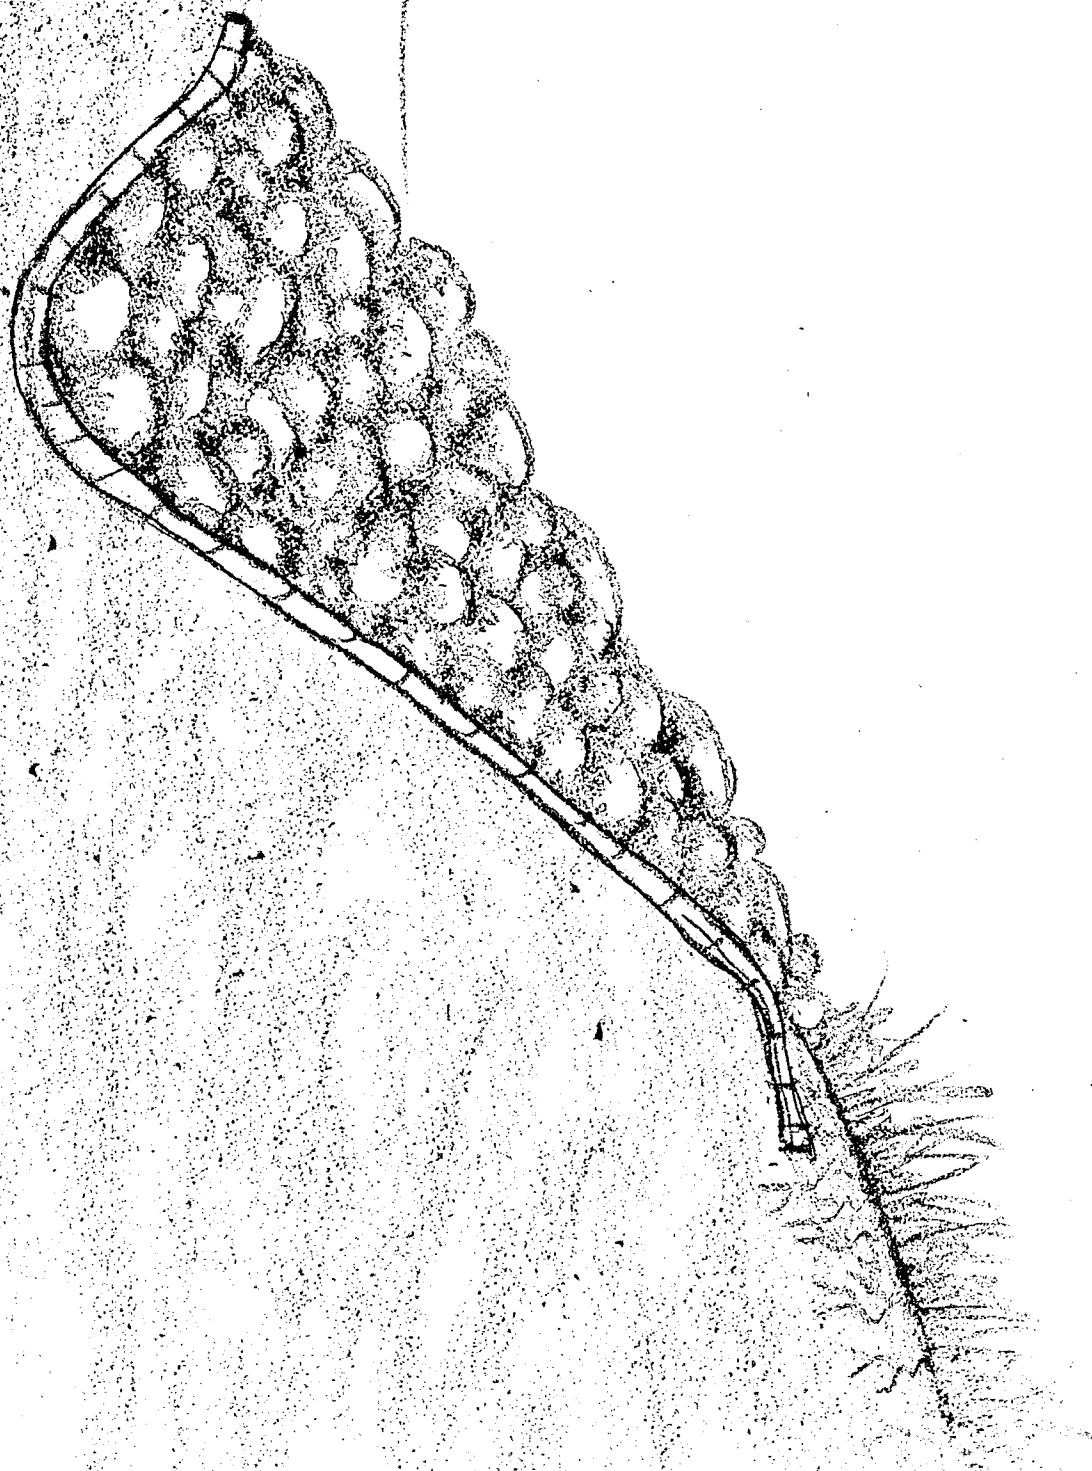
Rip-RAP and FILTER FABRIC STRUCTURE

**-West Slope:** Install 2" x 9" rip-rap on filter fabric to the top of the cut bank at overflow elevation. \* 1 150' @ \$75.00 per lf. = \$11,250.00

**-East Slope:** Install 2" x 9" rip-rap on filter fabric to the top of the cut bank at overflow elevation. \* 1 150' @ \$75.00 per lf. = \$11,250.00

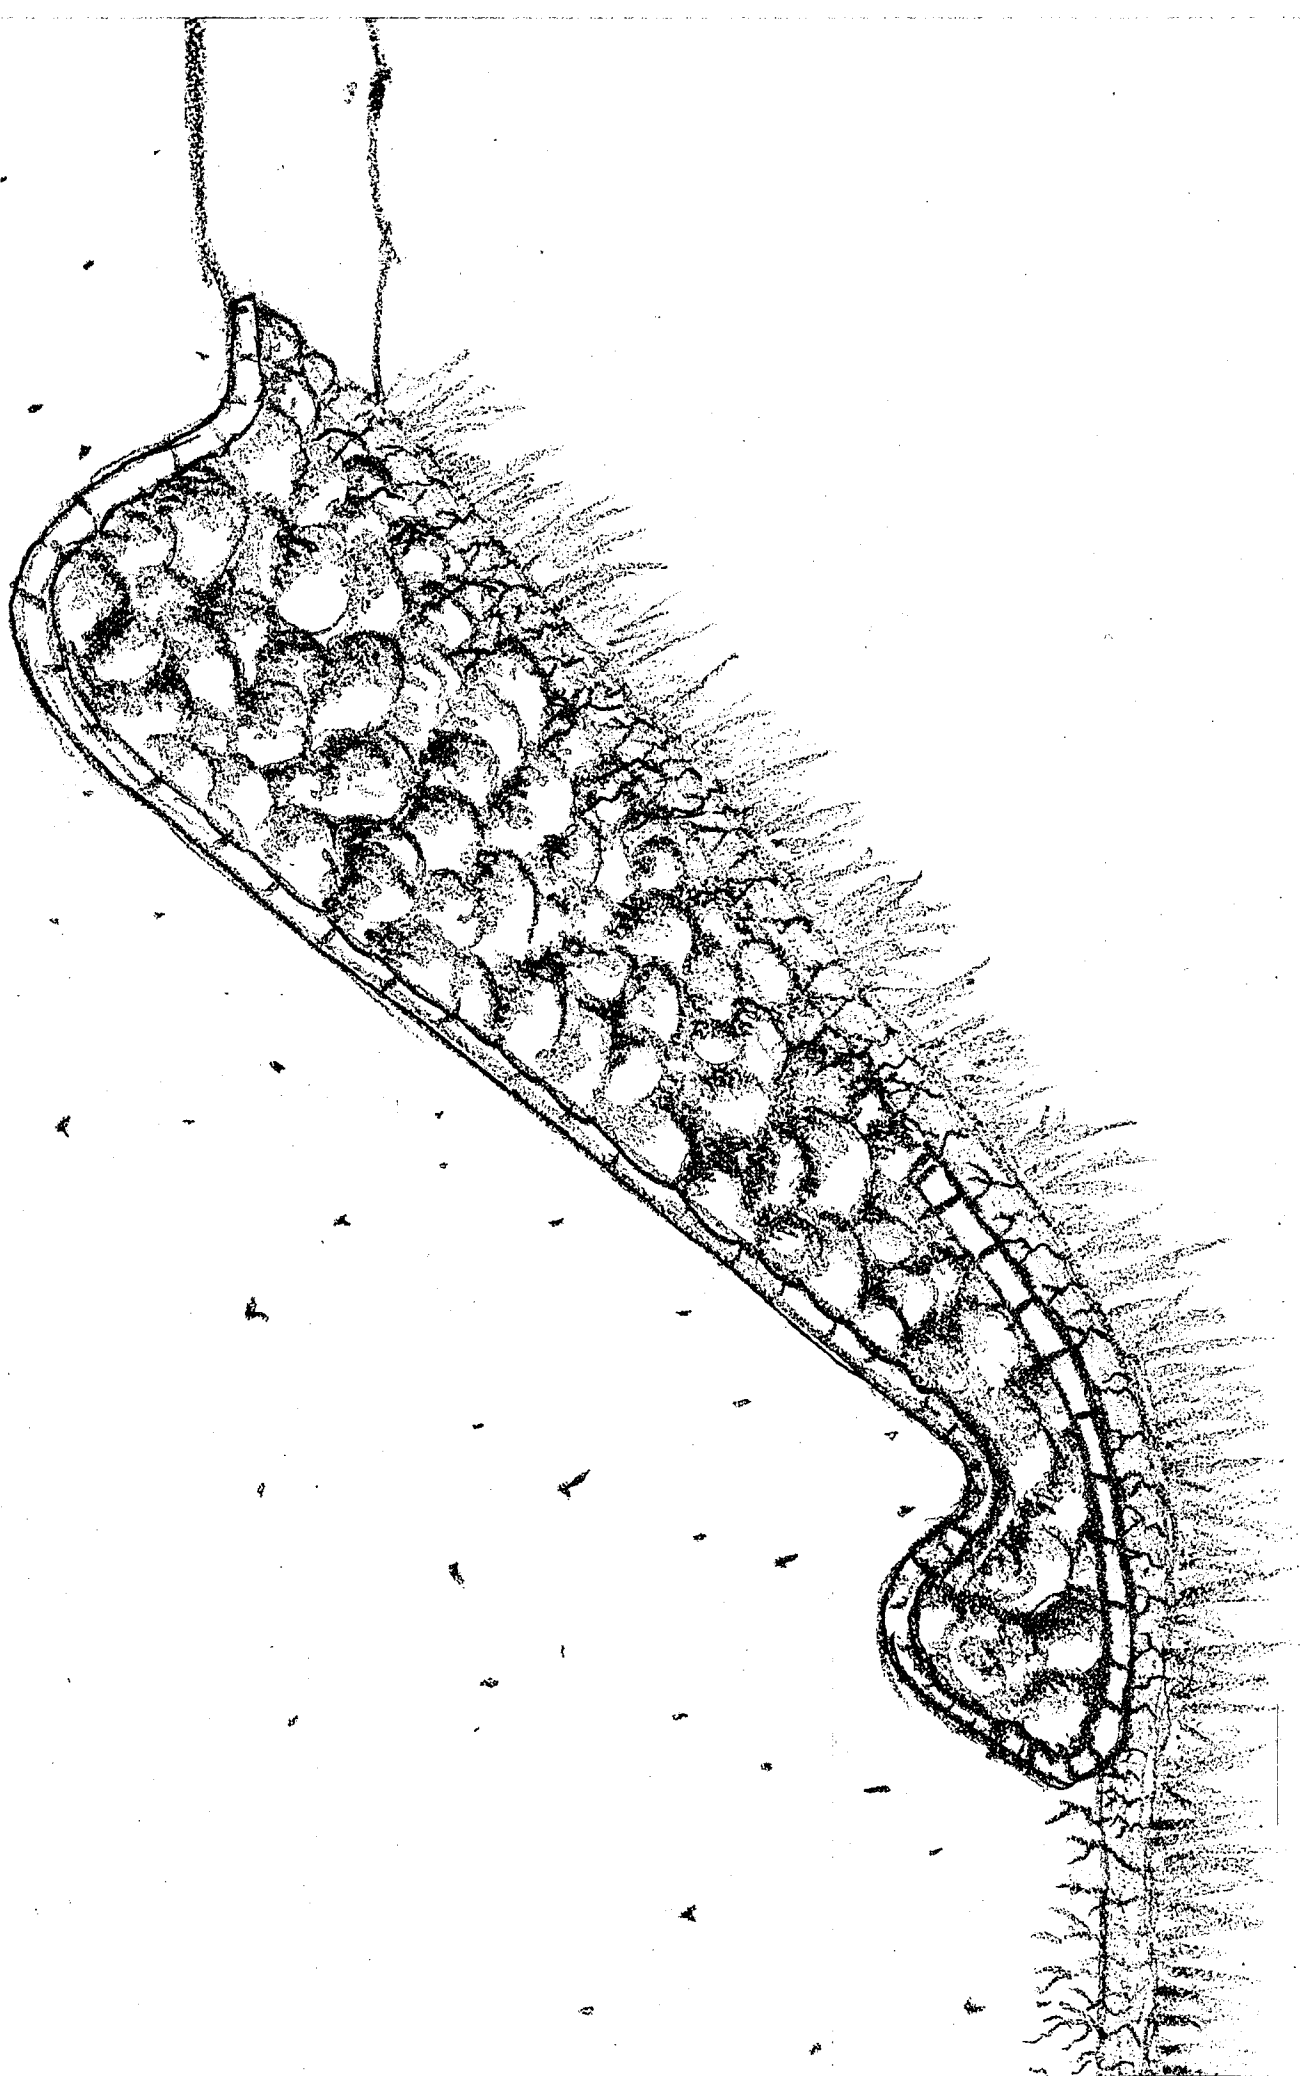
VEGETATED RIP-RAP STRUCTURE (ALTERNATE)

**-West Slope Alternate:** Install vegetated rock bank using filter fabric filled with rip-rap, C350 erosion blanket filled with topsoil, seeded with IDOT Class 3 slope stabilization mix topped with S-75 straw blanket \* 2 150' @ \$112.50 per lf. = \$16,875.00

**-East Slope Alternate:** Install vegetated rock bank using filter fabric filled with rip-rap, C350 erosion blanket filled with topsoil, seeded with IDOT Class 3 slope stabilization mix topped with S-75 straw blanket \* 2 150' @ \$112.50 per lf. = \$16,875.00
