# ROOF DIAGNOSTIC SURVEY FOR: CITY OF ORLAND PARK

15655 S Ravinia Ave - ORLAND PARK, IL

SHEET A-1 CITY OF ORLAND PARK - MOISTURE SURVEY

## 2020 VILLAGE OF ORLAND PARK ROOFING PROJECT

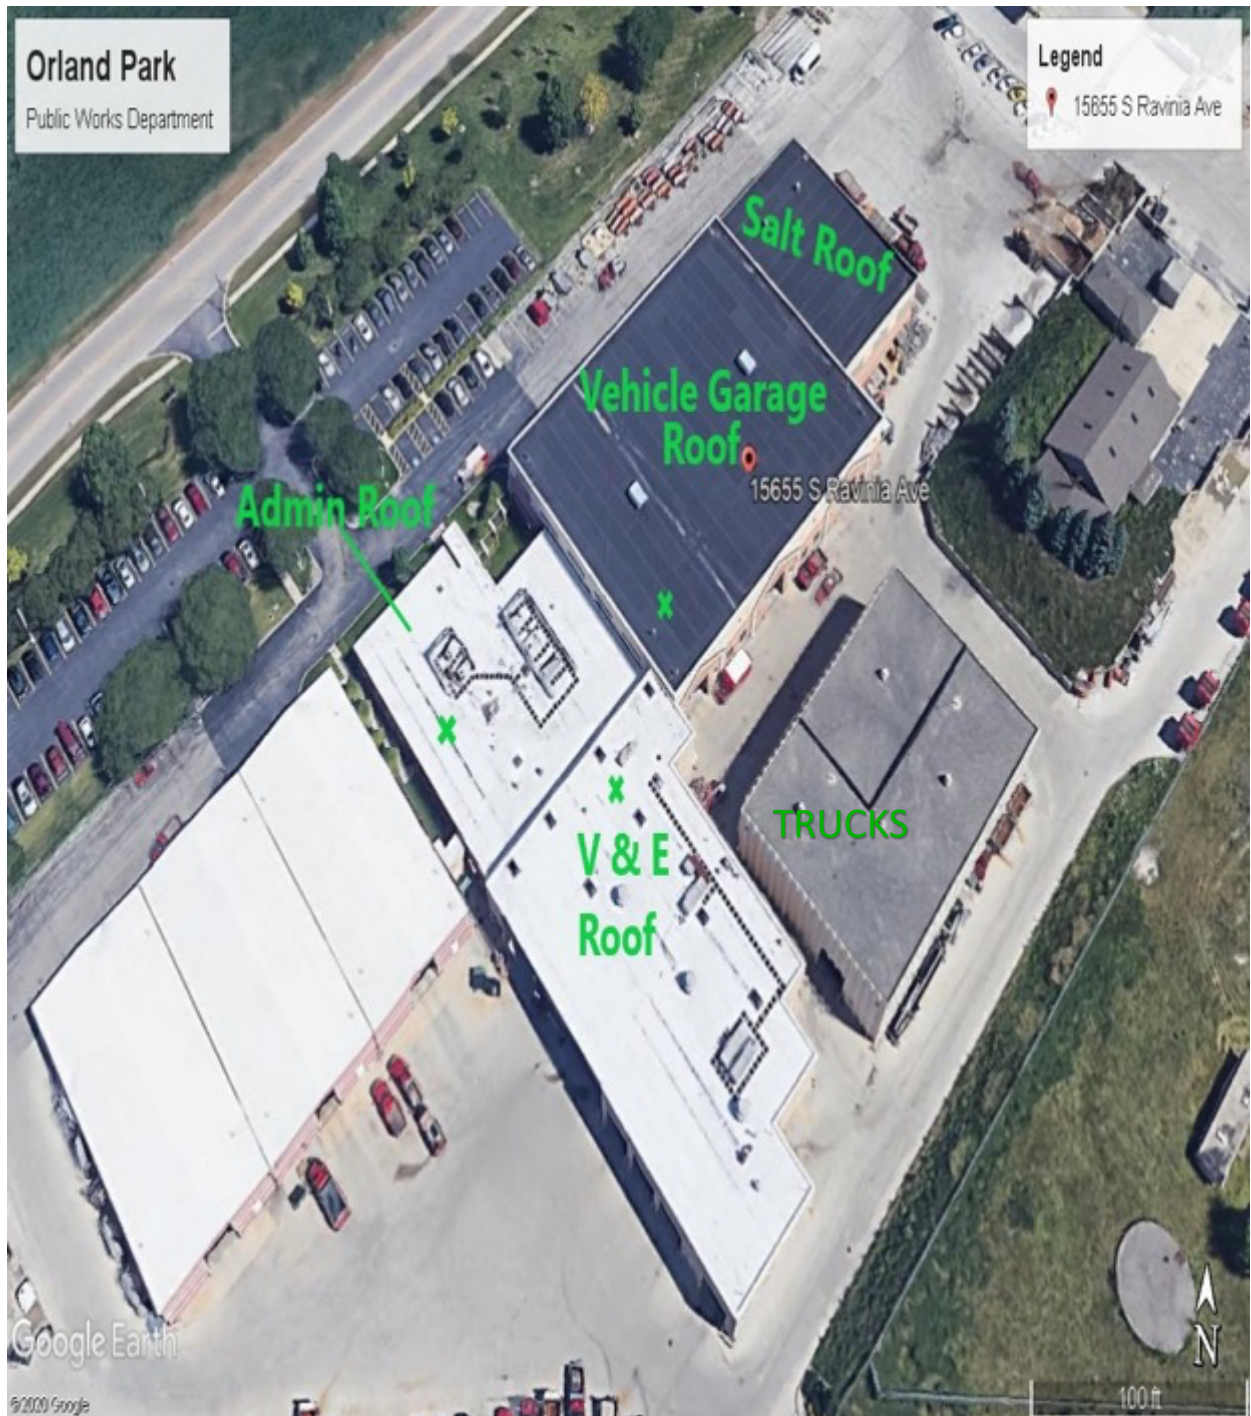
## MAP

Green X indicates roof core locations

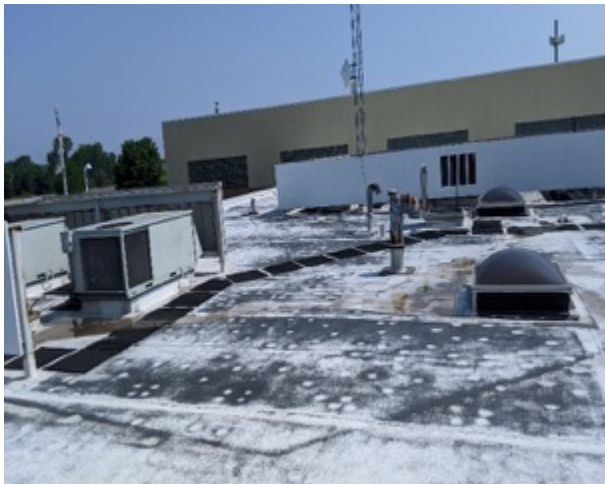
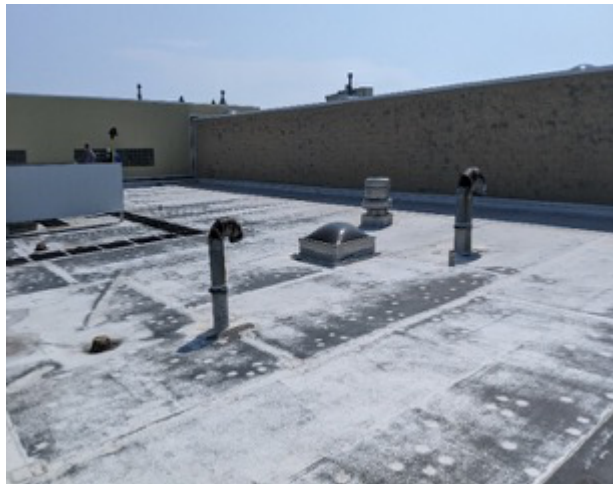
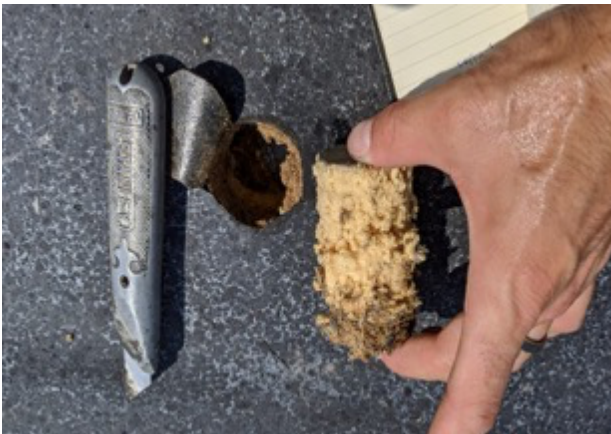
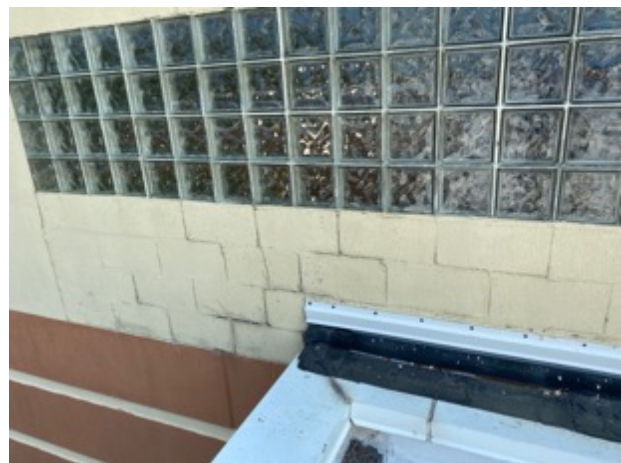
Section: **Admin Roof**  
Membrane: Adhered EPDM w/ coating  
Coverboard: Yes  
Insulation: 2.5" ISO, .5" Wood fiber Cover board  
Wet? Moisture present  
Deck type: Metal  
Size: Approx. 13,130 ft<sup>2</sup>  
Leaking: Yes  
Slope: Approximately ¼" per foot  
Drainage: Internal drains

Core sample- 2.5" iso .5 wood fiber

- Remove existing walk pads and mark their location for new walkways.
- Cut out wet areas and repair with same size insulation and fully adhered EPDM. Strip into existing field membrane at cut joints using 6" wide cured cover strip.

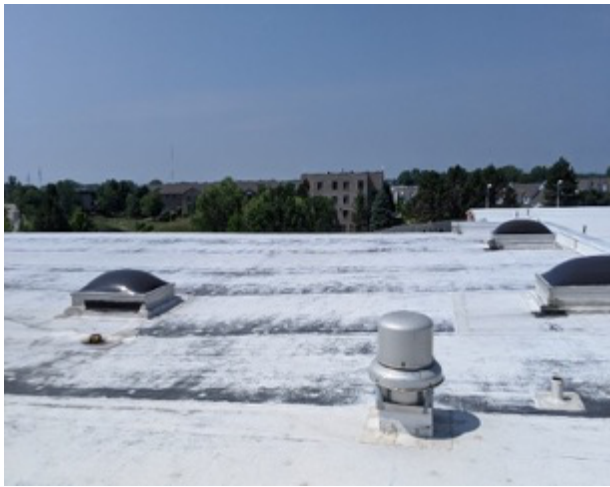
Overview

| Section: | <b>V &amp; E Roof</b> |
| Wet? | Moisture present |
| Leaking: | Yes |

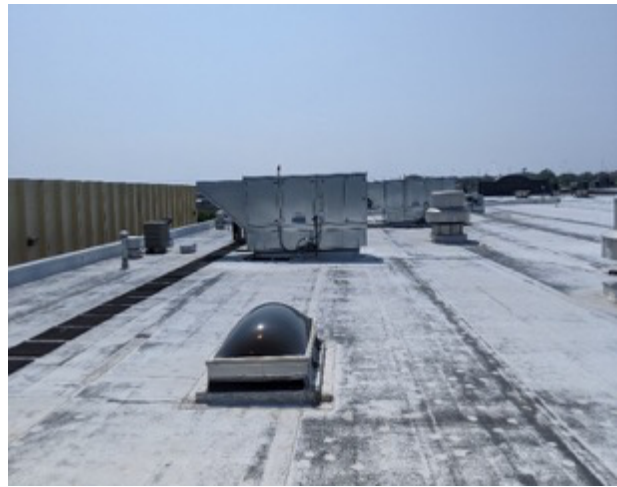
Overview

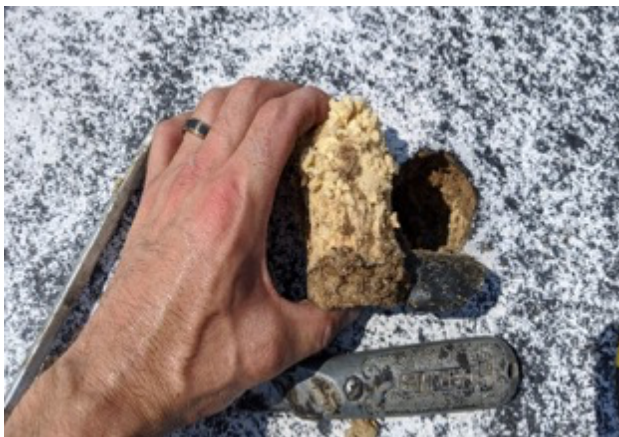
Core sample- 2.5" Iso, .5" Wood fiber cover board

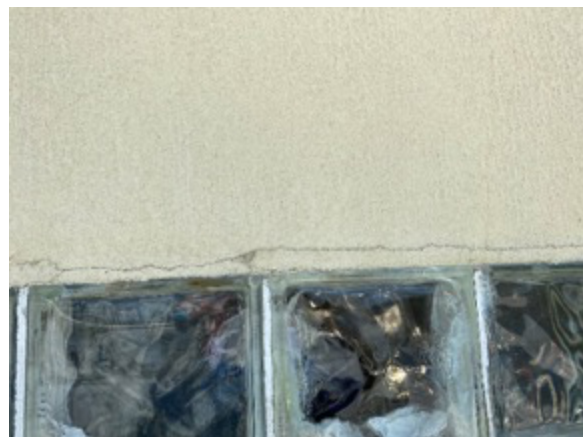
Large crack across the top of the window

- EIFS and Masonry Walls: cracks and open mortar joints are visible in the wall substrates. Power wash loose paint/coating from surface, prime with Solarguard primer, coat with Solarguard masonry coating.
