# THORNTON EQUIPMENT SERVICES, INC.

Village of Orland Park  
Mill Creek Pond Slope Stabilization

Oct. 19, 2015

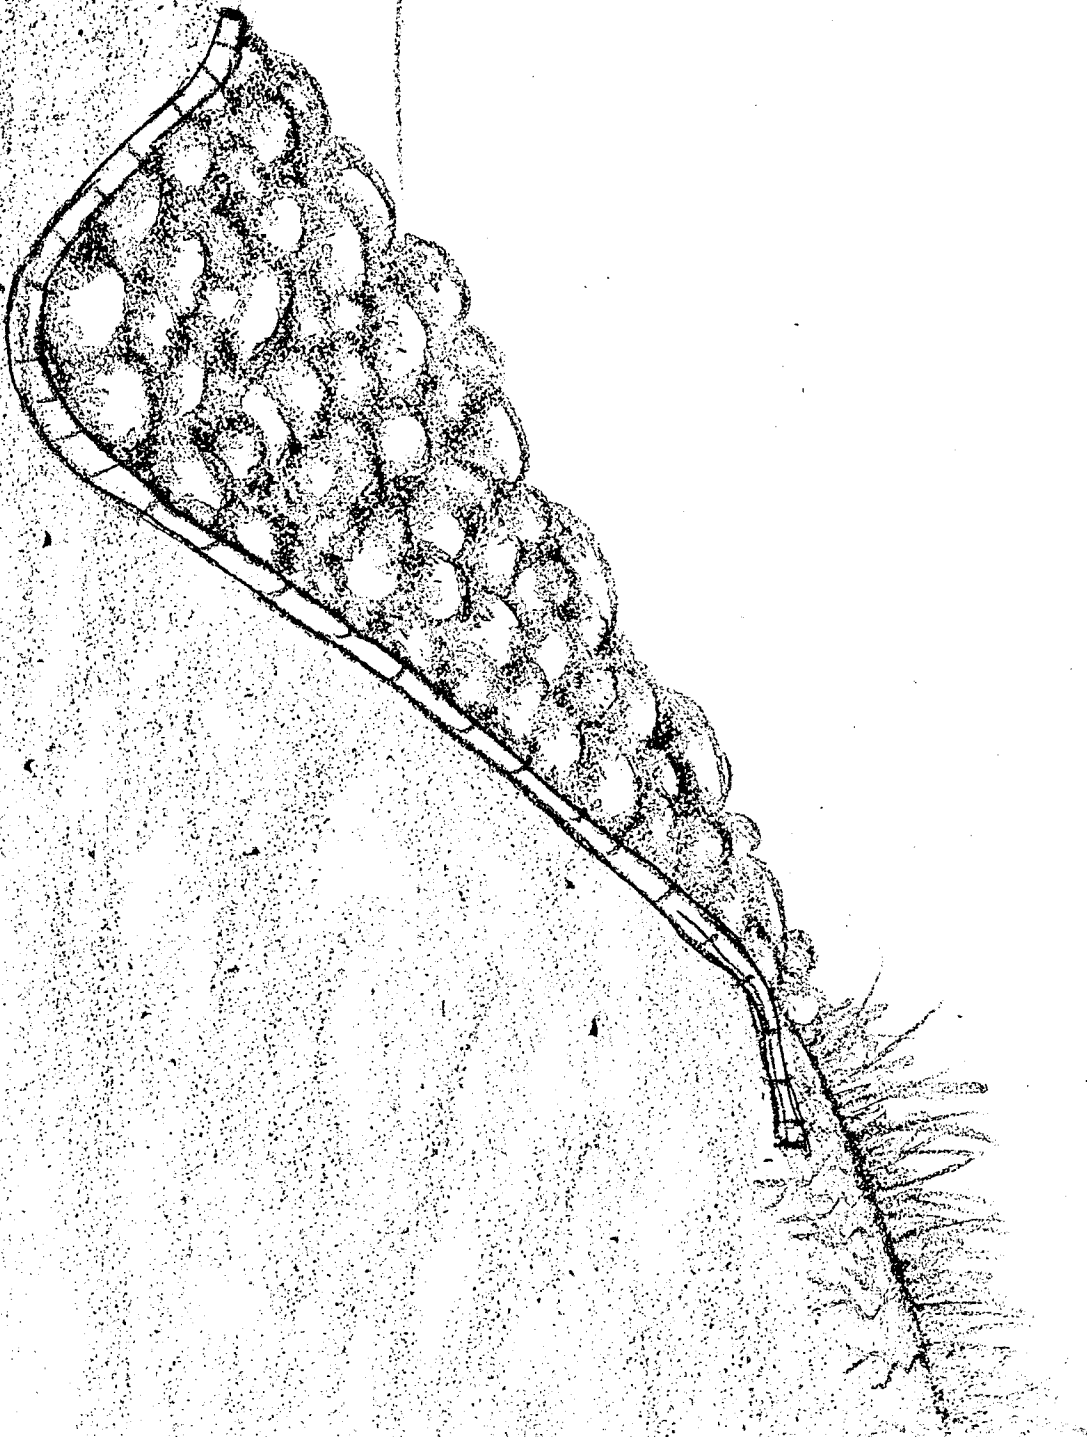
RIP-RAP AND FILTER FABRIC STRUCTURE

**-West Slope:** Install 2" x 9" rip-rap on filter fabric to the top of the cut bank at overflow elevation. \* 1 150' @ \$75.00 per lf. = \$11,250.00

**-East Slope:** Install 2" x 9" rip-rap on filter fabric to the top of the cut bank at overflow elevation. \* 1 150' @ \$75.00 per lf. = \$11,250.00

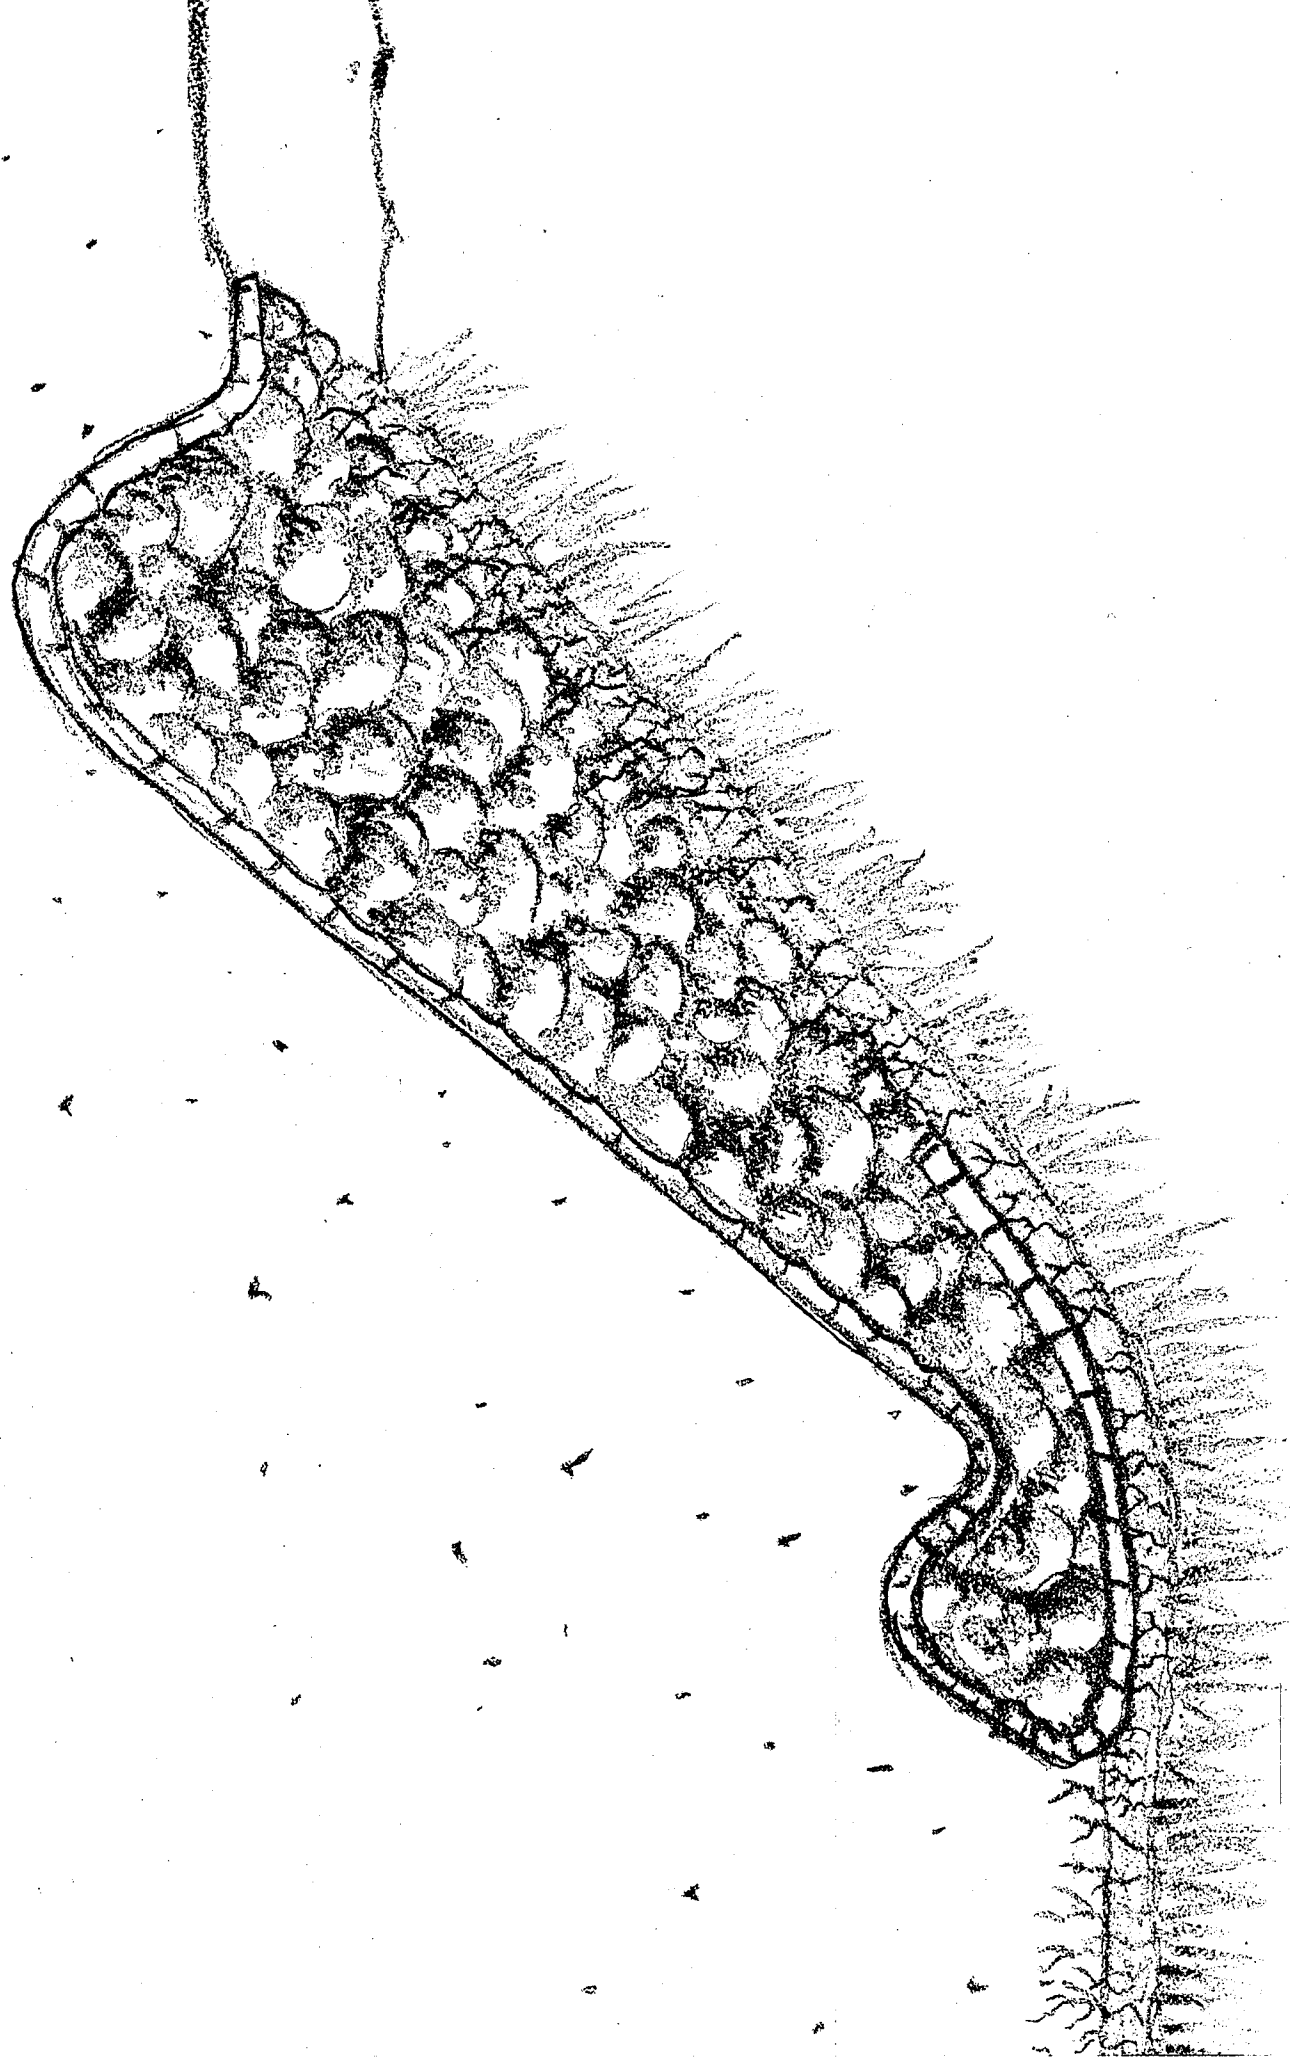
VEGITATED RIP-RAP STRUCTURE (ALTERNATE)

**-West Slope Alternate:** Install vegetated rock bank using filter fabric filled with rip-rap, C350 erosion blanket filled with topsoil, seeded with IDOT Class 3 slope stabilization mix topped with S-75 straw blanket \* 2 150' @ \$112.50 per lf. = \$16,875.00

**-East Slope Alternate:** Install vegetated rock bank using filter fabric filled with rip-rap, C350 erosion blanket filled with topsoil, seeded with IDOT Class 3 slope stabilization mix topped with S-75 straw blanket \* 2 150' @ \$112.50 per lf. = \$16,875.00
