# Storm Water Detention Basins Maintenance Program

Committee of the Whole  
6.02.2025

# Comprehensive Update

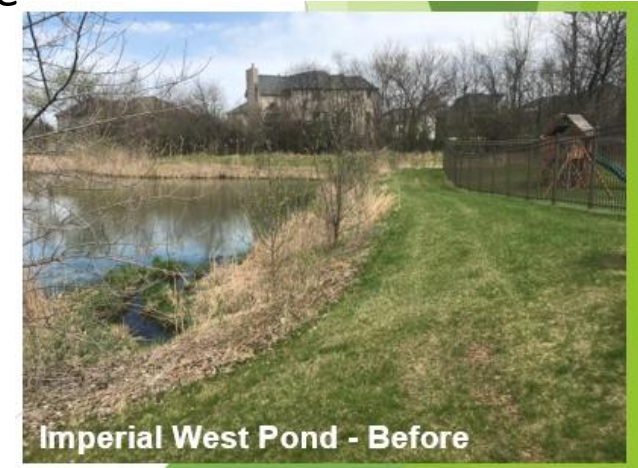
- February 2011, Village adopted Basin Best Practices Program (BBPP) to create a unified approach for restoration and stabilization of stormwater basin shorelines.
- Goals:
  - Establish a comprehensive Village-wide approach to water and basin shoreline management
  - Provide consistency in expectations among all stakeholders
  - Utilize the right resources at the right time provided by the best qualified parties
  - Follow industry best practices for ecological restoration and maintenance
- Progress:
  - At onset of program, 24 basins identified for shoreline restoration
  - Currently, 121 of basin are managed with the assistance of qualified ecological restoration contractors

- The primary approach: Use of native vegetation versus "hard edge" techniques such as sheet piling or stone riprap.
  - Sheet piling or stone riprap are costly to install and maintain
  - Native grasses/forbs proven to provide excellent means of erosion control and have been shown to filter out nutrient and sediment runoff from adjacent land, which contributes to improved water quality
  - The USEPA, US Army Corps of Engineers, the Morton Arboretum and the Chicago Botanic Garden utilize native plantings
- Benefits:
  - Protect shorelines from erosion
  - Provide and improve habitat for fish and other wildlife
  - Improve water quality and filter nutrients/sediments
  - Attract natural wildlife
  - Increase shoreline stability
  - More resilient than hard edge shorelines over time

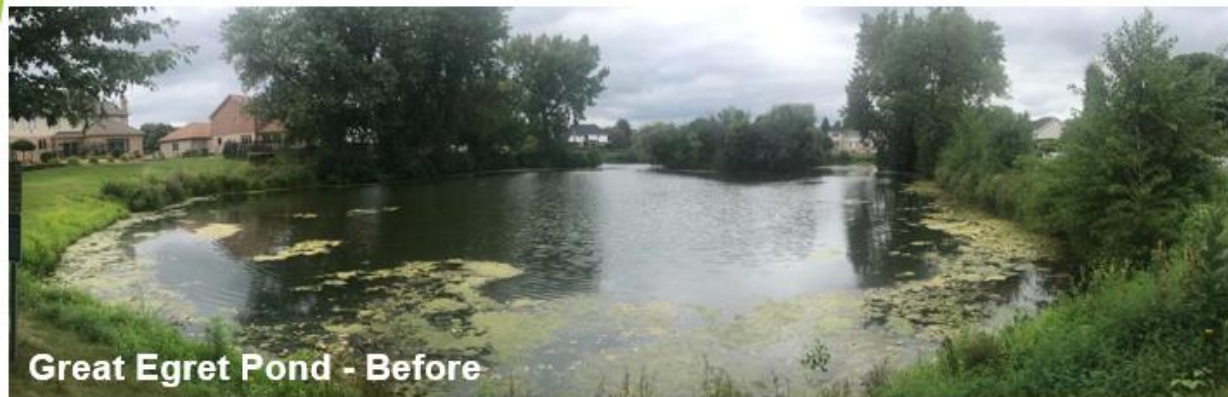
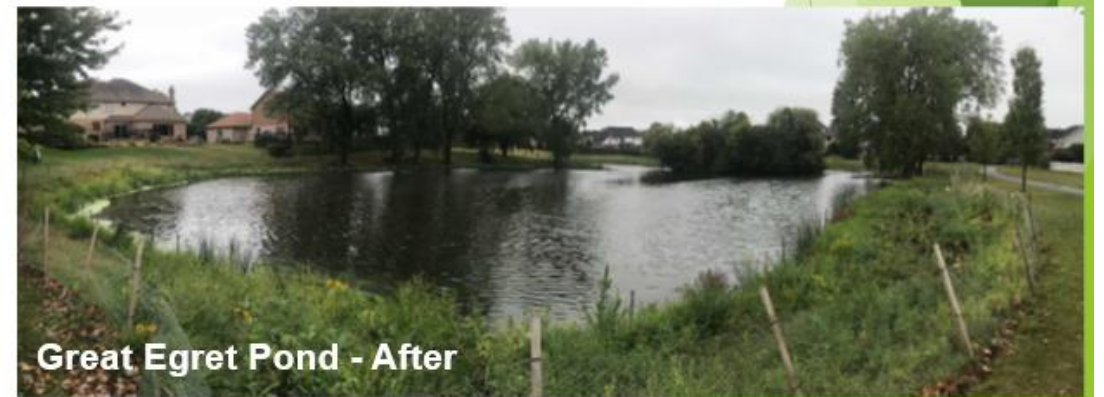
- Shoreline restoration projects include:
  - Establishment period (2-3 years):
    - Existing turf grass or invasive vegetation is removed and the establishment of native plant species begins. Occasional regrading of pond slopes also occurs at sites where substantial erosion or scouring has occurred. Additional work includes goose protection and seed/blanket.
  - A multi-year stewardship (maintenance) program follows:
    - Shoreline stewardships include the control of invasive woody and herbaceous flora through cultural methods, physical removal or the application of appropriate herbicides.

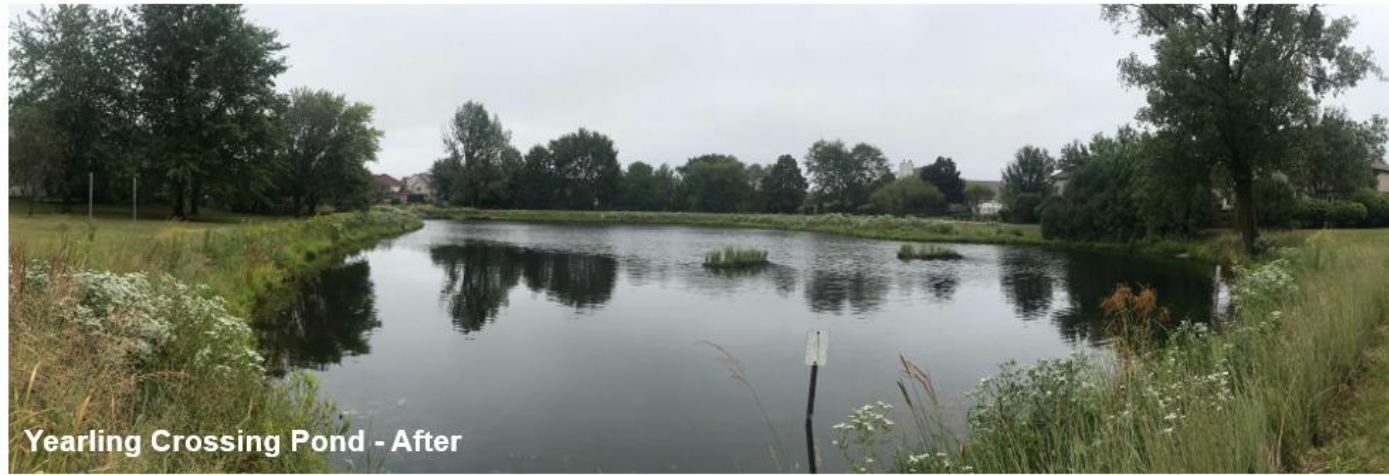
- The BBPP encourages the reduction of turf mowing areas around the stormwater basins throughout the Village. As turf grass provides little to no erosion control, bare spots, mower wheel tracks and toe of slope scour are often observable.
- Village's Land Development Code currently requires a minimum of 15' of native shoreline plantings, also known as buffer yards, around all new stormwater basins (Section 6-305.D.8), with the intent of establishing resilient shorelines and hopefully avoiding the need for future restoration projects. A turf grass shoreline is no longer permitted.
