EXTERIOR DESIGN ELEMENTS

El Cameno Retail Center | Orland Park

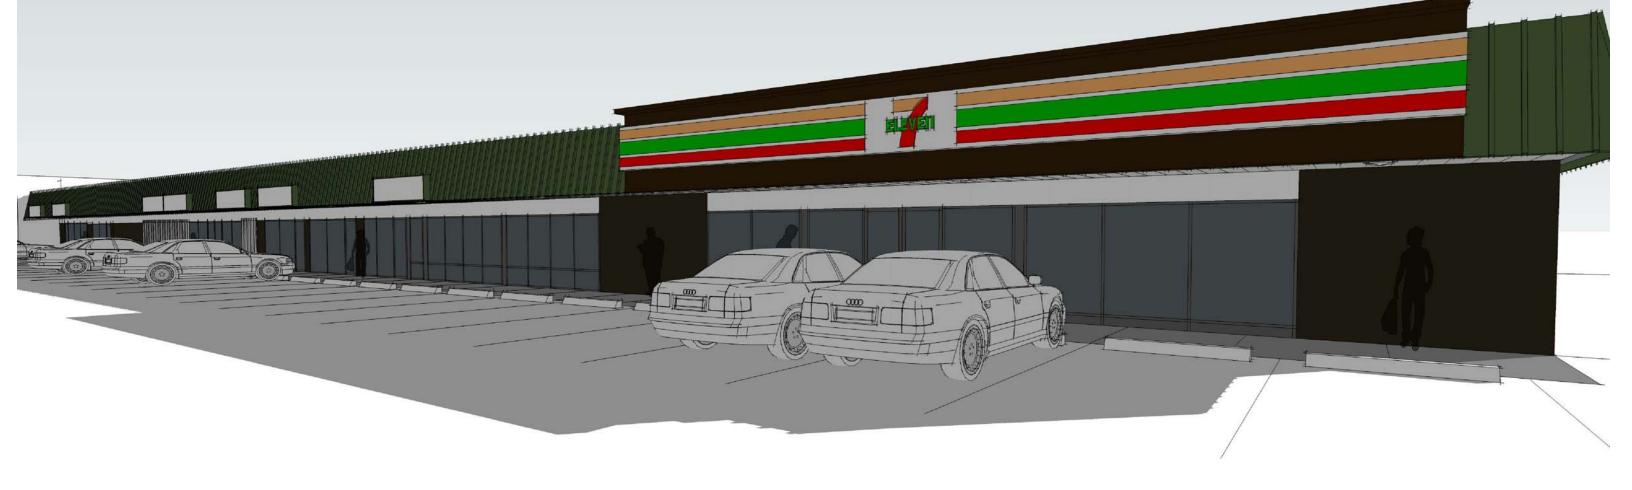
proposed exterior - northwest corner

- existing mansard metal panel to be removed and replaced with new, batten seam metal roofing, prefinished in dark green
- existing brick to be repaired, cleaned, and tuckpointed
- existing canopy ceiling to be covered with new flush metal soffit panel prefinished in white
- existing wood siding and headers above storefront to be painted to white
- existing lighting to be replaced with high efficiency, low maintenance LED light fixtures
- existing tenant signage to be repaired and refinished to match adjacent roofing panels

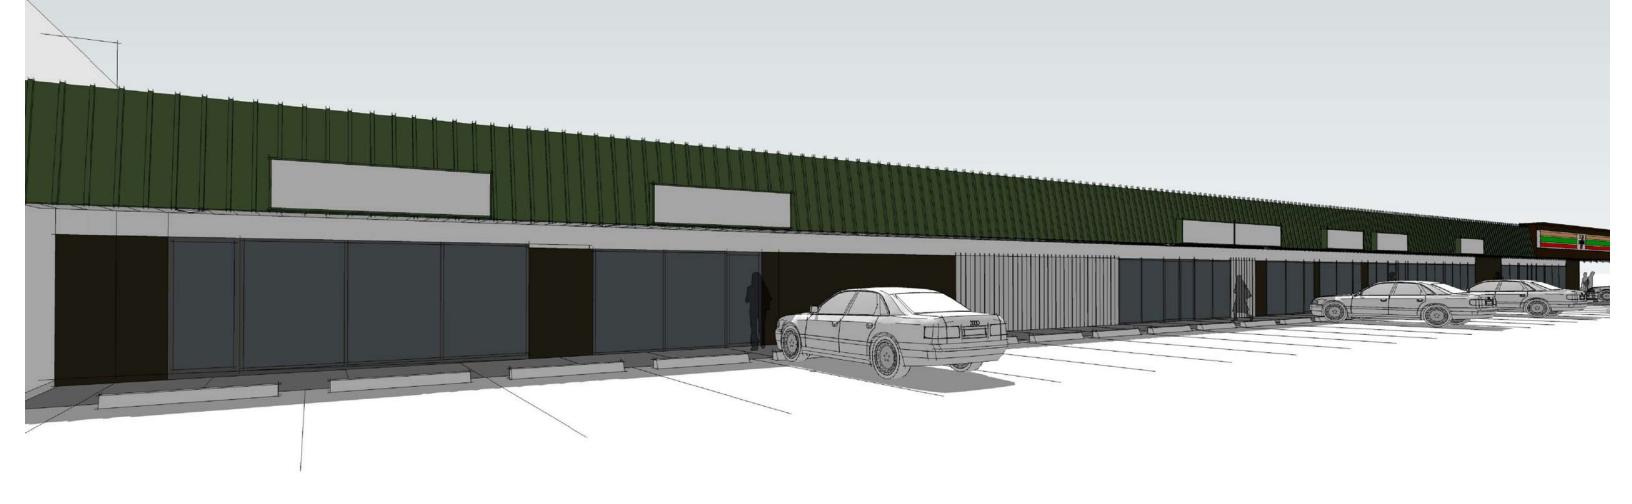
proposed exterior - northeast corner

- existing mansard metal panel to be removed and replaced with new, batten seam metal roofing, prefinished in dark green
- existing brick to be repaired, cleaned, and tuckpointed
- existing canopy ceiling to be covered with new flush metal soffit panel prefinished in white
- existing wood siding and headers above storefront to be painted to white
- existing lighting to be replaced with high efficiency, low maintenance LED light fixtures
- existing tenant signage to be repaired and refinished to match adjacent roofing panels

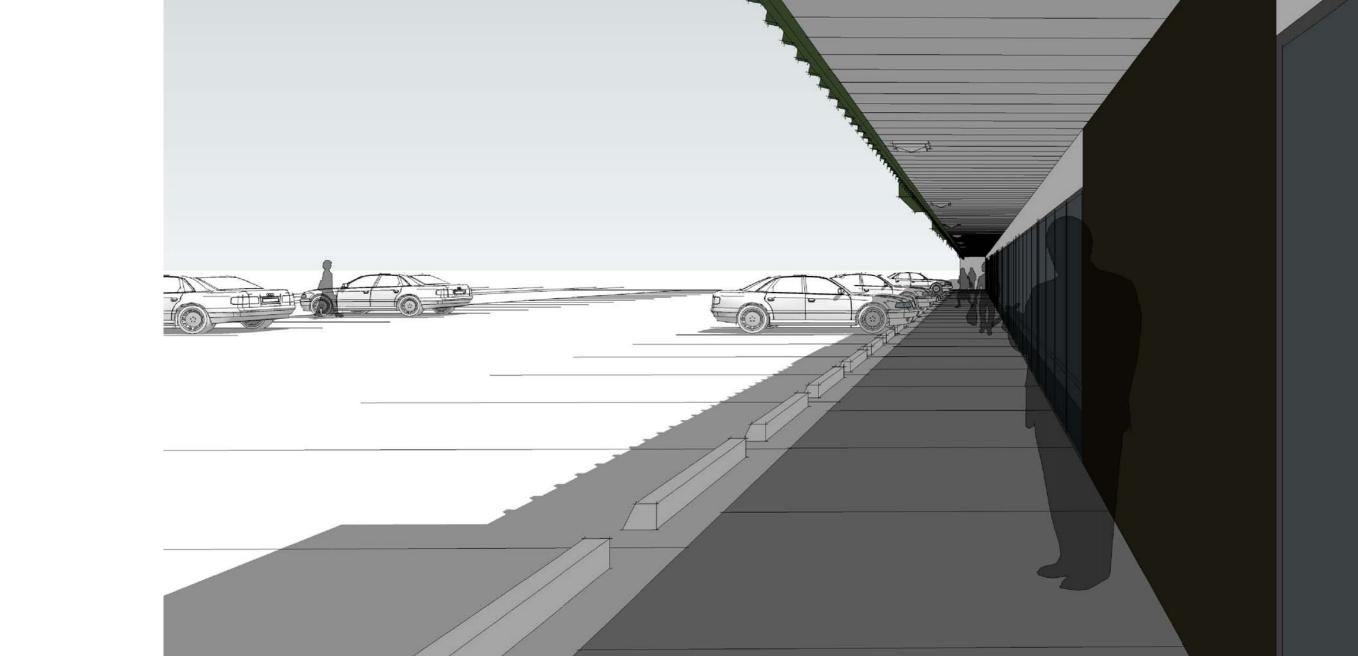
proposed exterior - under canopy

existing mansard metal panel to be removed and replaced with new, batten seam metal roofing, prefinished in dark green existing brick to be repaired, cleaned, and tuckpointed existing canopy ceiling to be covered with new flush metal soffit panel prefinished in white existing wood siding and headers above storefront to be painted to white existing lighting to be replaced with high efficiency, low maintenance LED light fixtures existing tenant signage to be repaired and refinished to match adjacent roofing panels
