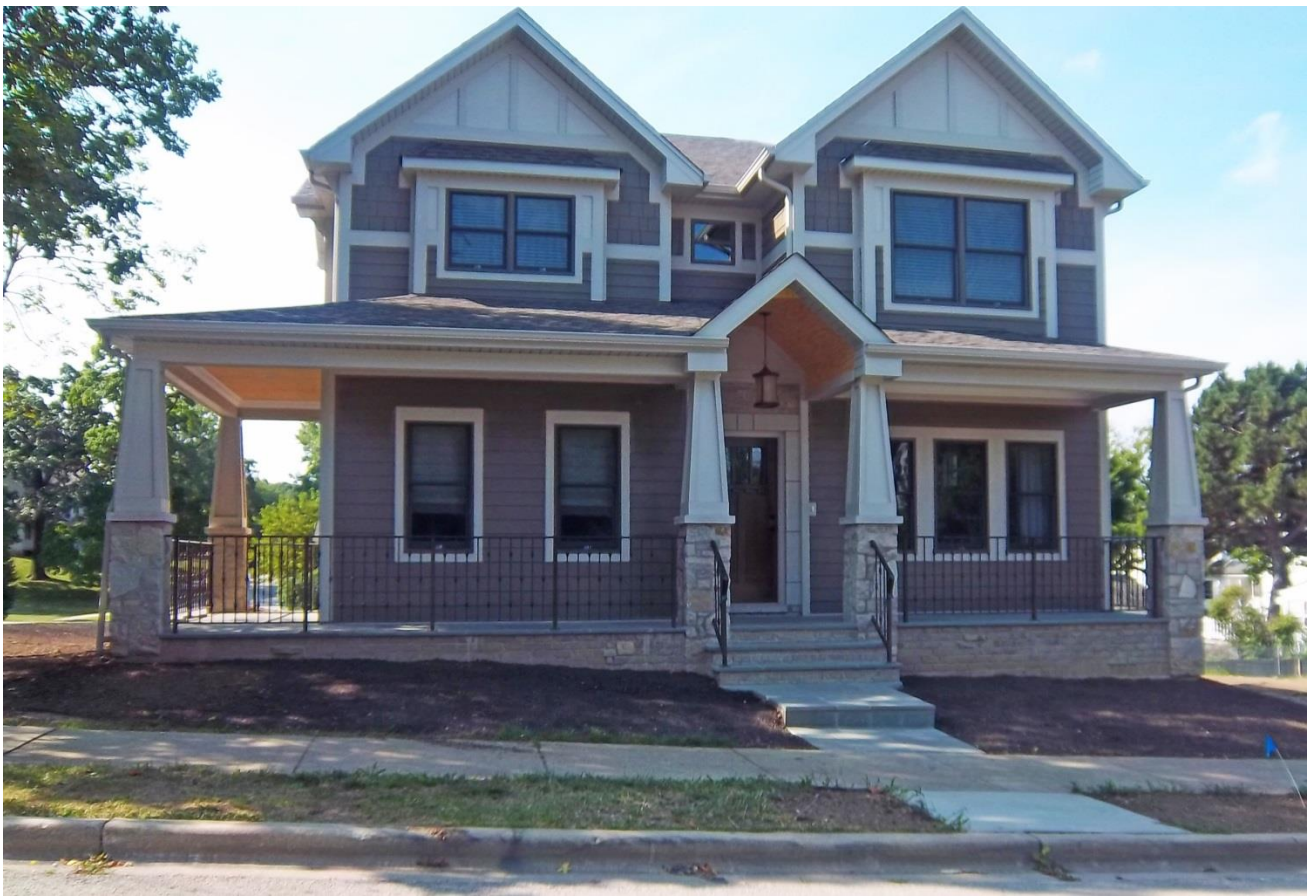
The 'fine' nature of the railing material, color, and design is lost in the mass of the homes attractive architecture. The appearance of the railing fades into the façade and almost makes the porch look incomplete.

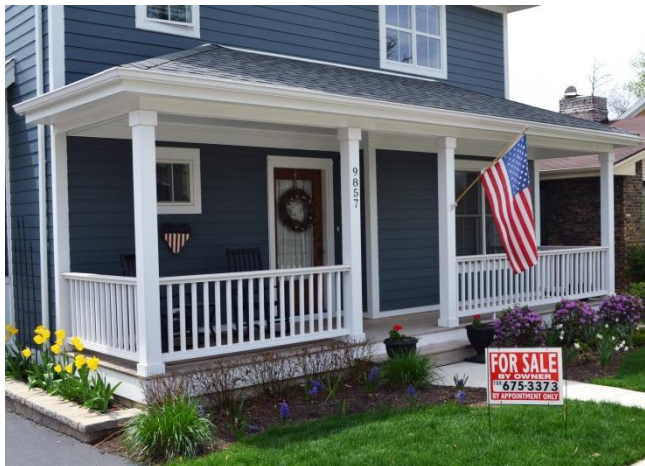
The material and style of this railing is much more typical of new homes in Old Orland, and is reflective of the design approved by the original COA.

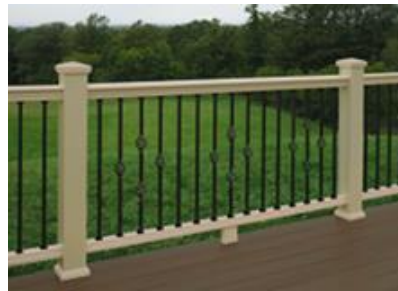
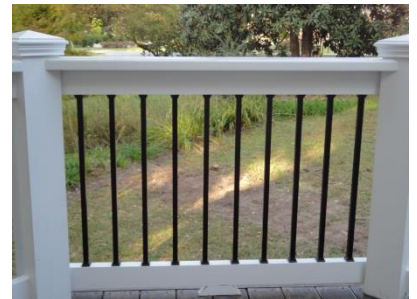
These photos are examples of the 'alternate solution' provided by staff in order to keep the metal material but change the design to make it more appropriate to the home architecture and Historic District standards.
