THE VILLAGE OF ORLAND PARK BASIN BEST PRACTICES PROGRAM

BASIN ASSESSMENT AND MANAGEMENT PLAN REPORT

Report Date:
June 30, 2011

Prepared by:
V3 COMPANIES

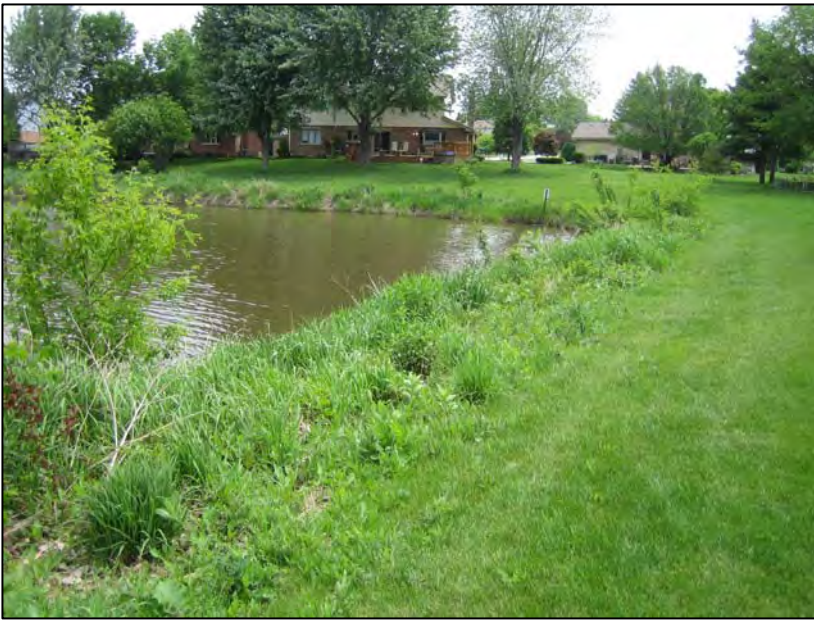
Eastern Portion of Caro Vista Pond: View east. Significant toe erosion along far slope.

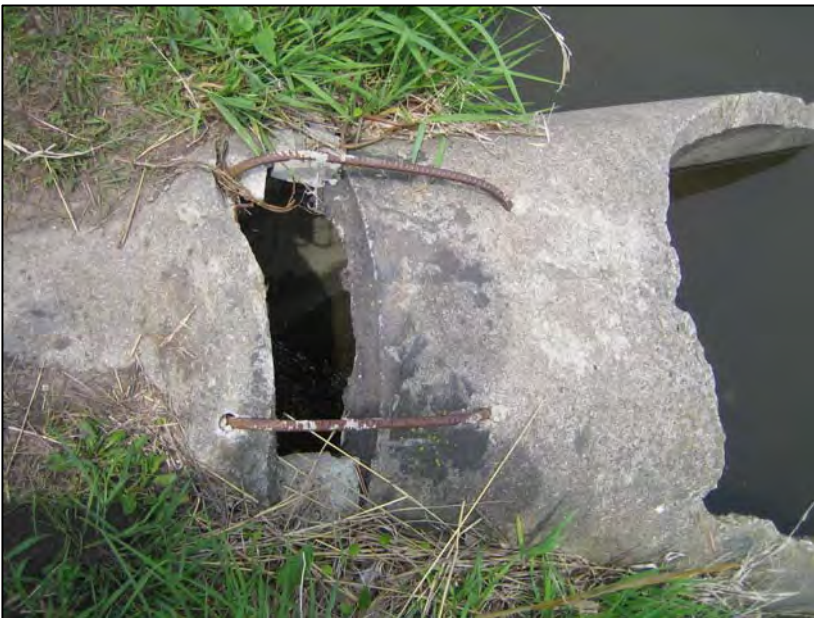
PHOTO 2

INLET PROBLEMS: Erosion is exposing FES. Rebar used to hold them in place. Failed FES should be repaired

Flared End Sections are undermined and falling into the lake. Attempt to keep them in place with rebar is not working.

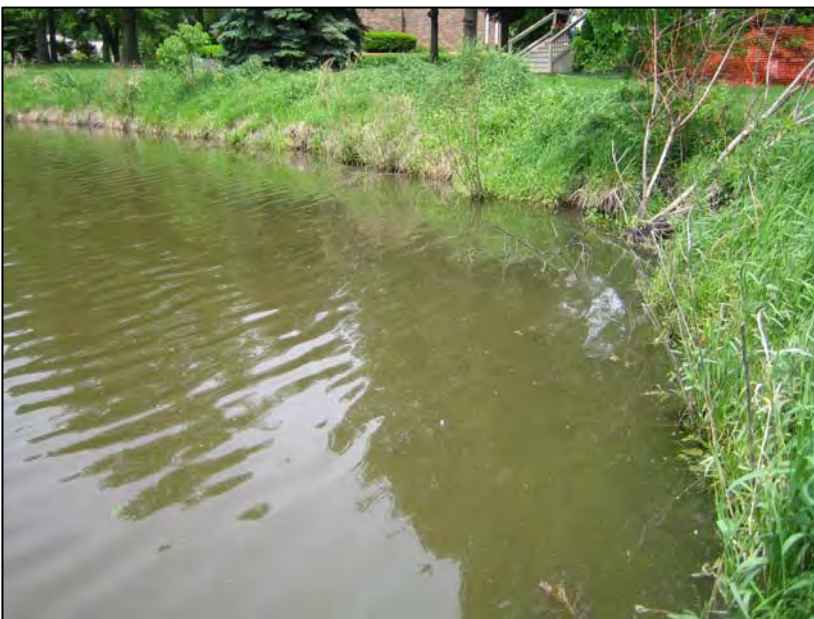
PHOTO 3

Northeast Corner – Sheer banks with 3 feet of vertical sloughing. Existence of stakes and permanent blanket from previous restoration efforts.

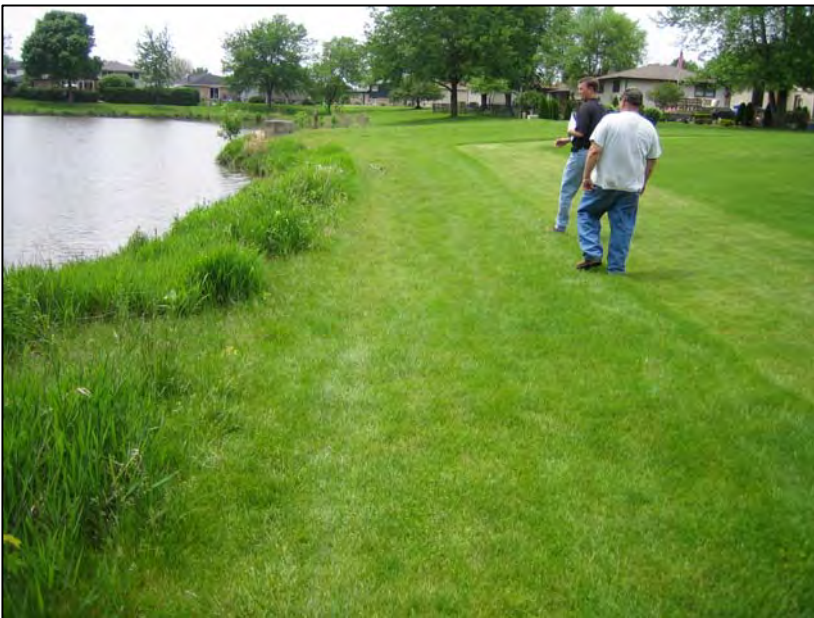
PHOTO 4

Permanent blanket exposed – minimal vegetative growth

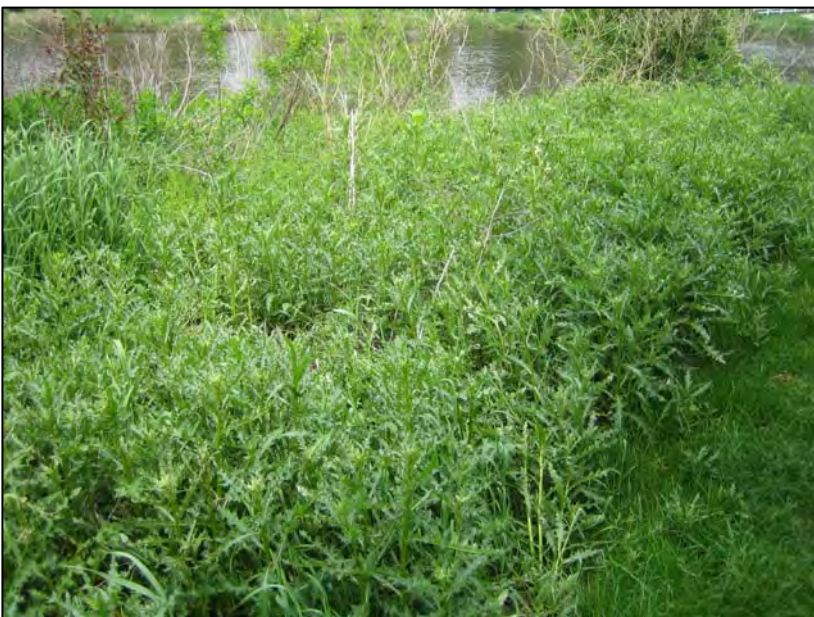
PHOTO 5

Minimal buffer (5-10 feet). Residential mowing into Village property shown on right side of photo.

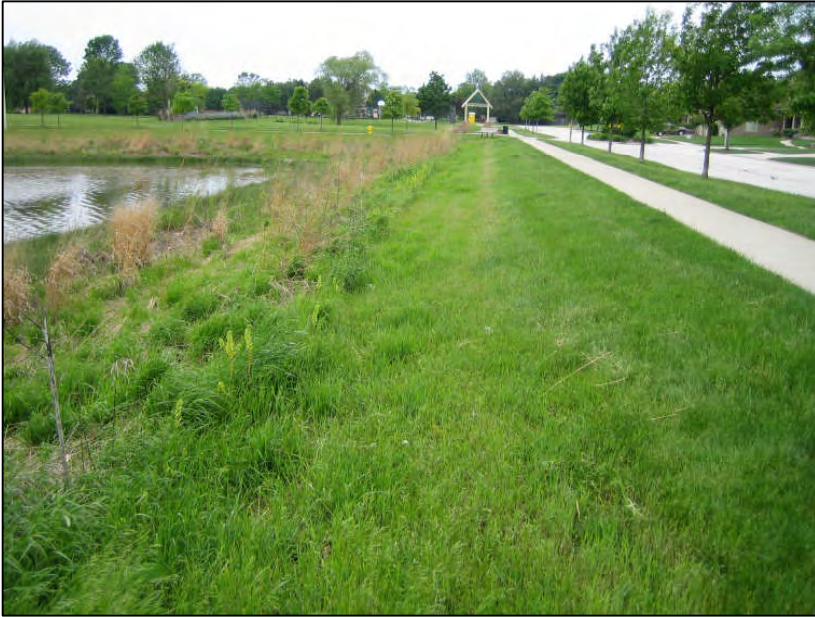
Northern slope – transition from sidewalk to turf to no-mow grass to prairie to wetland shelf.

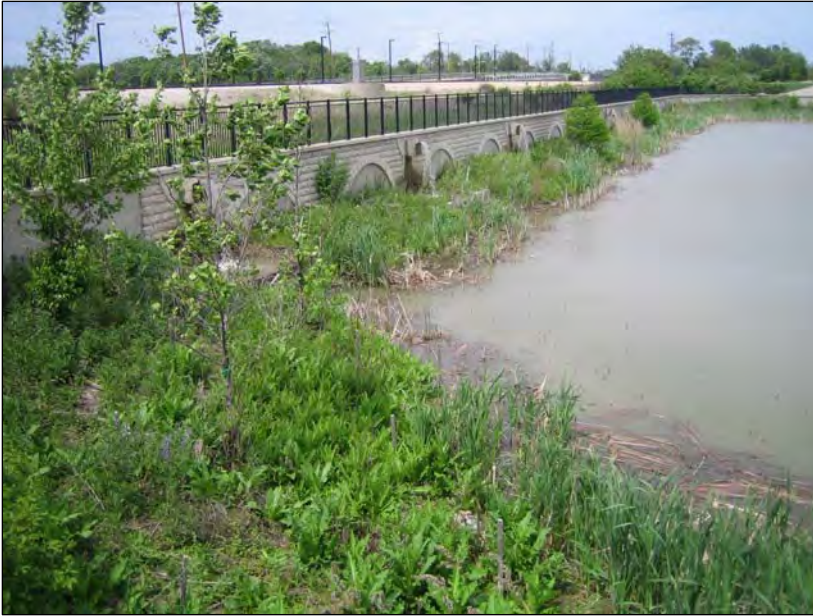
North Wall – Fountain features along wall with planter areas and cattail emergent shoreline. Significant weed invasion in planters.

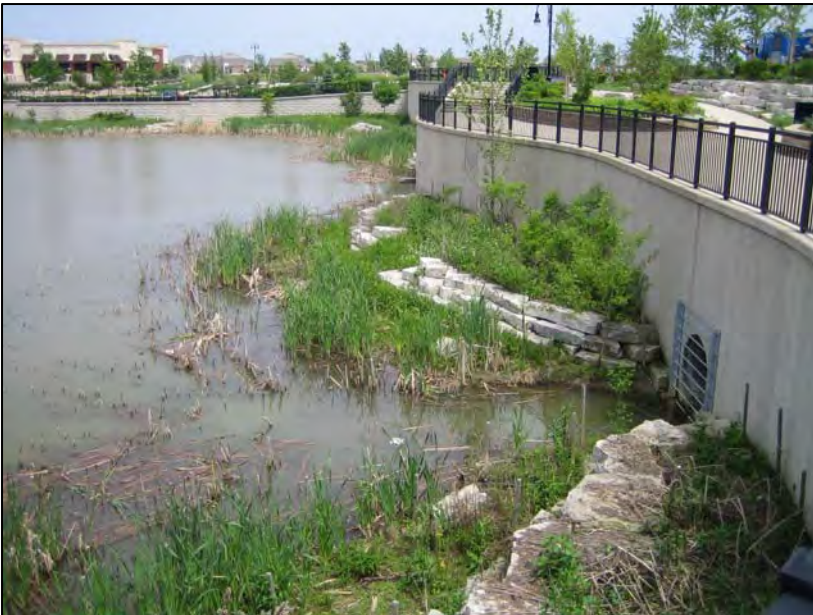
PHOTO 1

Southwest Corner – Lannon stone raised planter areas scattered along the concrete wall. Cut cattail material floating along edges of pond.

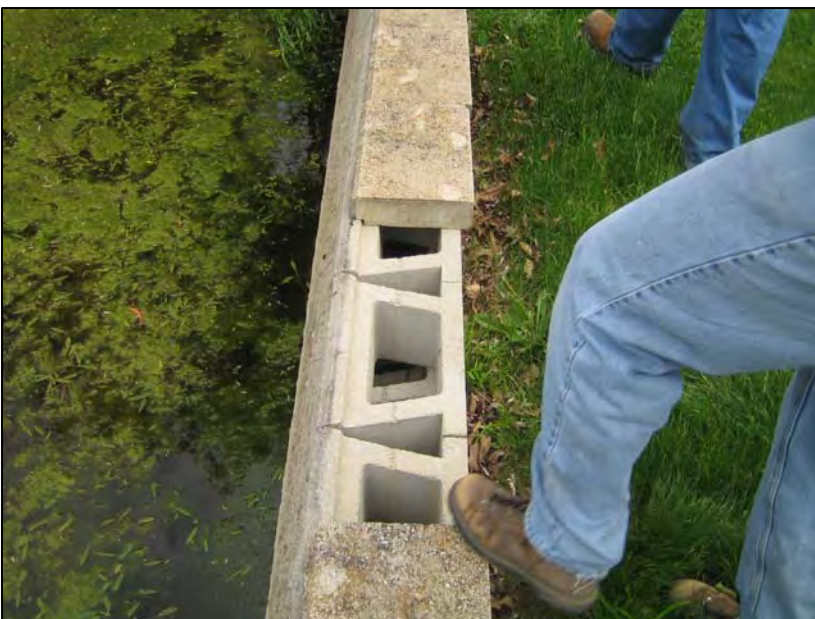
South Wall – Block wall completely lines the south shore of this pond. Mature willow trees in the background hang over the wall.

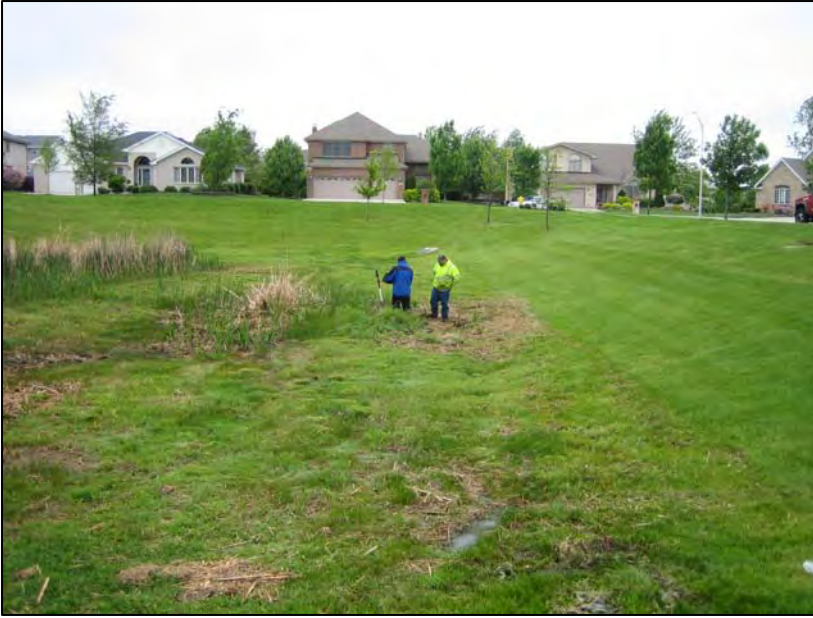
Pond overview from west bank. Mowing on pond bottom in wet area and in wetland vegetation.

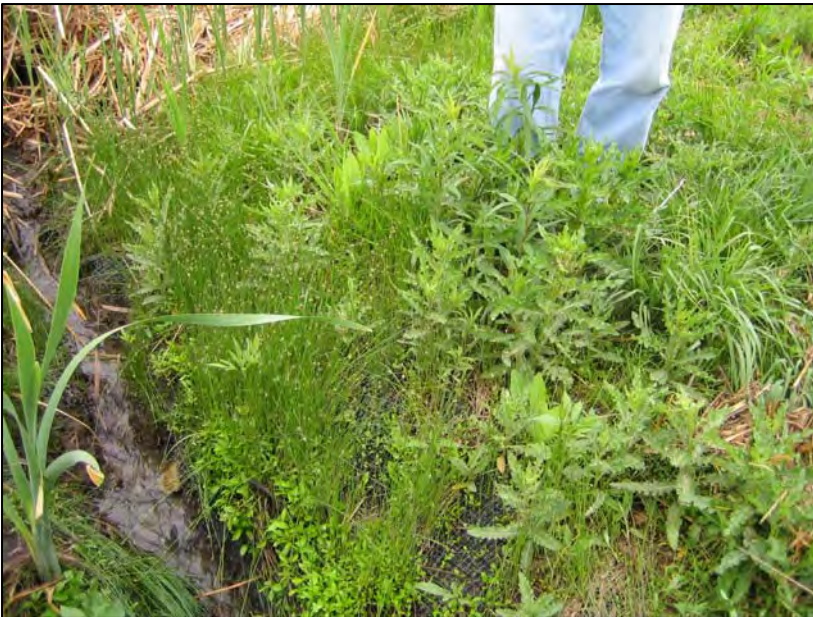
PHOTO 1

Channel cut through bottom of basin by residents to drain a cattail stand. Permanent erosion blanket exposed and cut along channel.

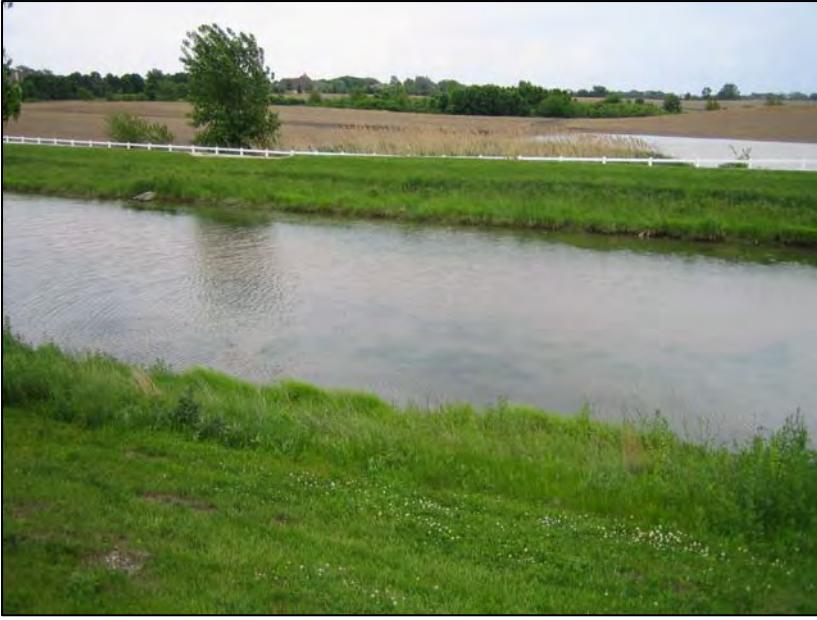
Pond overview from north bank. Narrow unmowed buffer along pond shoreline. Agricultural field in background is where pond outlets to.

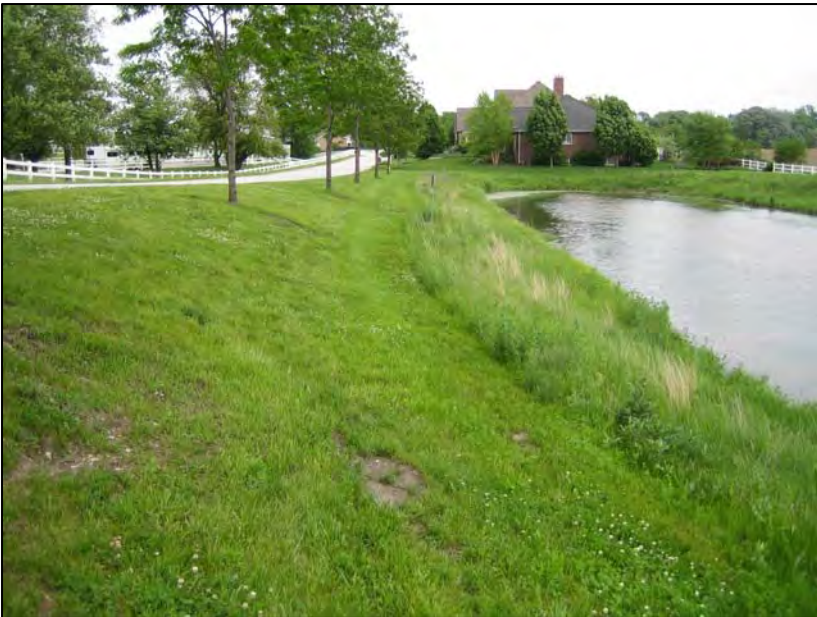
PHOTO 1

North slope – mowed area has some bare areas from mower tracks around trees.

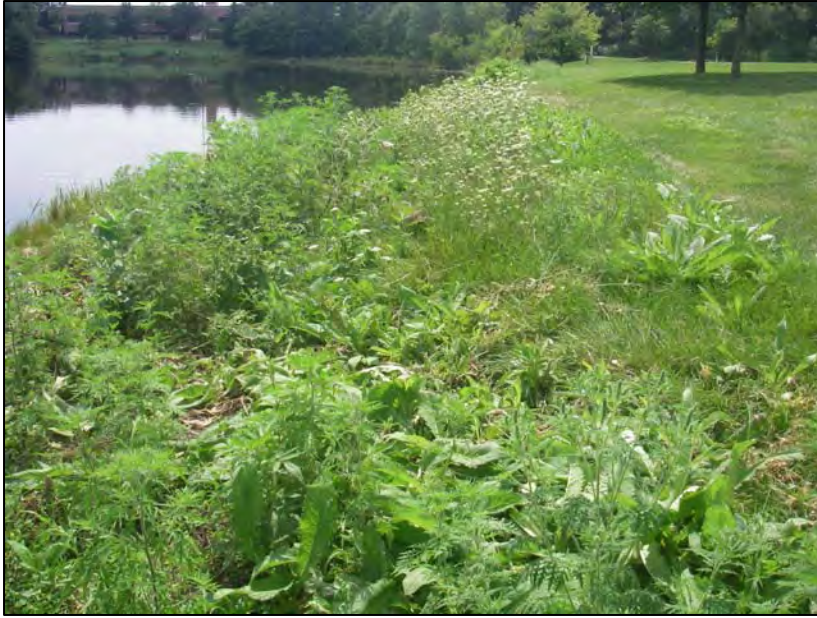
PHOTO 1

Teasel & thistle dominated west bank of Police Pond.

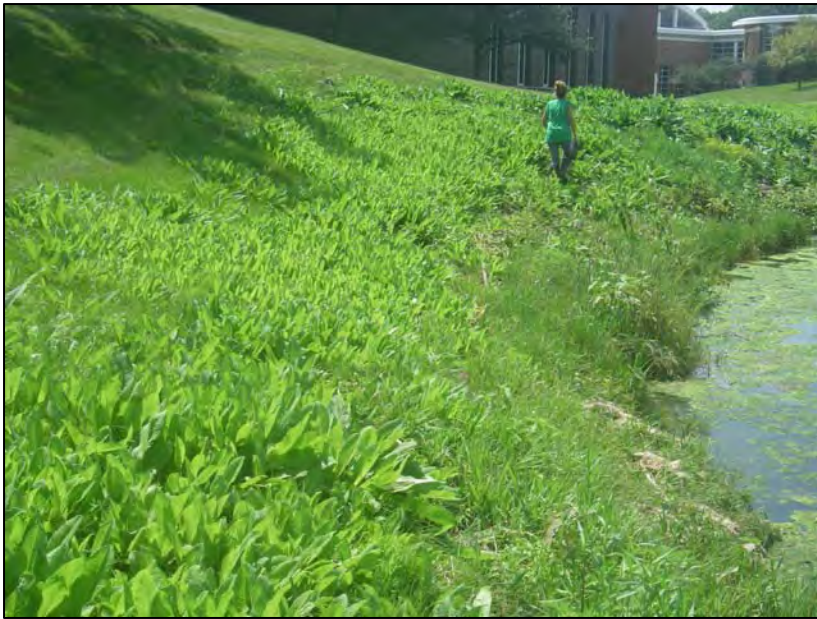
PHOTO 1

Banks of Village Center Pond dominated by teasel, thistle and turf grass.

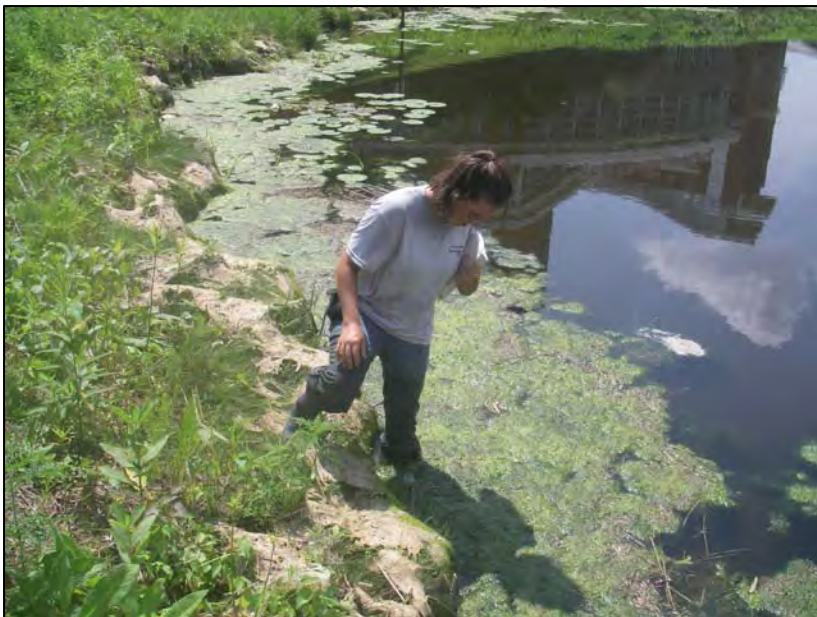
PHOTO 2

Approximate one (1') foot drop at toe of slope around much of the basin. Limited scour line appears to be forming above the water line. Obvious algae problem in the basin.

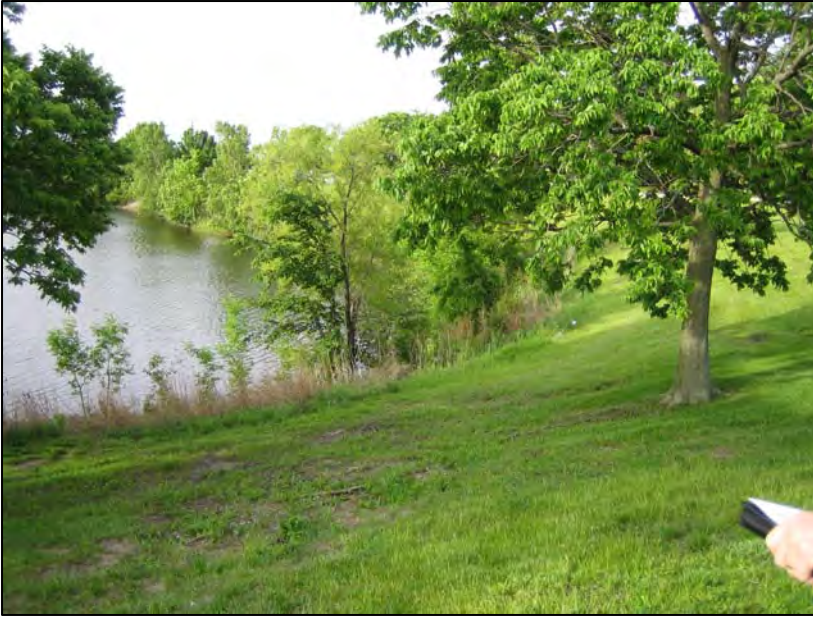
PHOTO 1

Northwest Corner. Bare spots in turf grass up slopes. Unmowed buffer of turf grass and mature trees lines entire basin.

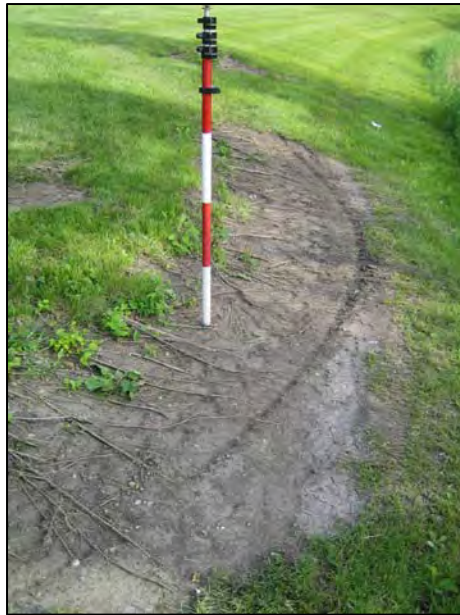
PHOTO 2

Area of bare slope due to mower tracks.

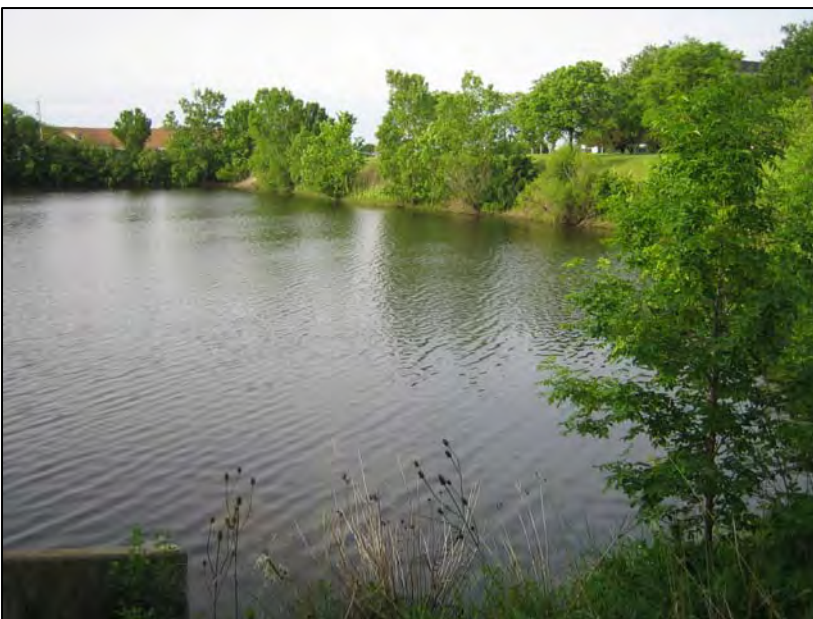
PHOTO 3

Overview from west slope showing condition of mature trees along shoreline.

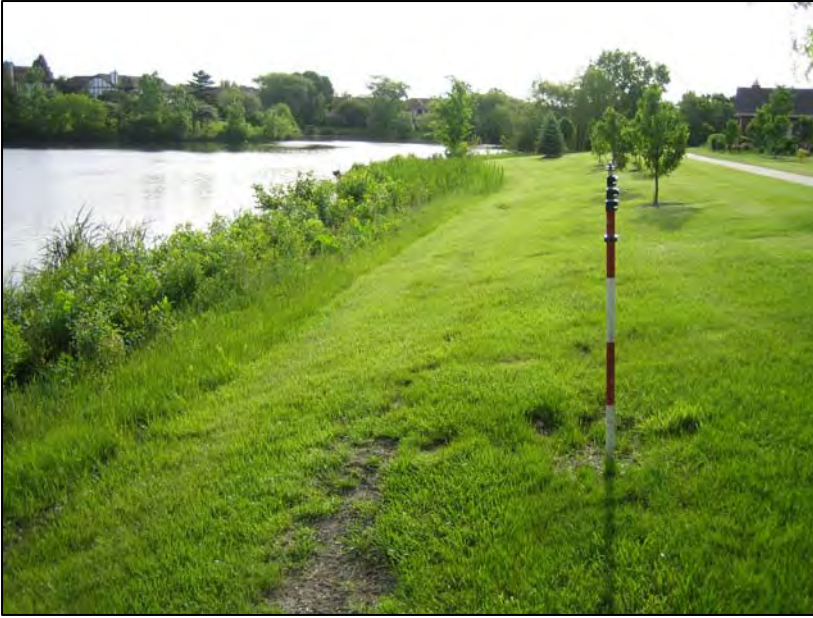
PHOTO 4

Slope slope – mowed turf area between sidewalk and un-mowed buffer along shoreline.

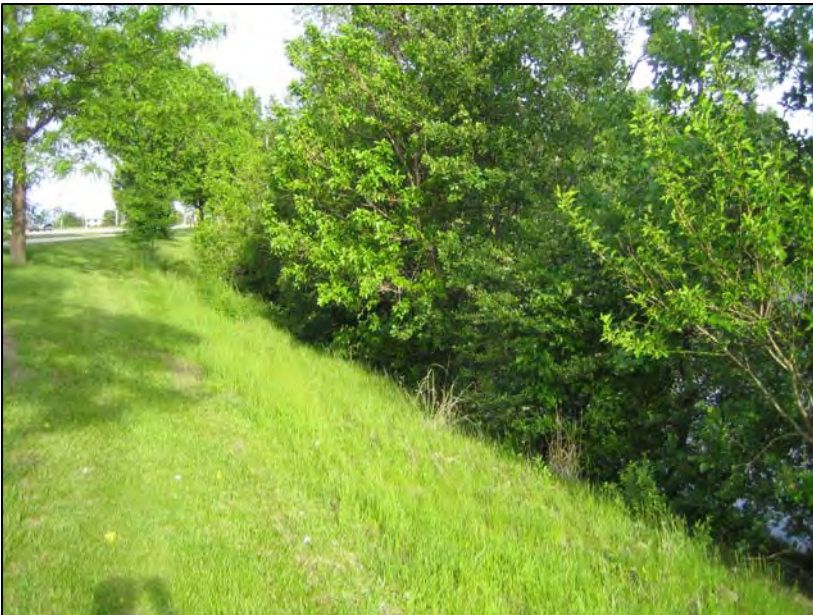
PHOTO 5

Steep banks at southwest corner of the pond.

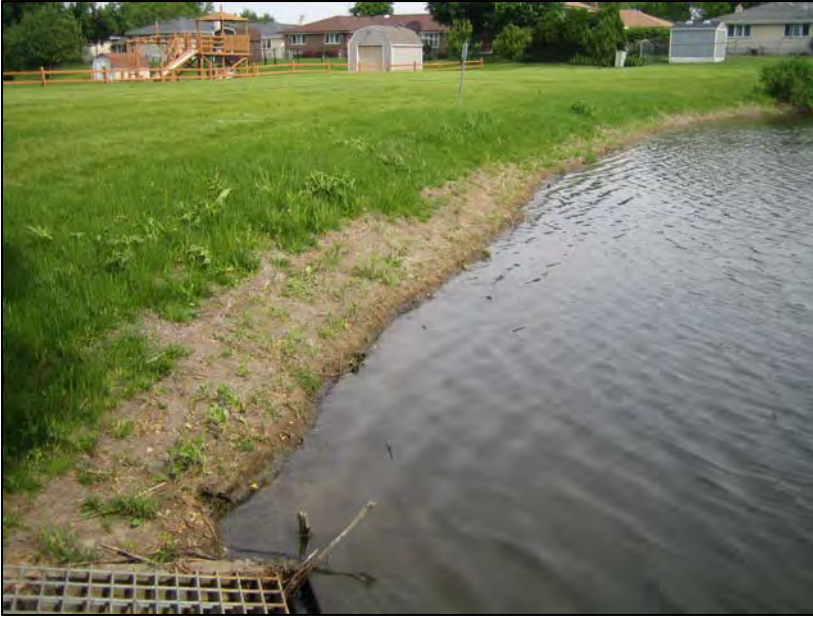
PHOTO 1

West Slope. Bare zone along shoreline due to chemical spill damage.

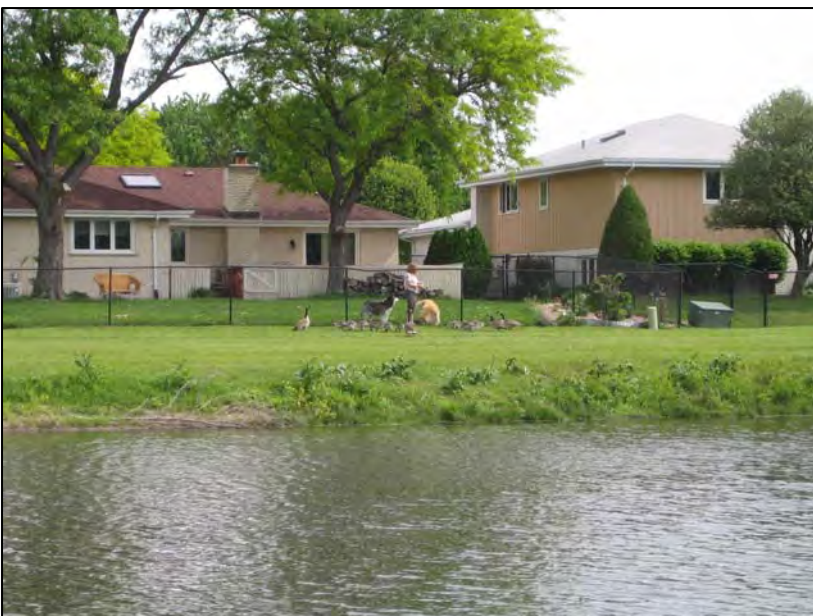
PHOTO 3

Flock of geese being fed by adjacent resident.

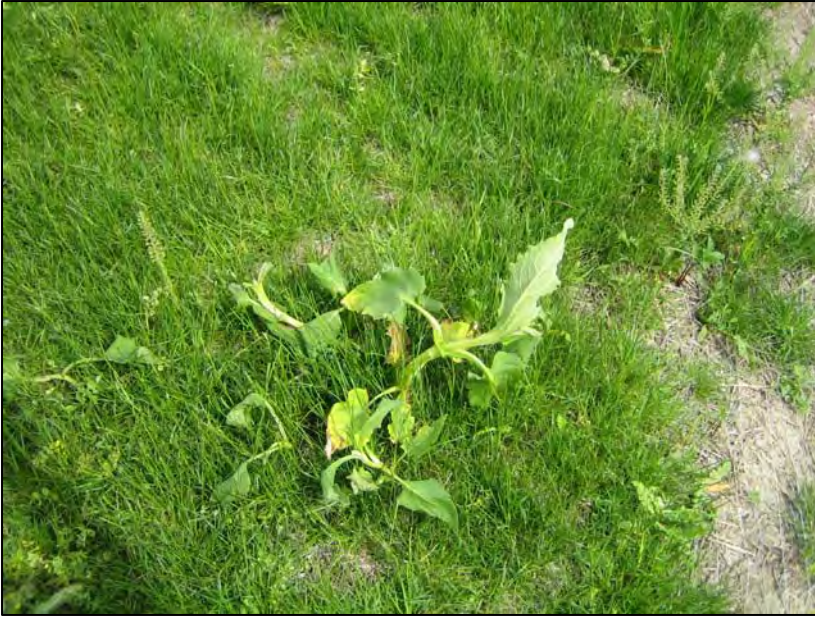
PHOTO 4

Signs of native plant damage due to Weed & Feed application on turf grass.

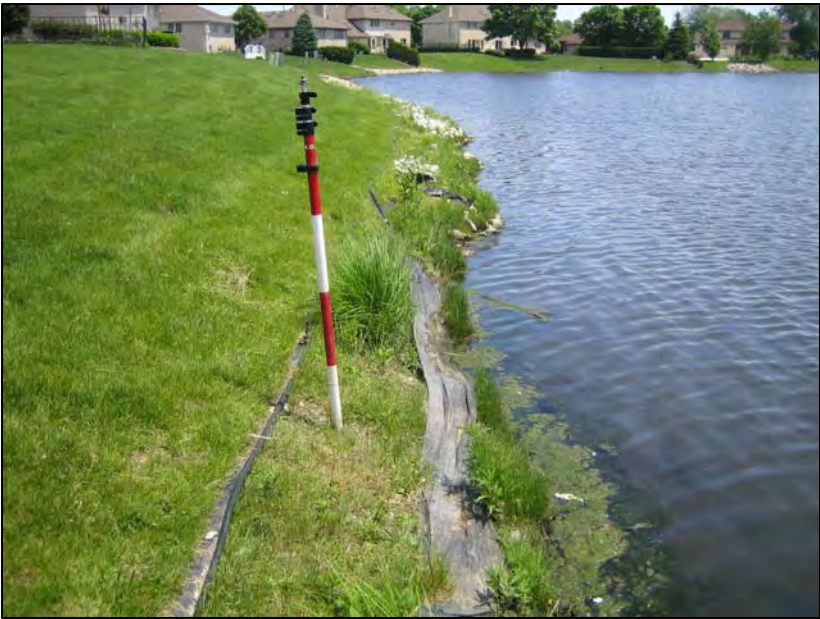
PHOTO 1

North slope – Village installed stabilization in near photo with exposed permanent erosion blanket.

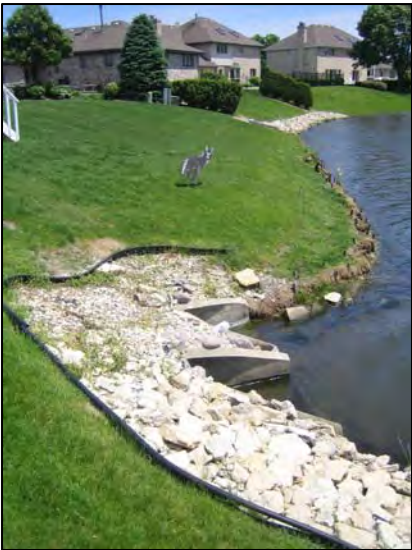
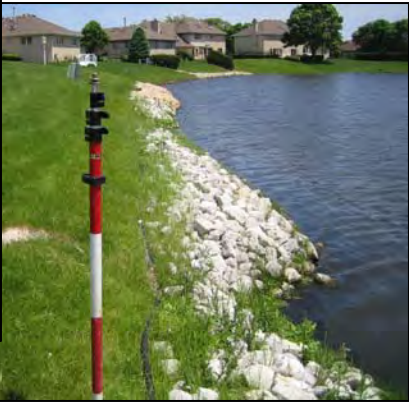
PHOTO 2 & 3

Various locations of resident installed stone shoreline. Left photo includes section of Village installed fiber roll.

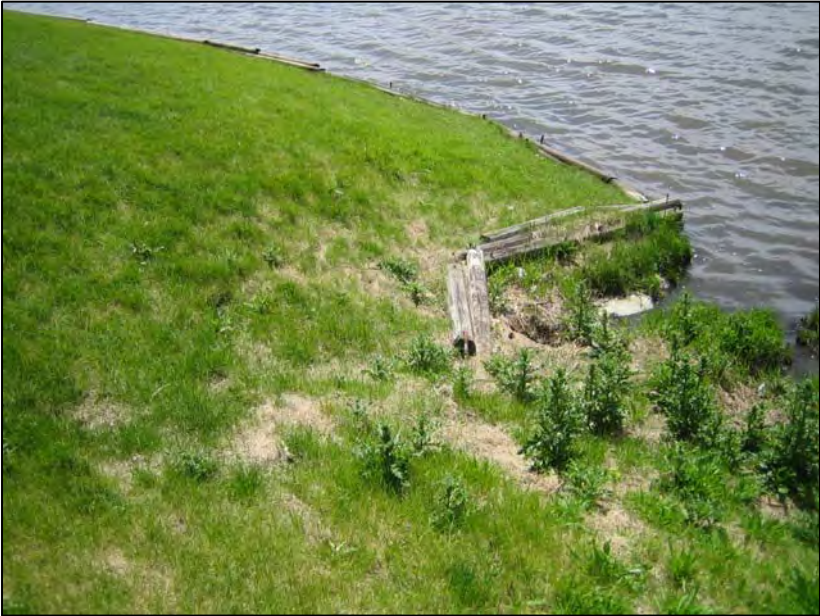
PHOTO 4

East slope – Resident installed timber wall along shoreline.

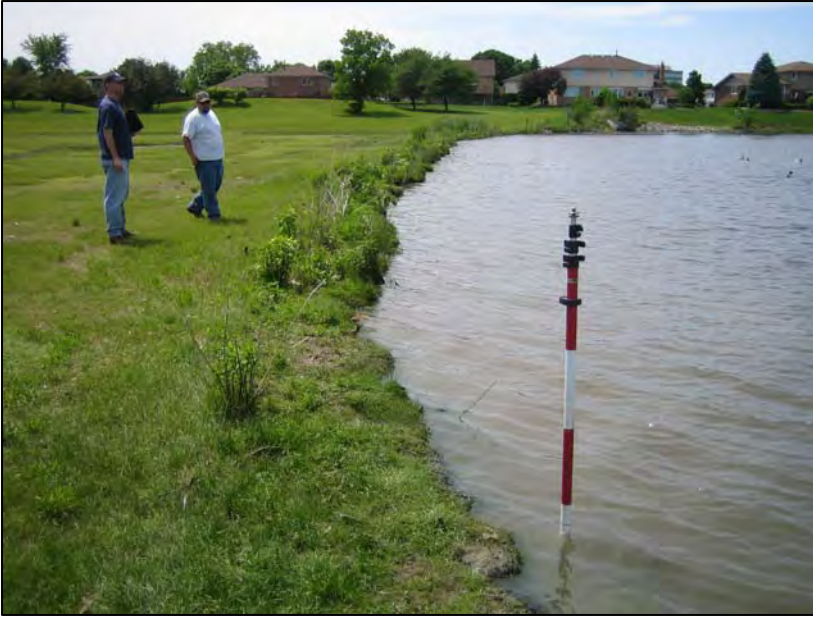
PHOTO 5

South shore – very flat slopes going up to baseball field – minimal buffer. Shallow emergent planting area potential within water line.

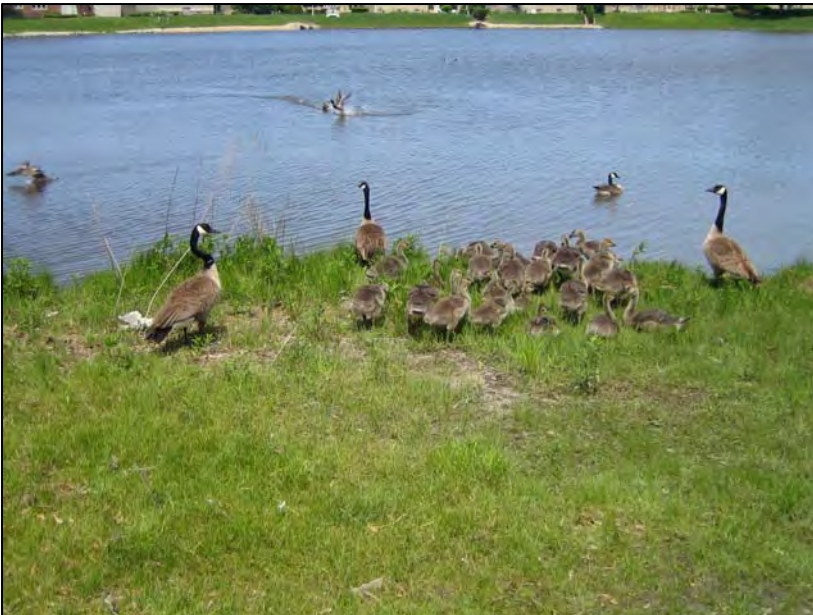
PHOTO 6

South shore – Significant geese population using this pond and adjacent turf grass field for raising their goslings.

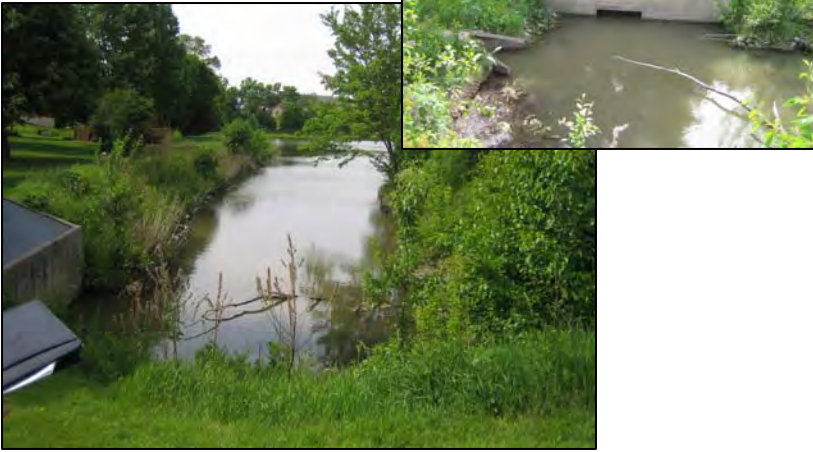
PHOTO 3

Locations of Village installed fiber roll still in place along outlet channel of Pond. Bare slopes above fiber roll will be a concern once the fiber roll degrades and is gone.

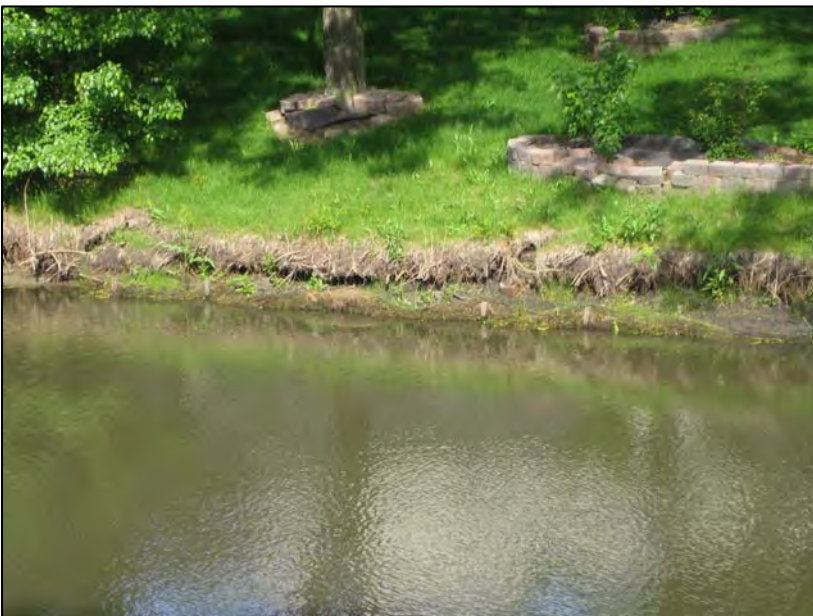
PHOTO 4

North slope – area of significant bank undercutting (approximately 2' scour).

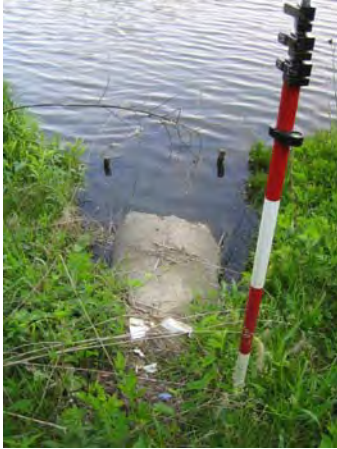
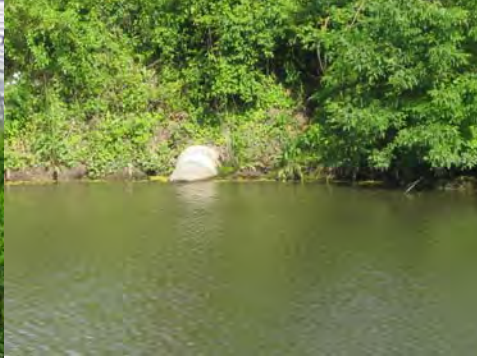
PHOTO 5 & 6

Locations of FES Failure. Left – Exposed FES on south shoreline. Right – FES dropped into water on north shoreline.

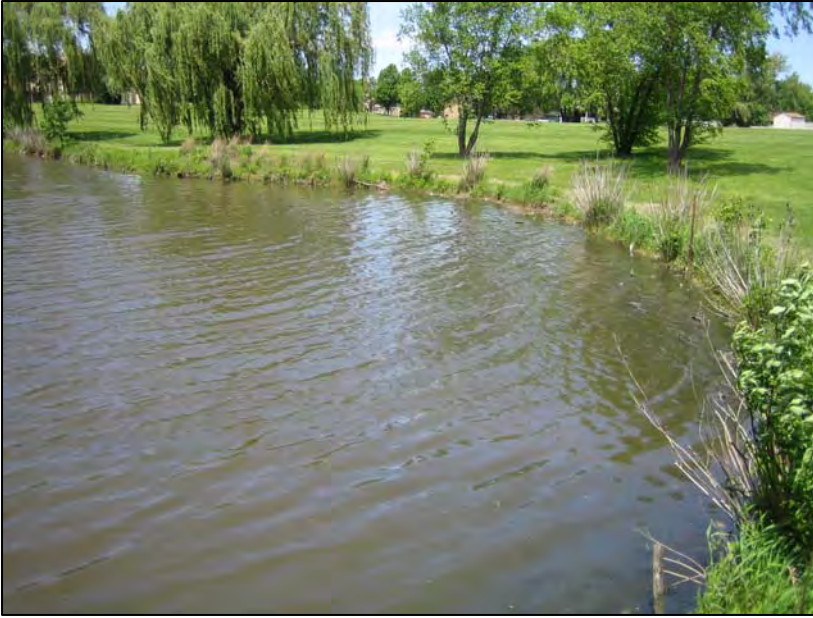
PHOTO 1

Northeast Corner – Small un-mowed buffer adjacent to large turf recreational area. Minimal erosion apparent in this location.

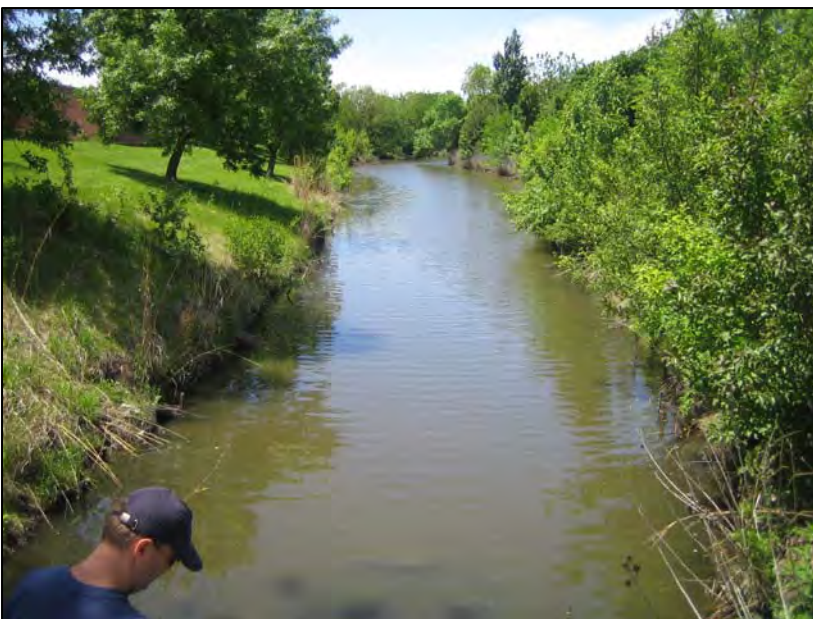
PHOTO 3

Steep banks outlet channel to east of pond. Mature tree and shrub growth exists along north slope of this outlet channel. Scour of approximately 1-2' along banks of this channel.

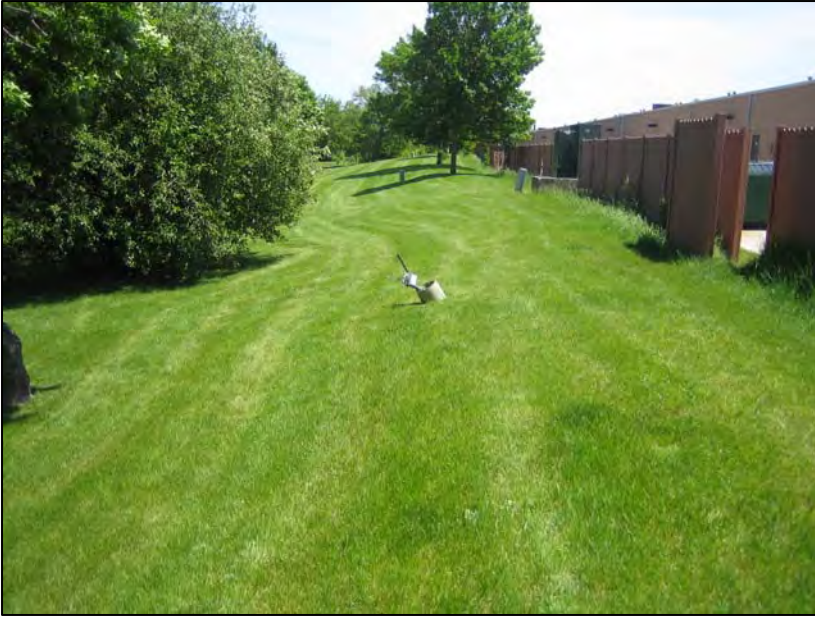
PHOTO 4

South of Pond – Large under-utilized turf grass area along commercial property. Mature trees line shoreline on south shoreline.

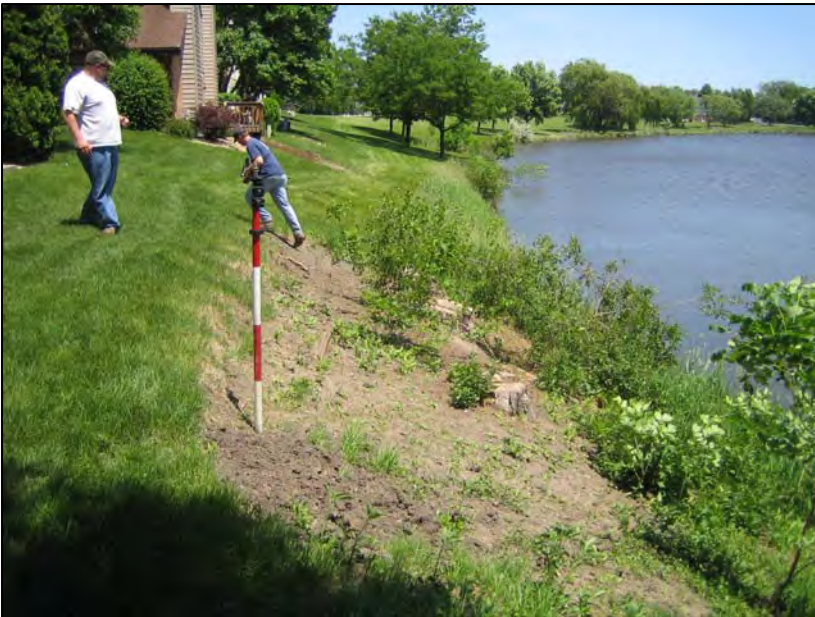
PHOTO 5

West slope – Location of 3 large trees (pine) removed on steep slope. Bare slopes above significant scour zone along shoreline.

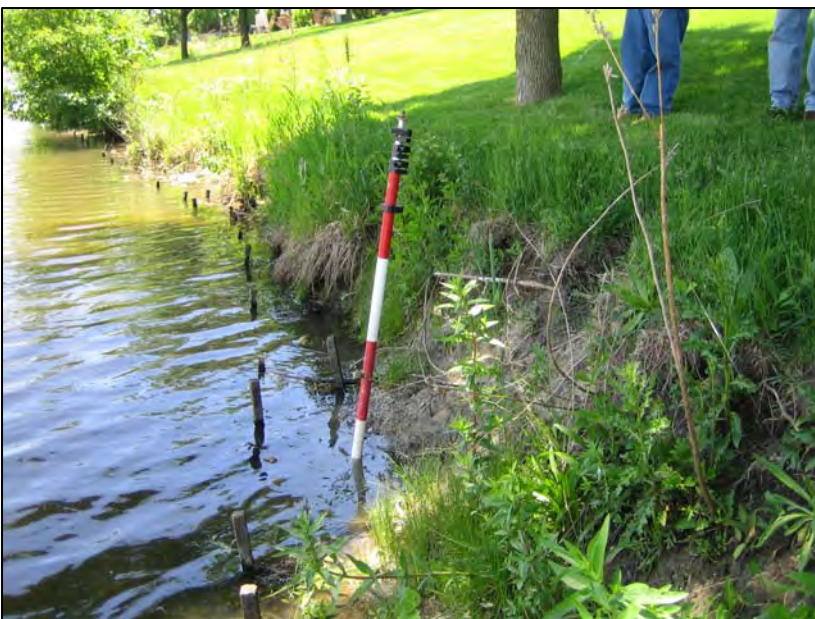
PHOTO 6

North slope – Severe bank erosion and sloughing along much of the north shoreline. Signs of historic fiber roll installation that has degraded.

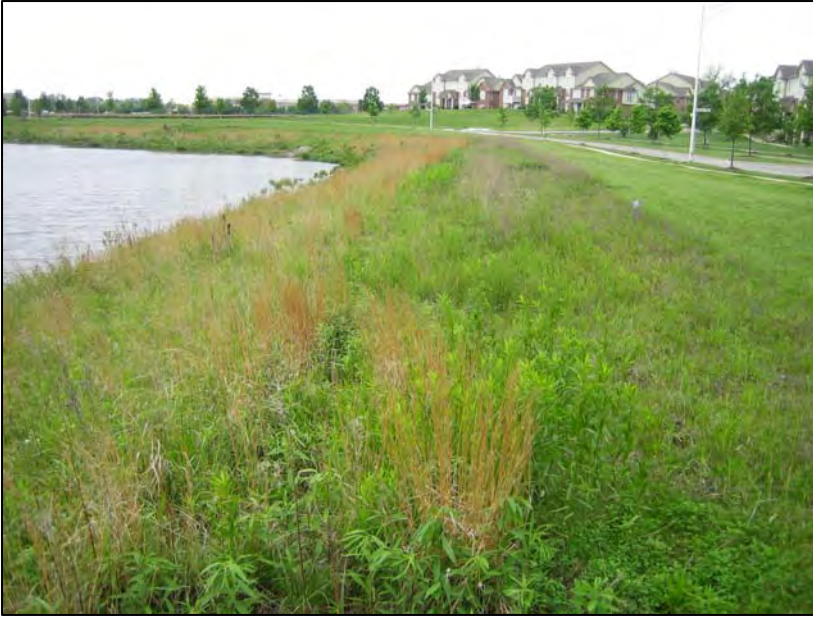
PHOTO 1

West slope – Transition from sidewalk to mowed turf to native prairie slope to emergent shoreline. Slopes in good condition and excellent mix of natives.

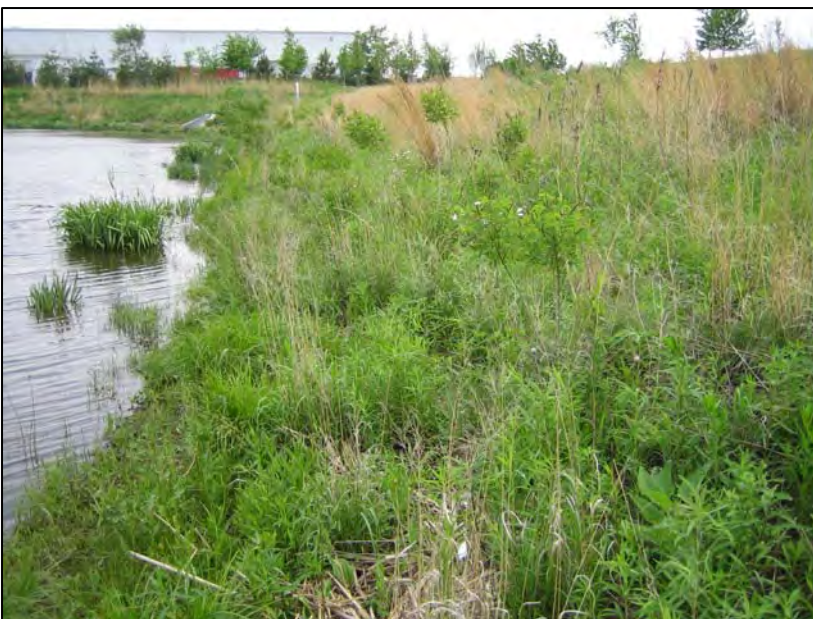
PHOTO 3

Healthy emergent shore and native prairie buffer surrounds the entire pond.

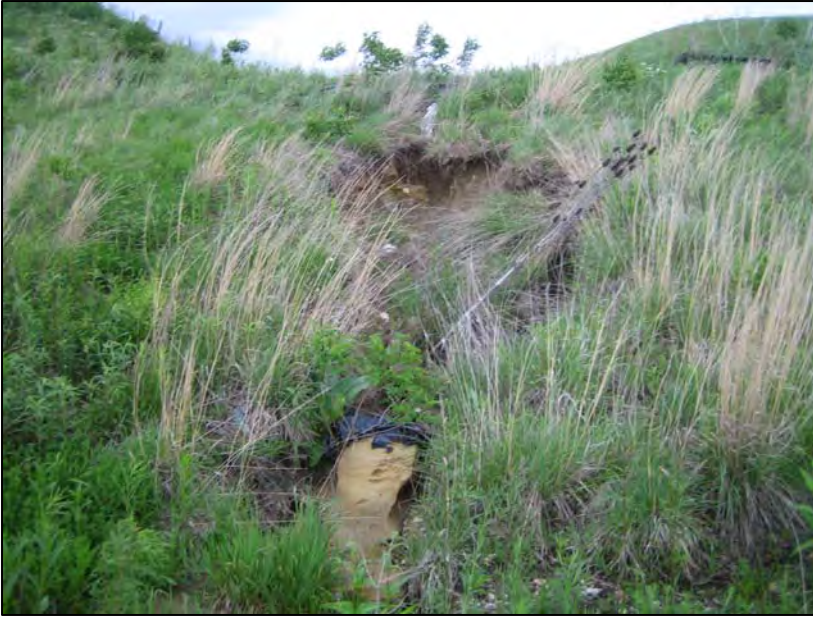
PHOTO 4

Severe rill (5' deep) coming from pavilion and venue area to the north of pond. Need to contain water in a dedicated rip-rap channel down slope.

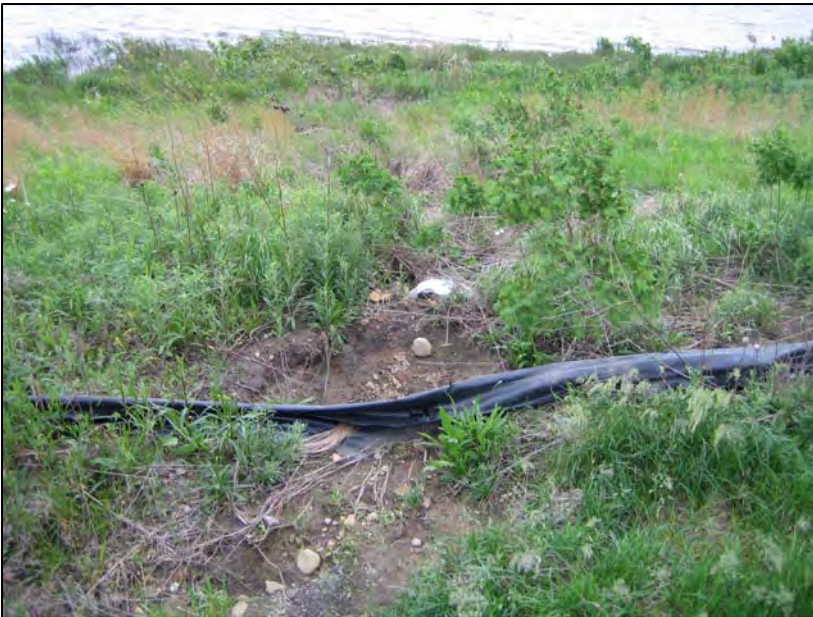
PHOTO 5

North slope – Location of historic silt fence within slopes which is now creating erosion points and rills. Should remove or cut off silt fence along entire length of north slope.

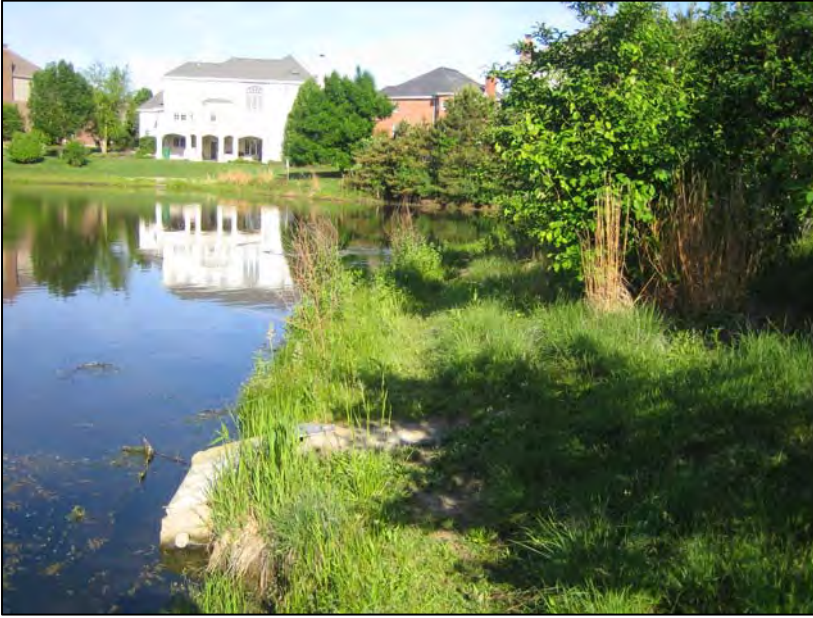
PHOTO 1

North slope – Mature trees & shrubs in unmowed turf buffer. Signs of fishermen trail around entire pond.

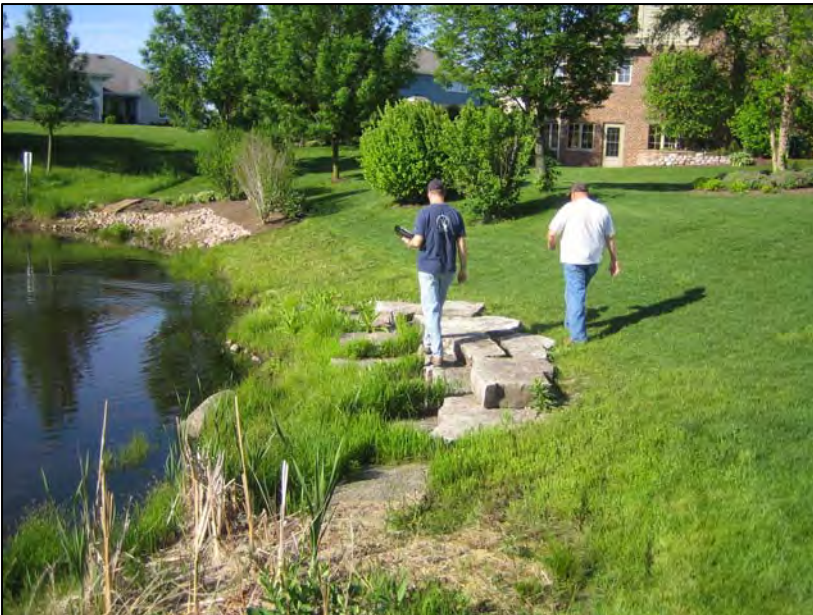
PHOTO 2

West slope – landscape installations and mowed turf grass to shoreline.

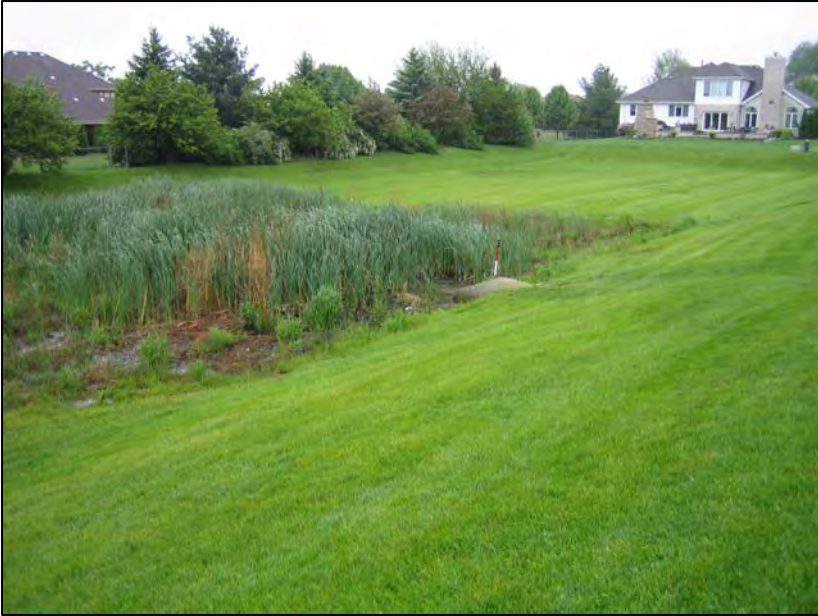
PHOTO 1

Overview from north slope – turf surrounding low area of cattails.
