THE VILLAGE OF ORLAND PARK BASIN BEST PRACTICES PROGRAM

BASIN ASSESSMENT AND MANAGEMENT PLAN REPORT

Report Date:
June 30, 2011

Prepared by:
V3 COMPANIES

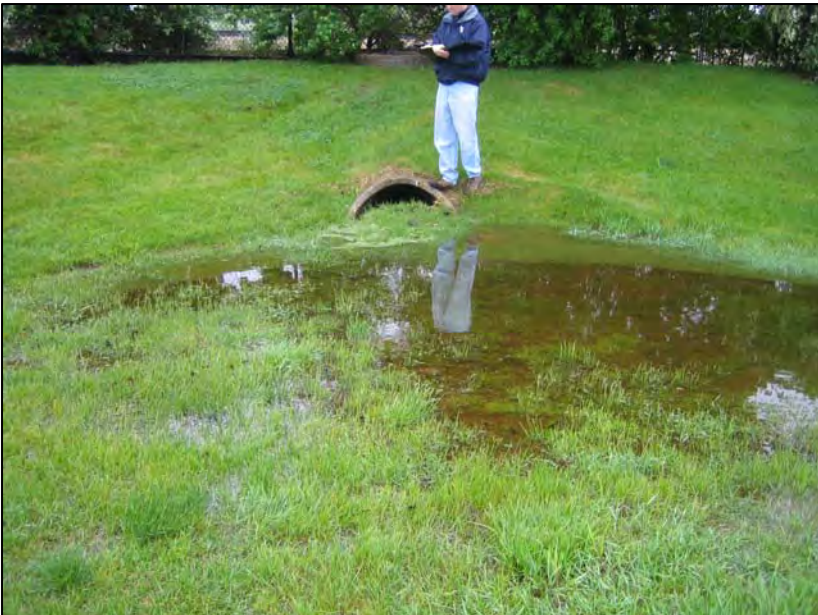
PHOTO 2

Southeast corner – One of the outlets blocked by sediment.

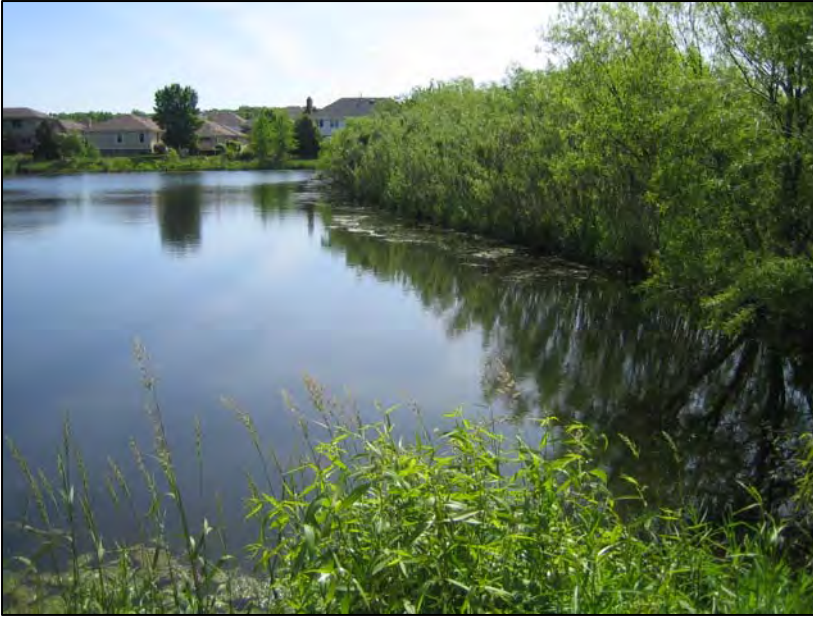
PHOTO 1

South shore of pond is mature willow growth and large wetland complex. Pond outlets to this wetland area.

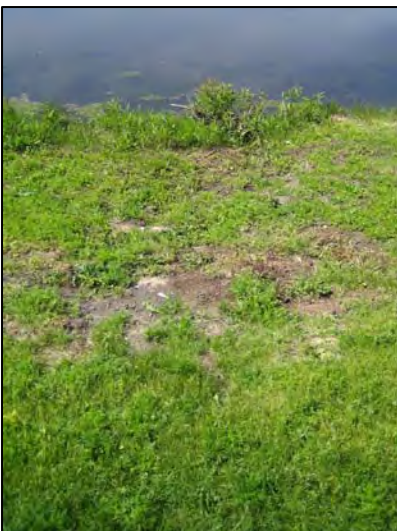
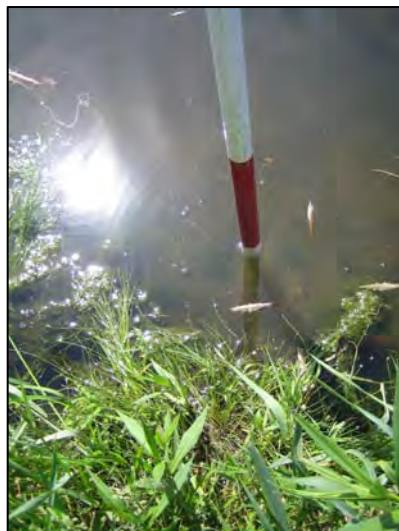
PHOTO 3 & 4

Bare spots on slope and 18-24” eroded shoreline typical around west and north slopes.

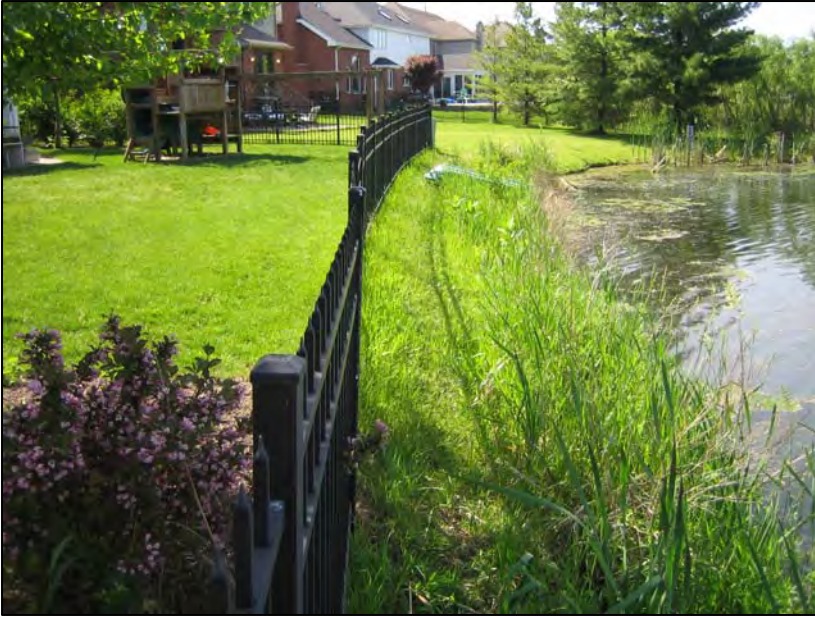
PHOTO 5

Severe erosion (2' scour) along eastern slope immediately adjacent to fence line.

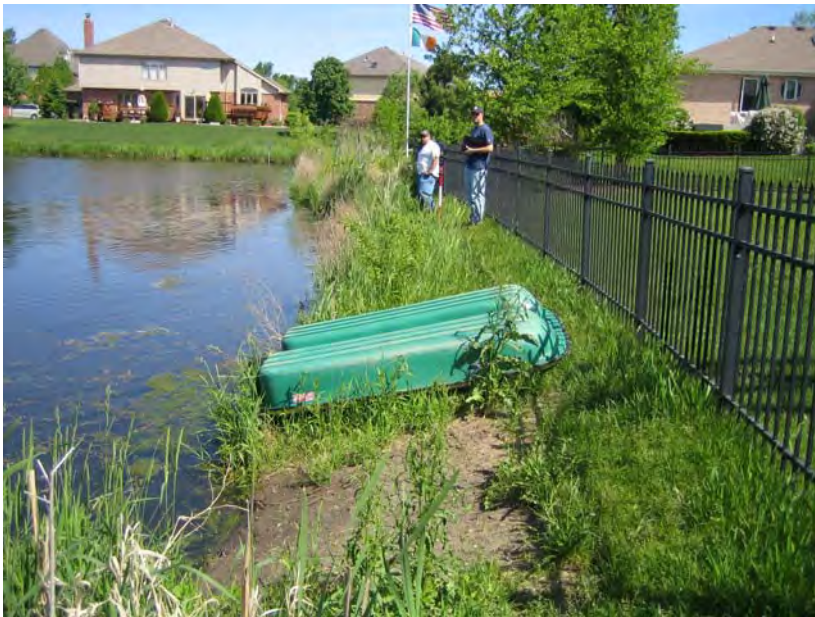
PHOTO 6

Resident use of slope for boat storage – signs of killed vegetation under boat.

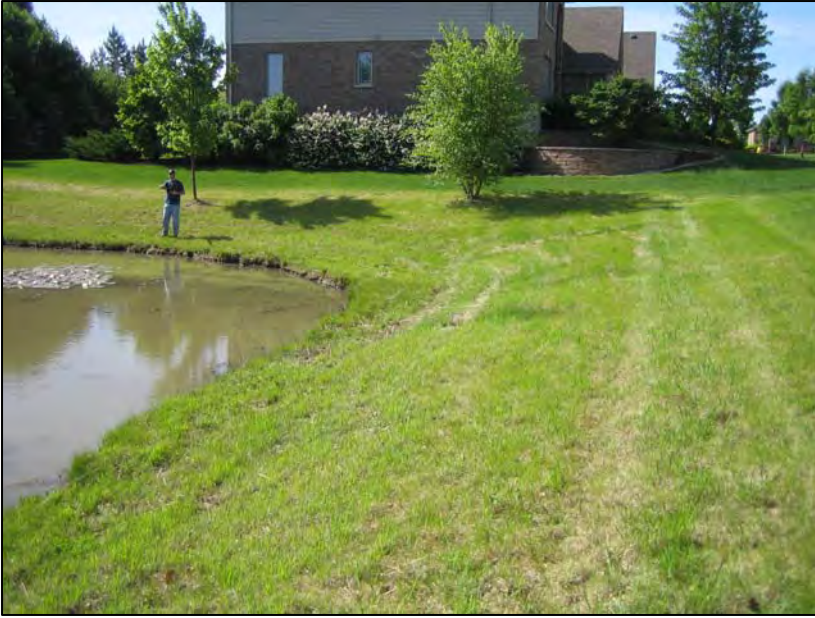
PHOTO 1

Mowed turf grass to shoreline – minor scour and erosion along toe of slope.

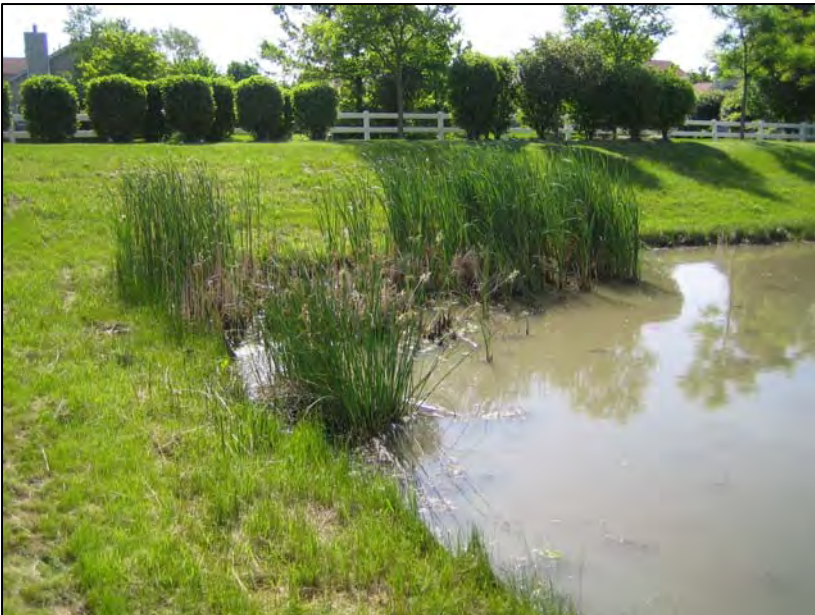
PHOTO 2

Cattail growth at outlet from basin. Also observed high turbidity of water likely due to carp or goldfish in shallow pond.

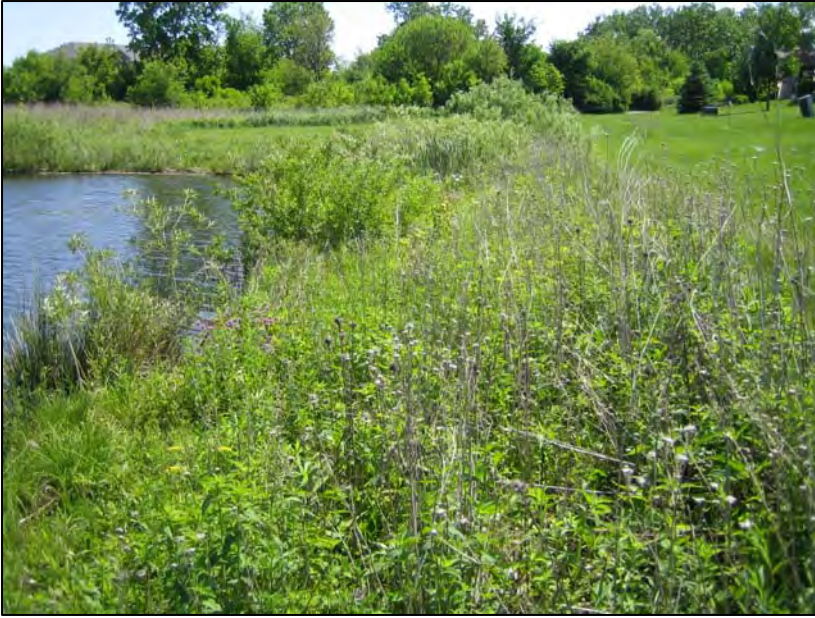
PHOTO 1

South slope – Native prairie slopes and emergent shoreline in good condition.

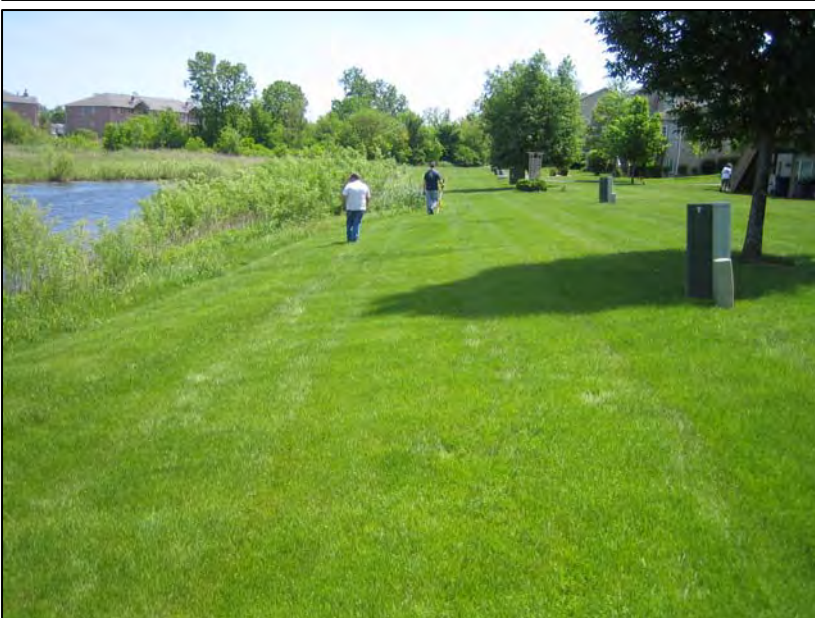
PHOTO 3

Regional trail along north top of slope.

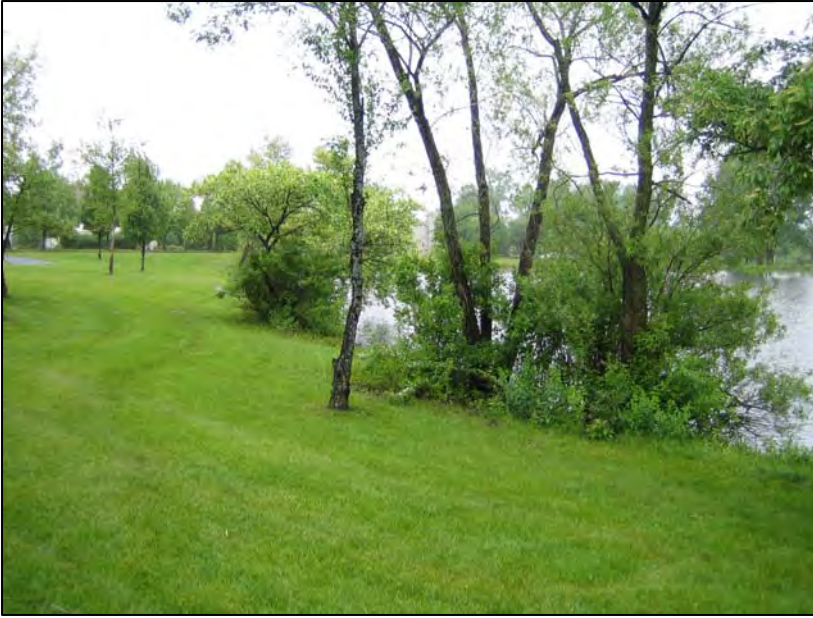
PHOTO 1

Minimal un-mowed buffer around pond. No residents on this pond – completely within park. Turf grass with a few mature trees.

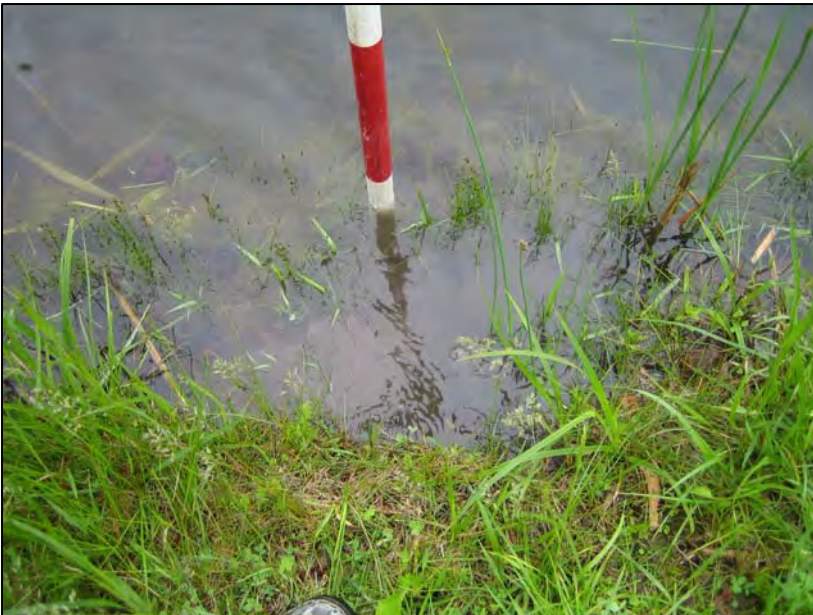
PHOTO 2

Good growth of emergent vegetation along shoreline and into water.

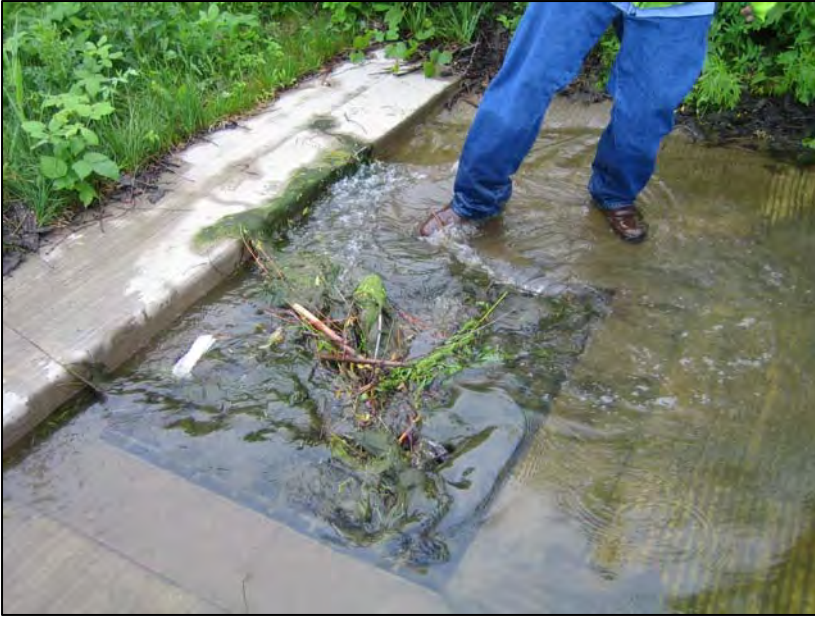
PHOTO 1

Blocked outlet grate due to grate design. Regular occurrence and maintenance issue.

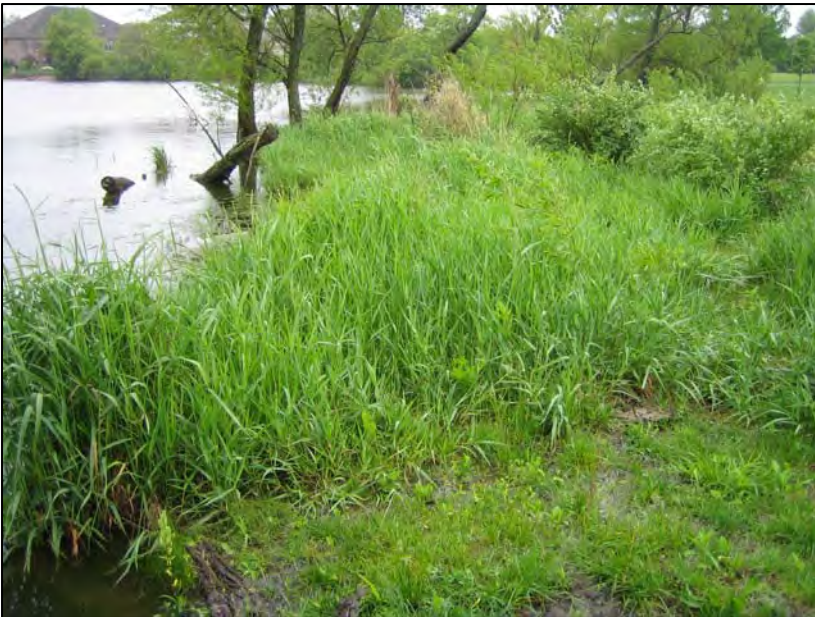
PHOTO 2

Un-mowed turf buffer and mature trees and shrubs along west slope.

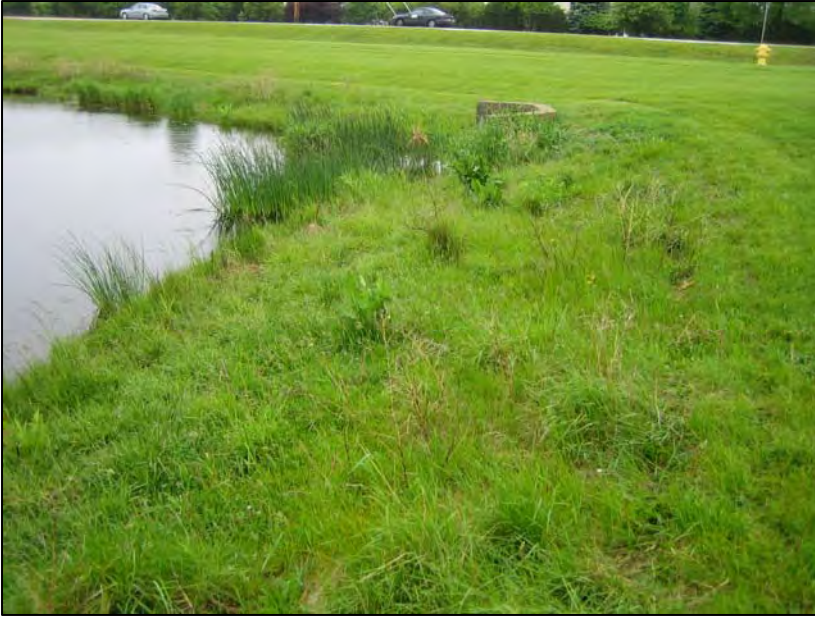
PHOTO 1

Flat slopes around entire pond – narrow unmowed buffer with surrounding turf grass.

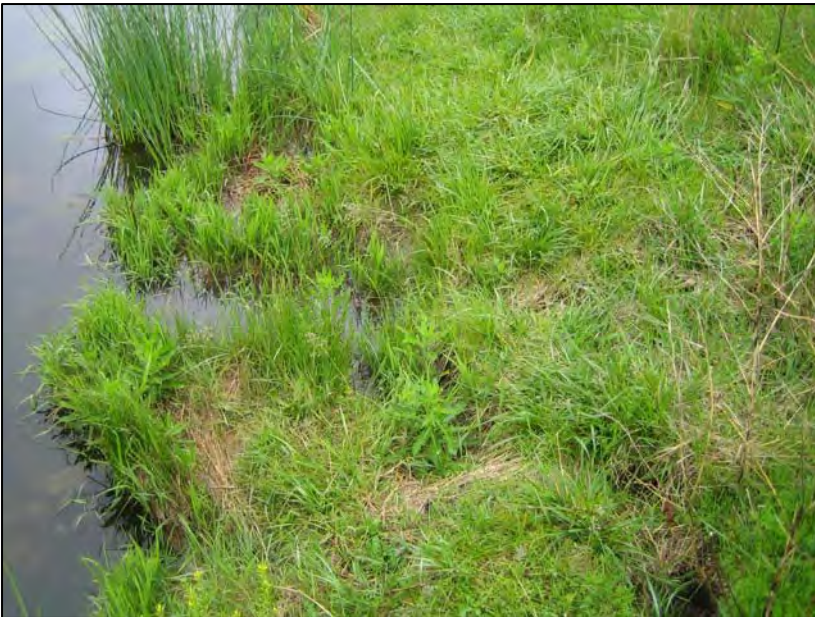
PHOTO 2

Good growth of emergent vegetation along shoreline. Signs of historic muskrat activity – not active.

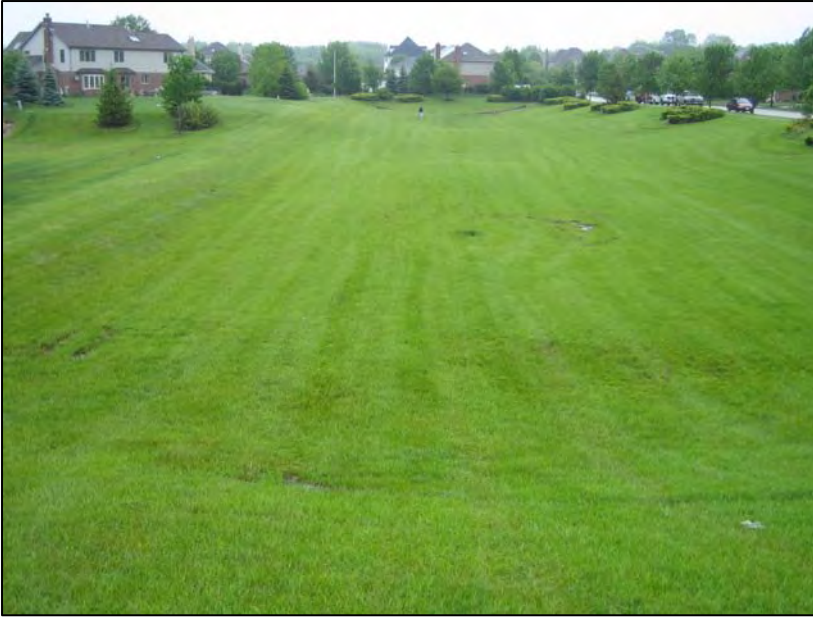
PHOTO 1

Overview of Amber Pond: View east.
